Inquiry MO-2010-206: Coastal container ship *Spirit of Resolution*  
grounding on Manukau Bar, Auckland, 18 September 2010

Marine inquiry 10-206  
coastal container ship *Spirit of Resolution*  
grounding on Manukau Bar, Auckland  
18 September 2010

Approved for publication: July 2015

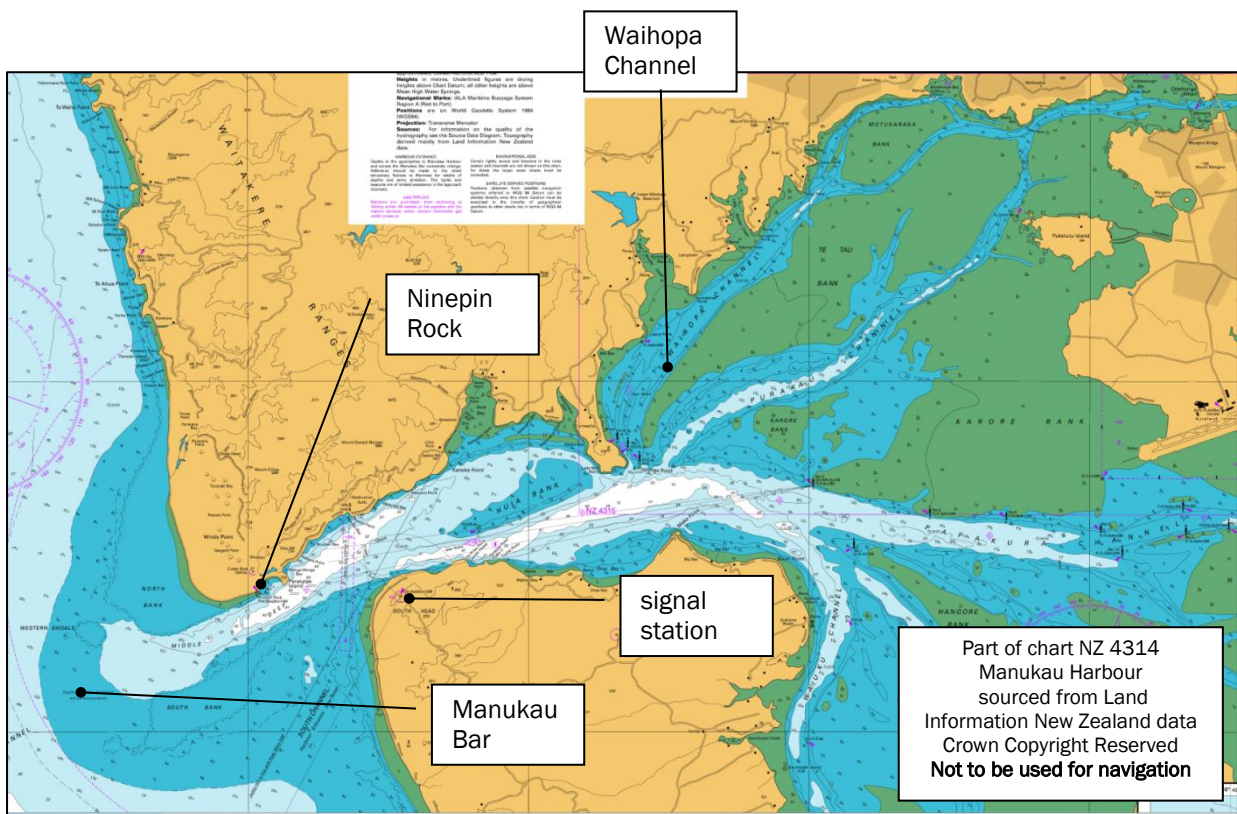
Figure 1  
Part of Chart NZ 4314, Manukau Harbour  
(Courtesy of Land Information New Zealand)

- 3.1.2. At about 0730 on Thursday 16 September 2010, the *Spirit of Resolution* had crossed the Manukau Bar and anchored off Lawry Point near the harbour entrance to await the incoming tide. This was in order to have sufficient depth in the channel for the vessel to make for Onehunga wharf (see Figure 1).

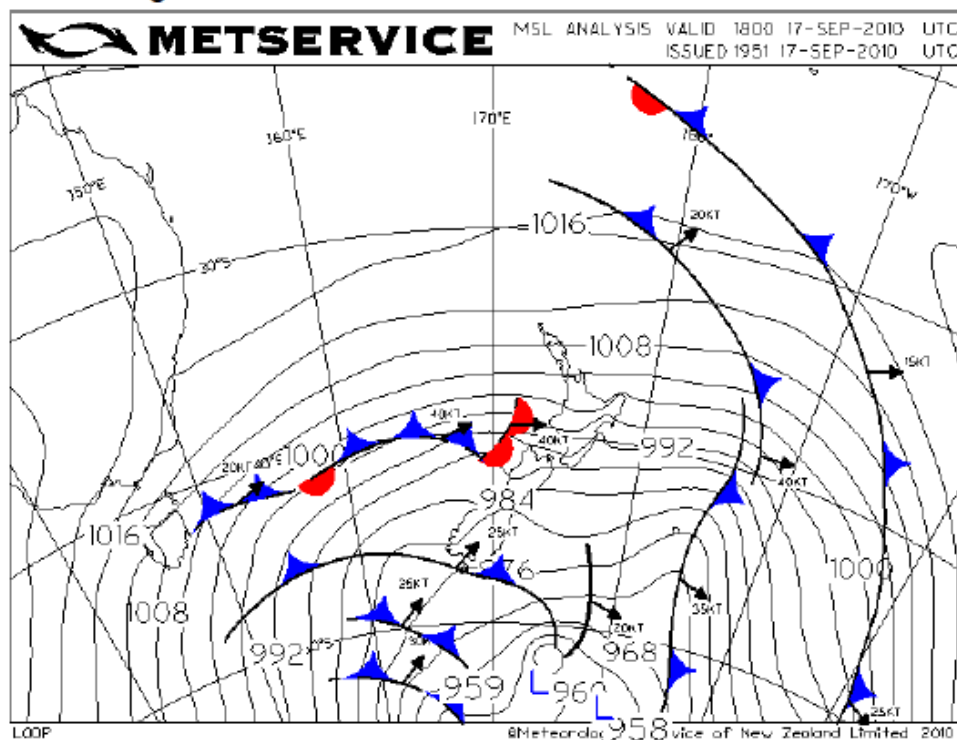
Figure 1: MetService 1800 UTC 17 Sep 2010 MSL analysis chart.

At 6am 18 September 2010 (see Figure 1 above) a very large trough of low pressure was moving very slowly eastwards across New Zealand. A broad belt of strong west to southwest wind covered the Tasman Sea. This belt of wind had been moving into the Tasman Sea area from south west of Tasmania over the previous two days.

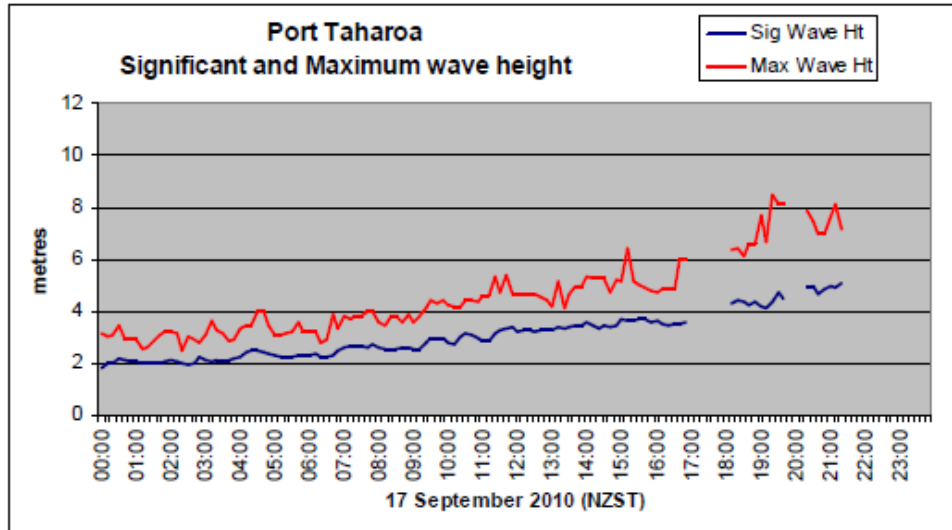
Figure 2: Significant and maximum wave height recorded at Port Taharoa on 17 September 2010. Data stopped recording at 23:24.

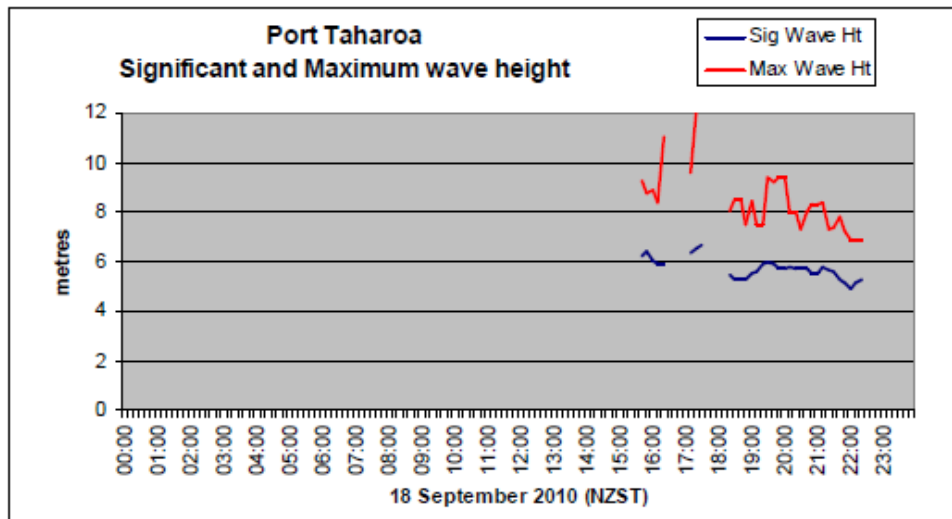
Figure 3: Significant and maximum wave height recorded at Port Taharoa on 18 September 2010. Data recommenced recording at 14:49.
