Inquiry 11-003: In-flight break-up ZK-HMU, Robinson R22,
near Mount Aspiring, 27 April 2011

Final Report

Aviation inquiry 11-003
In-flight break-up ZK-HMU, Robinson R22,
near Mount Aspiring,
27 April 2011

Approved for publication: February 2014

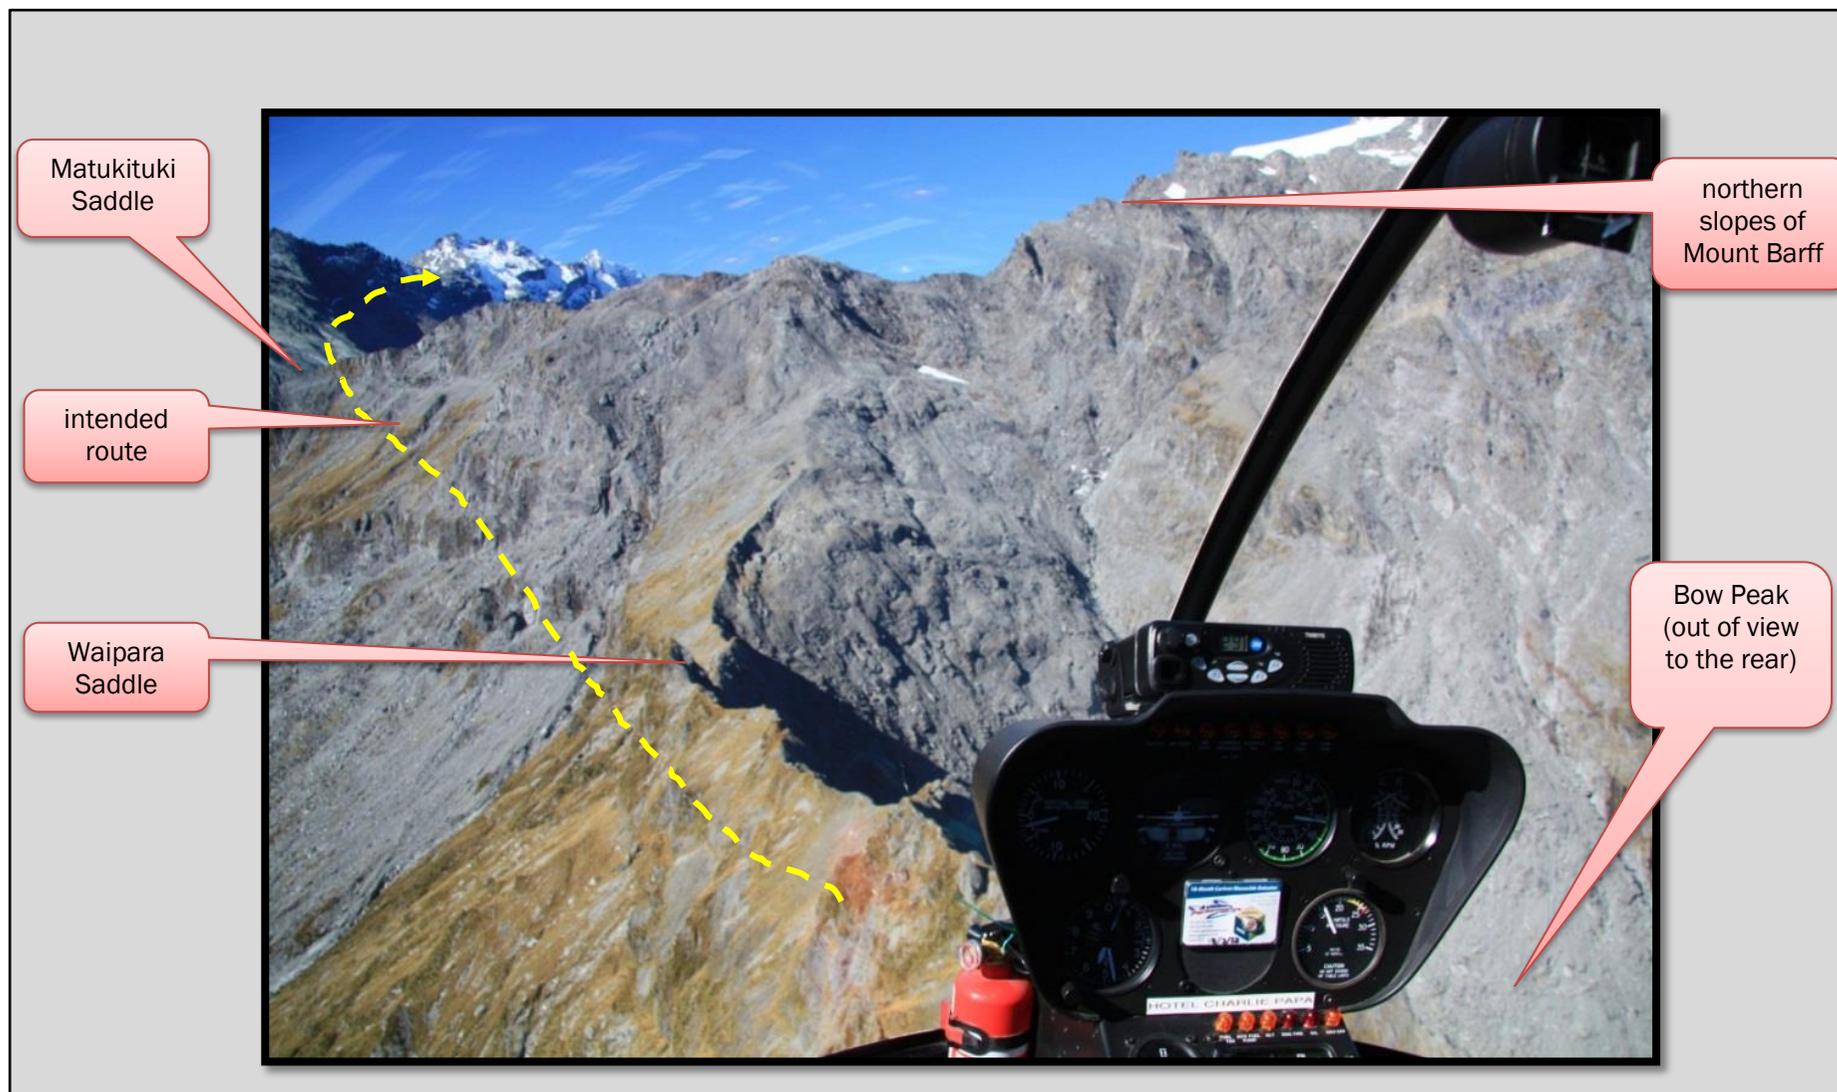
Figure 7
Approaching Matukituki Saddle towards the east
(In an R44 2 days later. Courtesy of Wanaka Helicopters Limited)

- 4.2.6. Instead the helicopter crossed Waipara Saddle to the right (see Figure 7). It could not be determined with any certainty why this happened. The flight plan was to cross Matukituki Saddle, an area with which the instructor was familiar, and the pilots had reconfirmed this in their last radio position report, only about 10 minutes before the accident.

- 4.2.10. Another search pilot flew a Eurocopter EC130 over Matukituki Saddle about 3 hours after the accident. He found it too rough to remain in the area to the west of the saddle, so he flew over Waipara Saddle towards the last known position of the helicopter. He estimated the wind across Waipara Saddle into the Arawhata River basin to be 30 knots and experienced very rough turbulence as he flew past Bow Peak.
