Report 11-103: Track workers nearly struck by passenger train  
near Paekakariki, North Island Main Trunk, 25 August 2011

Rail inquiry 11-103  
Track workers nearly struck by passenger train near Paekakariki,  
North Island Main Trunk  
25 August 2011

Approved for publication: April 2013

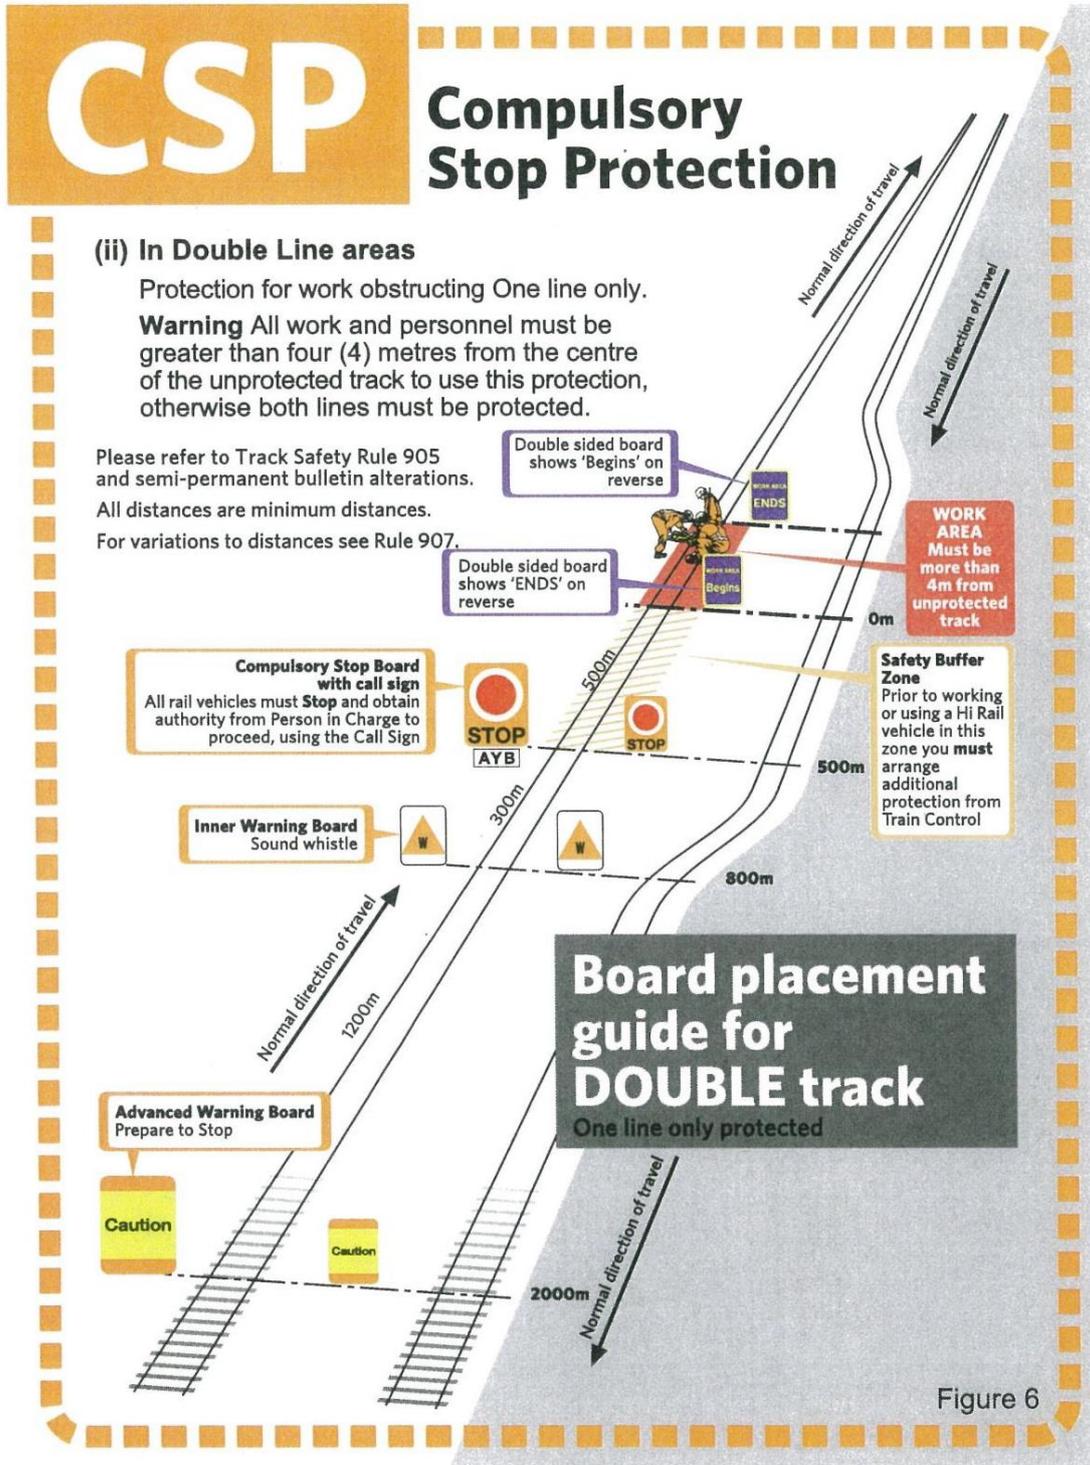
Figure 6

<b>Thursday 25 August 2011</b> Wellington – Waikanae, Johnsonville Line Wellington Junction – Masterton and Branches
--

Protected Work Area		Rule	Work Details
30.59km Pukerua Bay Up & Down lines	38.64km 4L, 2L, 14LAC signals. Paekakariki Up & Down lines	<b>905</b> Compulsory Stop Protection	<b>Multiple Activities: Rule 910</b> <ul style="list-style-type: none"> <li>• Overhead work</li> <li>• Cabling</li> </ul> 2300 previous day to 0500 2300 to 0500 next day 0272 634 5278 Call sign: <b>November Foxtrot Oscar</b>
<p><b>"CAUTION" – Rules 905 (c) &amp; 907 (b) applies. No Advanced &amp; Inner Warning Board(s) exiting EMU siding, Paekakariki Loop &amp; siding and for train services terminating and reversing at Paekakariki ."</b></p> <p>Down Compulsory Stop Boards are erected at 14LAC, 4L and 2L signals Paekakariki. Safety Buffer Zone reduced. Rule 905 (c) is modified accordingly.</p> <p>Work sites on lines not affected by the intended movement may remain occupied. The Person in Charge must inform all protected employees of the movement about to occur. Rule 902 is modified accordingly.</p> <p><b>The overhead power will be cut off between:</b></p> <ul style="list-style-type: none"> <li>• Pukerua Bay substation at 29.70km and Isolator 222 at 35.05km,  <b>Hours: 2005 previous day to 0455, 2005 to 0455, next day</b></li> <li>• Isolator 222 at 35.05km and Paekakariki substation at 39.12km ,  <b>Hours: 2015 previous day to 0430, 2015 to 0430, next day</b></li> </ul>

35.10km 10R North Junction Up & Down lines	38.64km 4L, 2L, 14LAC signals. Paekakariki Up & Down lines	<b>905</b> Compulsory Stop Protection	<b>Multiple Activities: Rule 910</b> <ul style="list-style-type: none"> <li>• EM80 faults</li> </ul> 0900 to 1500 0212 414 726 Call sign: <b>Alpha Lima November</b>
<p><b>"CAUTION" – Rules 905 (c) &amp; 907 (b) applies. No Advanced &amp; Inner Warning Board(s) exiting EMU siding, Paekakariki Loop &amp; siding and for train services terminating and reversing at Paekakariki ."</b></p> <p>Up Advanced Warning Board erected at 32.12km (by 8L signal).                      Down Compulsory Stop Boards are erected at 14LAC, 4L and 2L signals Paekakariki. Safety Buffer Zone reduced. Rule 905 (c) is modified accordingly.</p>
