Inquiry 11-203: passenger ferry *Jet Raider*,  
catastrophic engine failure, Hauraki Gulf, 27 August 2011

## Final Report

Marine inquiry 11-203  
passenger ferry *Jet Raider*, catastrophic engine failure,  
Hauraki Gulf, 27 August 2011

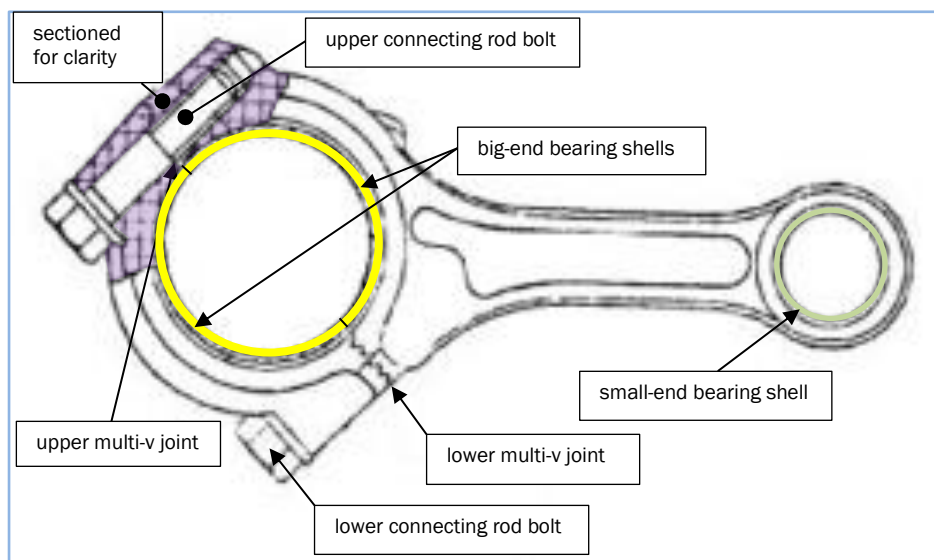
Figure 7  
Diagram of a connecting rod

- 4.2.1. The failure of an engine connecting rod assembly is one common cause of catastrophic engine failure. The connecting rods in this case failed when the connecting rod bolts clamping the big-end of the connecting rod to the crankshaft failed in overload.

- 4.2.4. For each of the 2 possible failure sequences the outcome was the same – there was an increase in the clearances in the big-end bearings where the connecting rods were connected to the crankshaft. This increase in clearances causes minor shock loading within the bearings, which can lead to failure of the connecting rod bolts. The failure of the connecting rod bolts allows the big-end of the connecting rods to open and the connecting rod is thrown off the rotating crankshaft with considerable force. The resultant massive imbalance in the engine can cause other components to fail as well. One possible scenario is where clamping force on the bearings is lost due to a loosening of the connecting rod bolts. The other is where the bearings become worn. The result in either case was increased clearances within the bearing assembly.
