Inquiry RO-2012-103: Derailment of freight Train 229,
Rangitawa-Maewa, North Island Main Trunk, 3 May 2012

Final Report

Rail inquiry RO-2012-103
derailment of freight Train 229,
Rangitawa-Maewa
North Island Main Trunk
3 May 2012

Approved for publication: May 2016

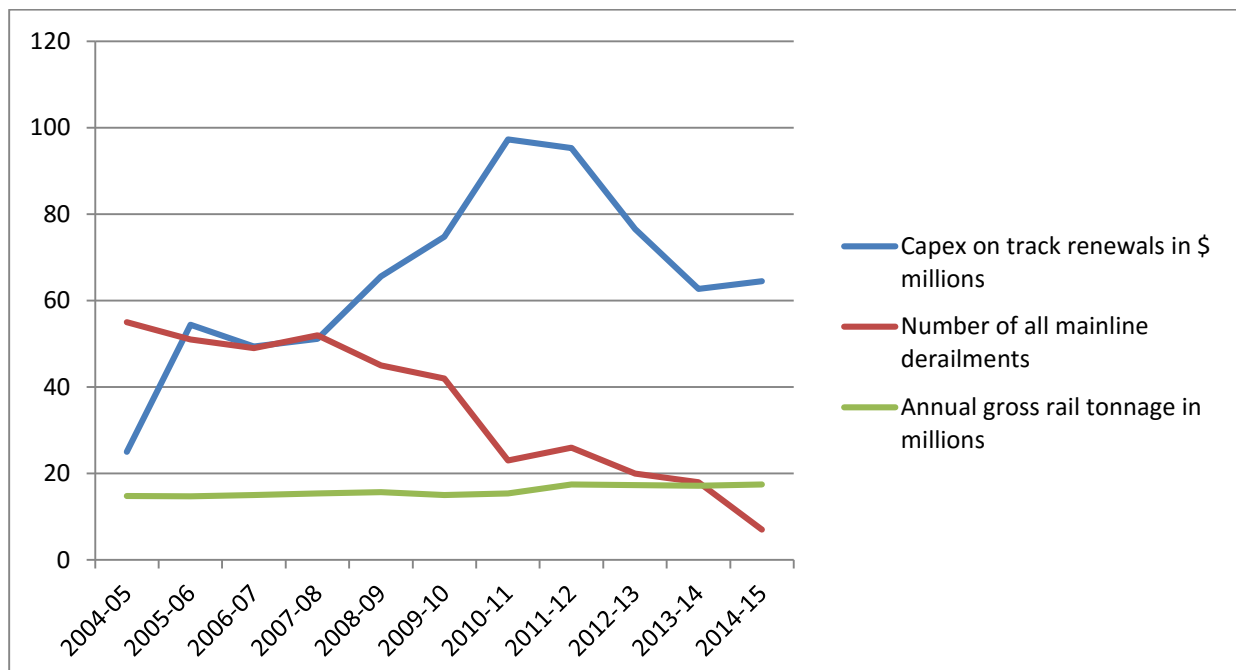
Figure 7
Mainline derailment trend statistics

4.4.2. Figure 7 has been compiled using data supplied by KiwiRail. It shows the decline in mainline derailments reported by KiwiRail between 1 July 2004 and 30 June 2015, compared with KiwiRail's capital expenditure on track renewals and its annual gross rail tonnage. The trend lines indicate that the financial investment in track improvements has positively contributed to the reduction in derailments.

4.4.3. Figure 7 shows that the capital expenditure (capex) on track renewals grew and peaked in the 2009-2012 period when track-related problems were encountered in the Maewa area.

4.4.4. In view of the derailment statistics shown in Figure 7 and the safety actions taken by KiwiRail, the Commission has not made any recommendations.
