Final report MO-2012-203: Fire on board *Amalal Columbia*  
12 September 2012

Marine inquiry MO-2012-203  
Fire on board *Amaltal Columbia*  
12 September 2012

Approved for publication: February 2017

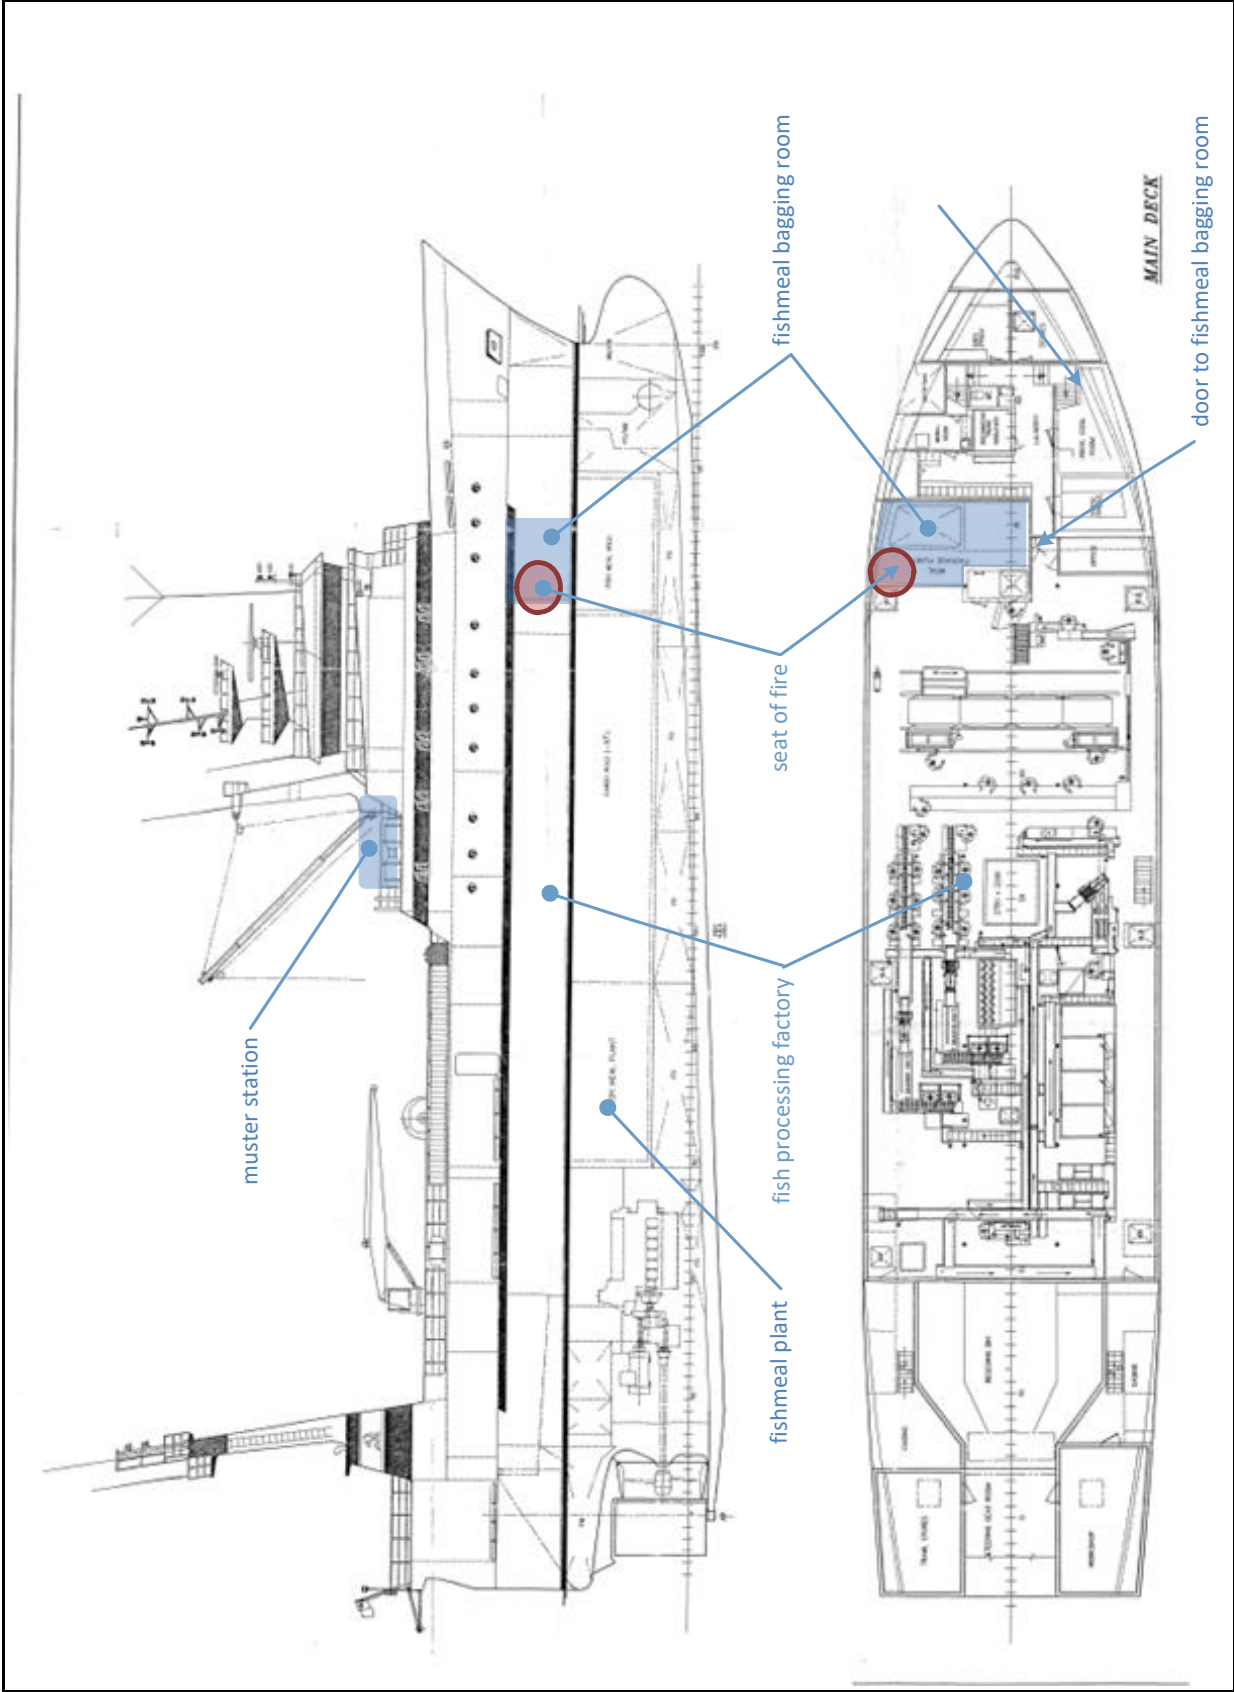
Figure 1  
 General arrangement of the Amaltal Columbia

- 3.1.5. The actual rendering machine was located aft of and below the fish processing factory (see Figures 1). The dried fishmeal was fan-blown in powder form through ducting from the rendering machine to the bagging room, which was a purpose-built room on the same level as and forward of the fish processing factory, sectioned off by a steel-framed plywood bulkhead.

- 4.2.1. The seat of the fire was in the fishmeal bagging room located at the forward port side of the fish processing factory (shown in Figure 1). The fishmeal bagging room of the *Amaltal Columbia*'s sister vessel is nearly identical in layout and content. A photograph of it is reproduced in Figure 2.
