Final Report AO-2013-003: Robinson R66, ZK-IHU,
Mast bump and in-flight break-up, Kaweka Range, 9 March 2013

Aviation inquiry AO-2013-003
Robinson R66, ZK-IHU
Mast bump and in-flight break-up
Kaweka Range, 9 March 2013

Approved for publication: April 2016

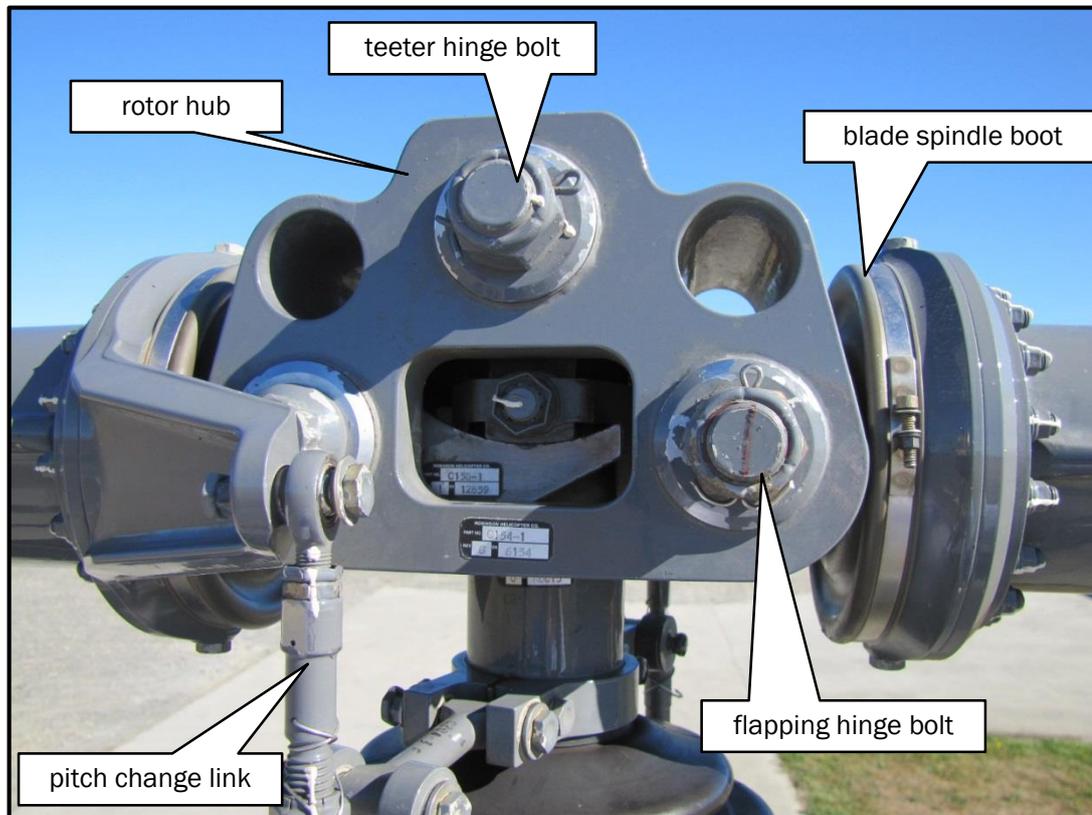
Figure 2
R66 main rotor head

- 3.3.3. All three Robinson types have two-blade, teetering main rotors. The blades have independent flapping hinges, a feature unique to Robinson¹⁴ (see Figure 2). Helicopters with two-blade, teetering main rotor systems must avoid low-G conditions,¹⁵ because these can cause the helicopter to roll without its pilot making a control input (an uncommanded roll) if the tail rotor (sideward) thrust acts at a distance well above the helicopter's centre of gravity.¹⁶ The R66 flight manual prohibited intentional low-G manoeuvres.
