Final Report AO-2013-008: Boeing 737-300, ZK-NGI,
Loss of cabin pressure, near Raglan, Waikato, 30 August 2013

Aviation inquiry 13-008
Boeing 737-300, ZK-NGI
Loss of cabin pressure
near Raglan, Waikato
30 August 2013

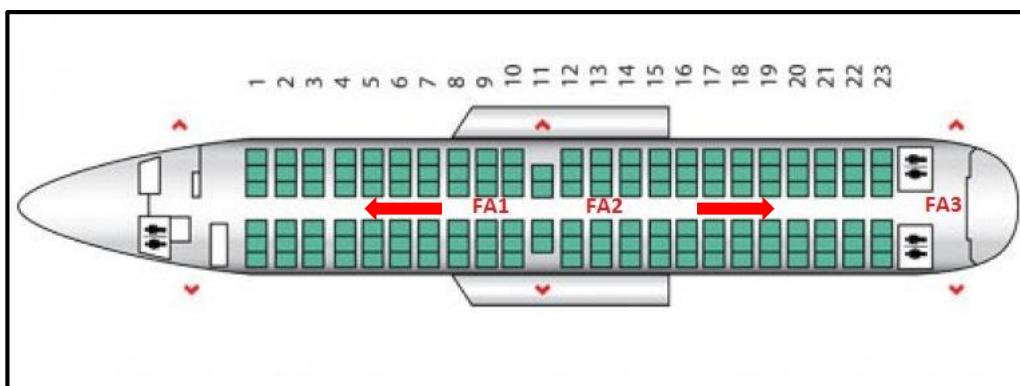
Figure 2
Positions of cabin crew and their subsequent movements (generic cabin layout)

- 3.2.6. The cabin crew were preparing the cabin for landing when the masks deployed. FA1 was at about mid-cabin, moving forward; one attendant (FA3) was in the rear galley; and the third (FA2) was pushing a cart to the rear galley (see Figure 2). FA1 continued walking to her normal crew station at the front left entry door and fitted a mask. She said the green flow indicator was visible but the attached reservoir bag was not inflating. She was later uncertain whether oxygen had been flowing. FA1 remained standing by her seat, observing the cabin, until the pilots announced that masks could be removed.

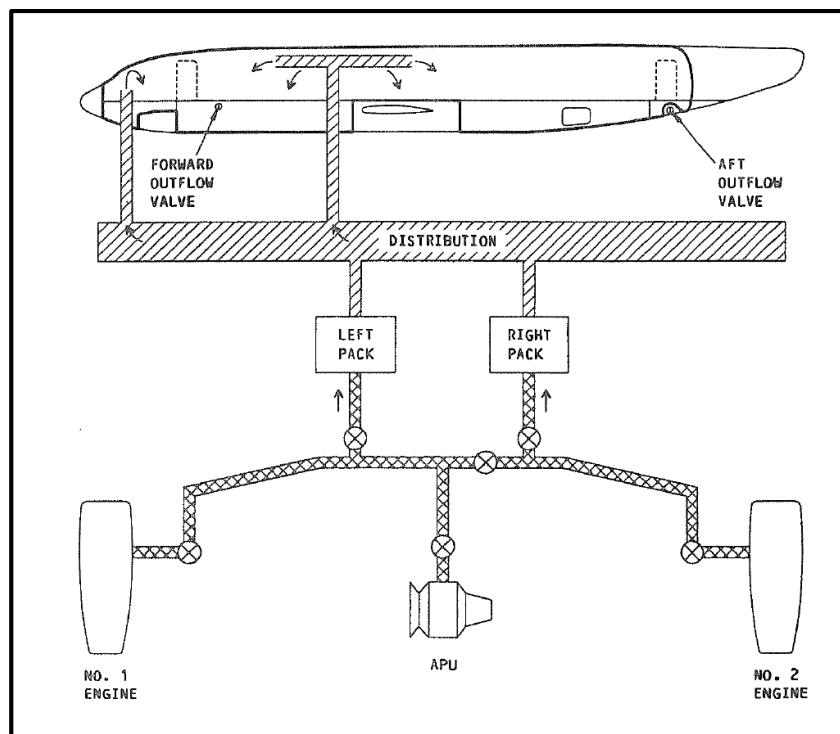
Figure 3
Schematic of Boeing 737 pressurisation system

engines. The air-conditioning system ('packs') cools the very hot bleed air, then distributes it at the desired temperature to the cabin. The continuous inflow of conditioned air pressurises the cabin, with excess air being vented back to the atmosphere through the aft outflow valve.

- 3.5.2. Under normal circumstances one of two identical digital pressure controllers regulates the cabin pressure. The controllers maintain the required pressure by adjusting the aft outflow valve. Unintended changes to the cabin pressure can be caused by low air inflow from the engines or air-conditioning system, excessive leakage or a defect in the control system. The pressure controllers detect internal and external failures that affect the control of cabin pressure and, if appropriate, annunciate them on a flight deck panel regardless of whether the faults are intermittent or not.
- 3.5.3. See Appendix 1 for more information on the Boeing 737-300 cabin pressurisation system.

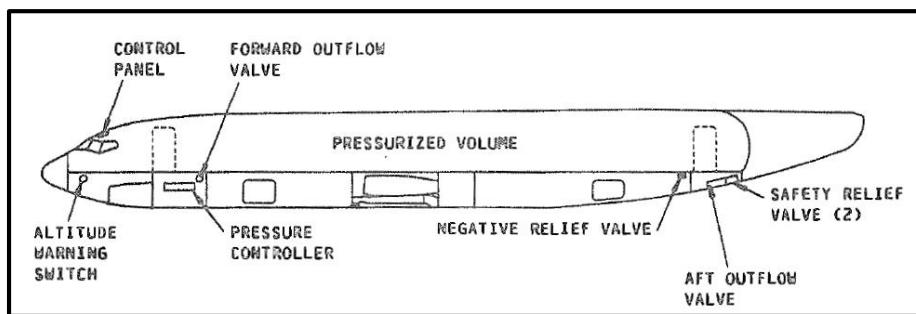
Figure 5
Boeing 737 pressurisation system components

2. Aeroplane pressurisation control includes the pressurisation control system, pressure relief valves and the indication and warning system. The pressurisation control system is electrically operated and electronically controlled, and comprises a control panel, two digital pressure controllers and the aft outflow valve (see Figure 5).

3. The forward outflow valve shown in Figure 5 is part of the cargo heating system, but the pressure control panel (in automatic or manual mode) signals the valve to close when the aft outflow valve is almost fully closed. This prevents the forward outflow valve adversely affecting the cabin pressure.

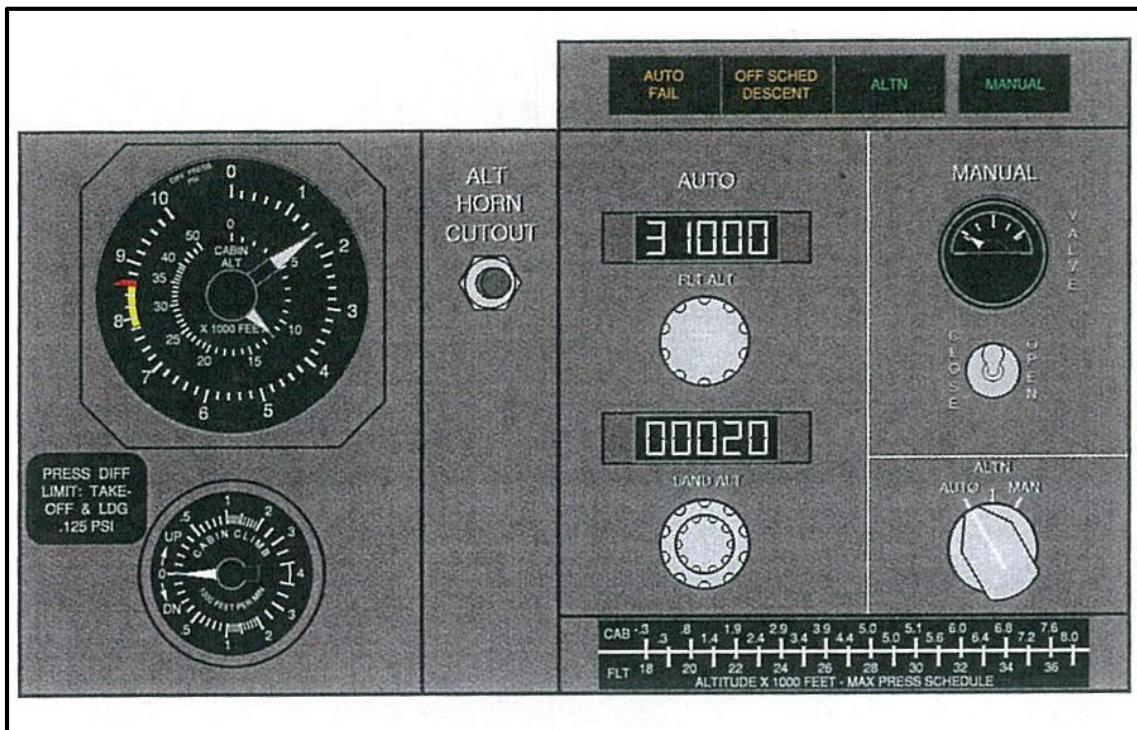
Figure 6
Boeing 737-300 pressurisation system control panel
(Source: Boeing Airliner magazine, Oct-Dec 1994)

4. The pressure control panel, located on the flight deck overhead panel, allows the pilots to select the system mode, enter the flight and landing altitudes, and control the aft outflow valve manually (see Figure 6). System status annunciators²⁷, including the cabin altitude warning, are located on the forward and overhead instrument panels. Adjacent to the pressure control panel are a combined cabin altitude and differential pressure gauge and a cabin rate-of-climb gauge.
