Inquiry AO-2013-009: RNZAF Boeing 757, NZ7571, landing below published minima  
Pegasus Field, Antarctica, 7 October 2013

Aviation inquiry 13-009  
RNZAF Boeing 757, NZ7571  
landing below published minima  
Pegasus Field, Antarctica  
7 October 2013

Approved for publication: December 2014

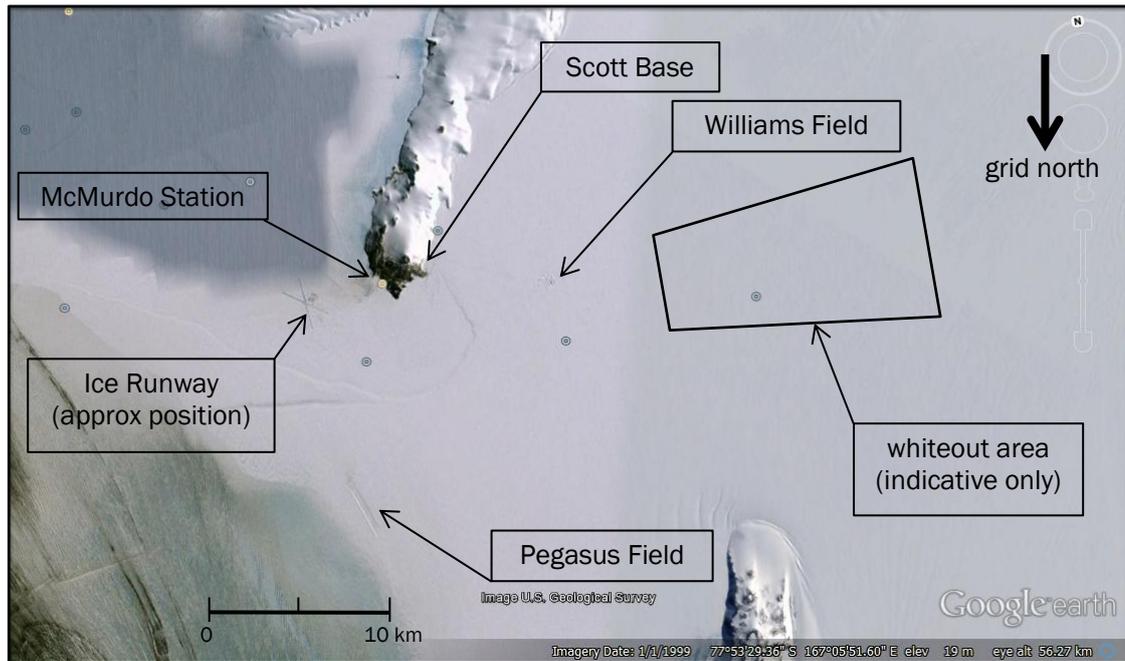
**Figure 6**  
**Local area**  
 (Courtesy of Google Earth)

- 3.4.4. Pegasus Field was located on the Ross Ice Shelf about seven nautical miles grid north of McMurdo Station (see Figure 6). The airfield consisted of one major runway orientated 33/15, with a nearby second skiway for ski-equipped aeroplanes.<sup>15</sup> The runway was constructed on permanent ice for use by wheeled aeroplanes and was normally 10,000 feet long and 150 feet wide (approximately 3,050 m x 45 m).<sup>16</sup> On 7 October 2013 a NOTAM advised that an inset threshold for runway 33 reduced the available length to 9,000 feet (2,745 m).

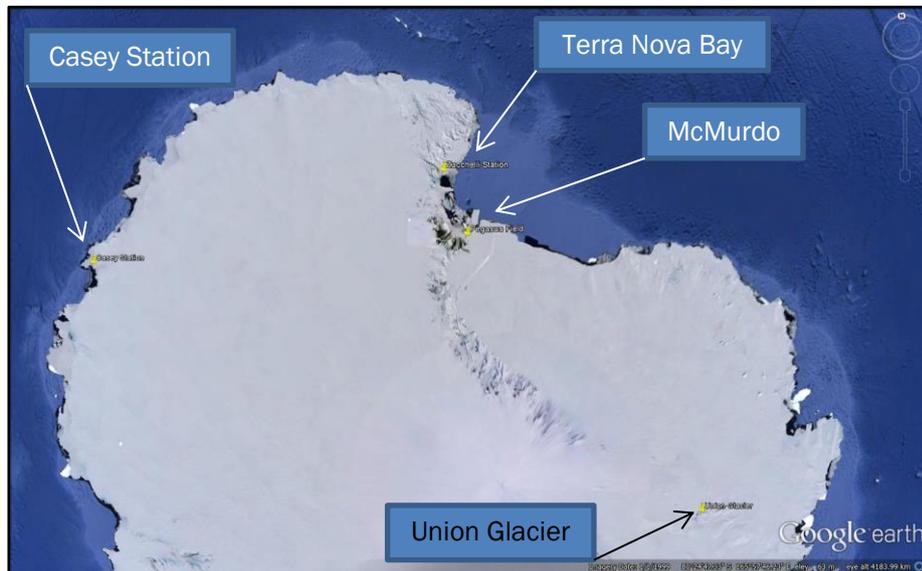
Figure 7  
Antarctica – general  
(Courtesy of Google Earth)

- 3.4.9. A fourth runway at the Italian station at Terra Nova Bay, 190 nautical miles grid south of McMurdo, was designed to handle aircraft no larger than the Hercules.<sup>18</sup> On 7 October 2013 it had yet to be opened for the summer season and the level of emergency services was unknown.
- 3.4.10. Other than the airfields listed above, the nearest airfields that could possibly be used by the Boeing 757 are the blue ice runways<sup>19</sup> about 2,100 km away at Wilkins, near the Australian Casey Station, and Union Glacier operated by Chile in the Ellsworth Mountains.<sup>20</sup>
