Final report RO-2013-101: derailment of freight Train 345,
Mission Bush Branch line, 9 January 2013

Rail inquiry R0-2013-101
derailment of freight Train 345
Mission Bush Branch line
9 January 2013

Approved for publication: May 2017

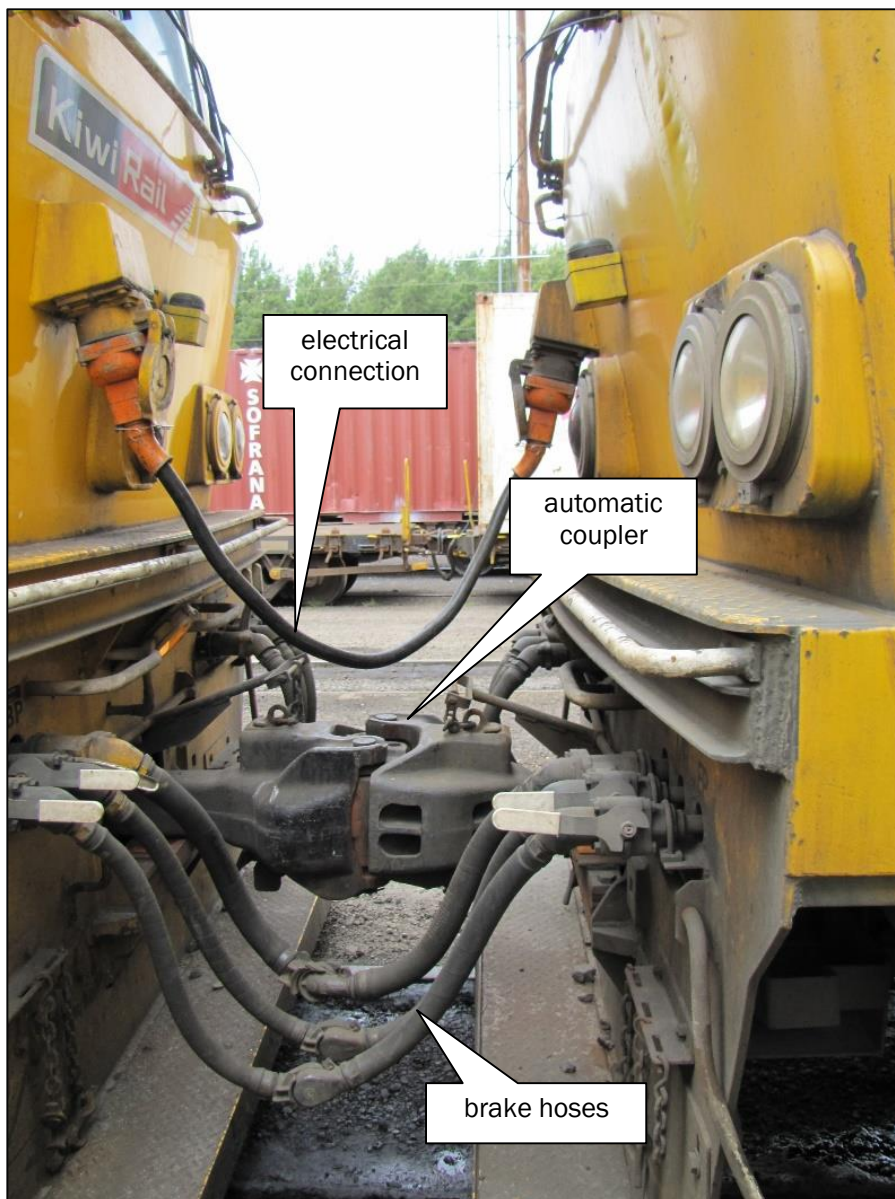
Figure 1
The three components used to join locomotives and wagons to form a train

3.1.1. There are three components used to join locomotives and wagons to form a train (see Figure 1). The components are:

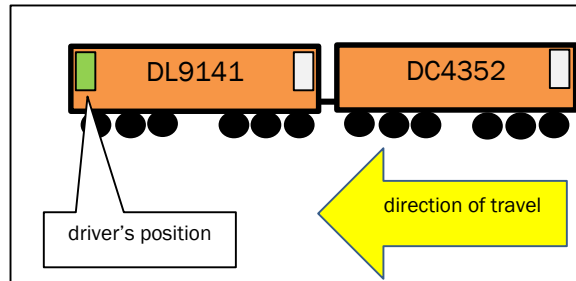
Figure 2
The two locomotives that travelled from Auckland to Mission Bush (not to scale)

- 3.2.1. Between 1630 and 1650 on 8 January 2013, KiwiRail's locomotive servicing staff at Auckland coupled two diesel locomotives together and recorded details of the air brake and electrical connection tests that were carried out.
- 3.2.2. At 1630 on the same day a KiwiRail train driver (driver A) started work to drive the two locomotives from Auckland to Mission Bush, a distance of 50.5 kilometres (km). The locomotives left Auckland at 1718 (see Figure 2).

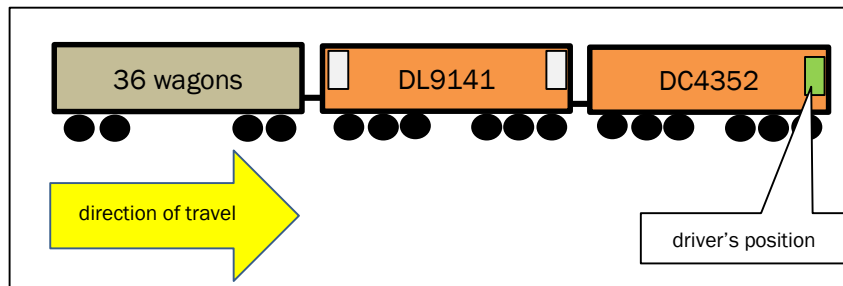
Figure 4
Train 345 (not to scale)

- 3.2.4. The two locomotives arrived at Mission Bush at 1832 and were coupled to a rake of loaded wagons to form freight Train 345 (the train) destined for Mount Maunganui. The train weighed 1,845 tonnes, which was within the haulage capacity of the two locomotives. Driver A transferred control of the train to the new lead locomotive (see Figure 4).

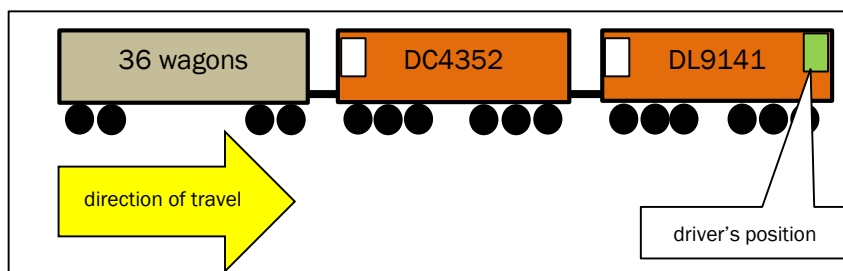
Figure 5
Reoriented Train 345 (not to scale)

- 3.2.9. Meanwhile, driver A had reached his own conclusion that his locomotive was not performing satisfactorily. Although he had walked past the area between the two locomotives on several occasions while at Mission Bush, he had not seen that the electrical plug was not fully engaged on DC4352. The two locomotives were disconnected from the train and reoriented using a triangular track layout provided for this purpose and that negated the need to break the couplers between the two locomotives (see Figure 5).

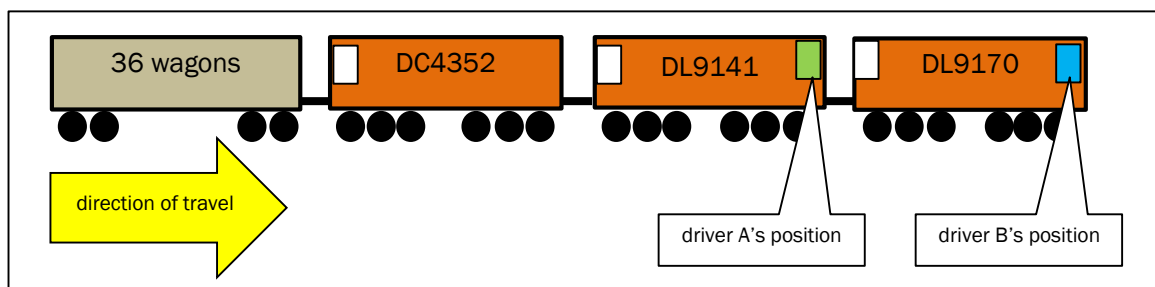
Figure 6
Train 345 with the third locomotive (not to scale)

- 3.3.1. Train control arranged for an assisting (third) locomotive from Auckland. It left Auckland with a Hamilton-based driver (driver B) at 0320 and travelled to Glenbrook, where it arrived at 0422.
- 3.3.2. The third locomotive was coupled and the brake hoses were connected. The train examiner had remained on duty and had driven by road from Mission Bush to Glenbrook to assist with the recovery of the disabled train.
- 3.3.3. The third locomotive now became the lead for the train (see Figure 6), but control had to be transferred to the driver's cab at the other end of the locomotive. An electrical connection cable was plugged in between the two DL locomotives. These two locomotives now provided sufficient tractive power to enable the train to recommence its journey to Mount Maunganui.
