Inquiry RO-2013-107: express freight MP16 derailment,
Mercer, North Island Main Trunk, 3 September 2013

Final Report

Rail inquiry R0-2013-107
express freight MP16 derailment
Mercer, North Island Main Trunk

3 September 2013

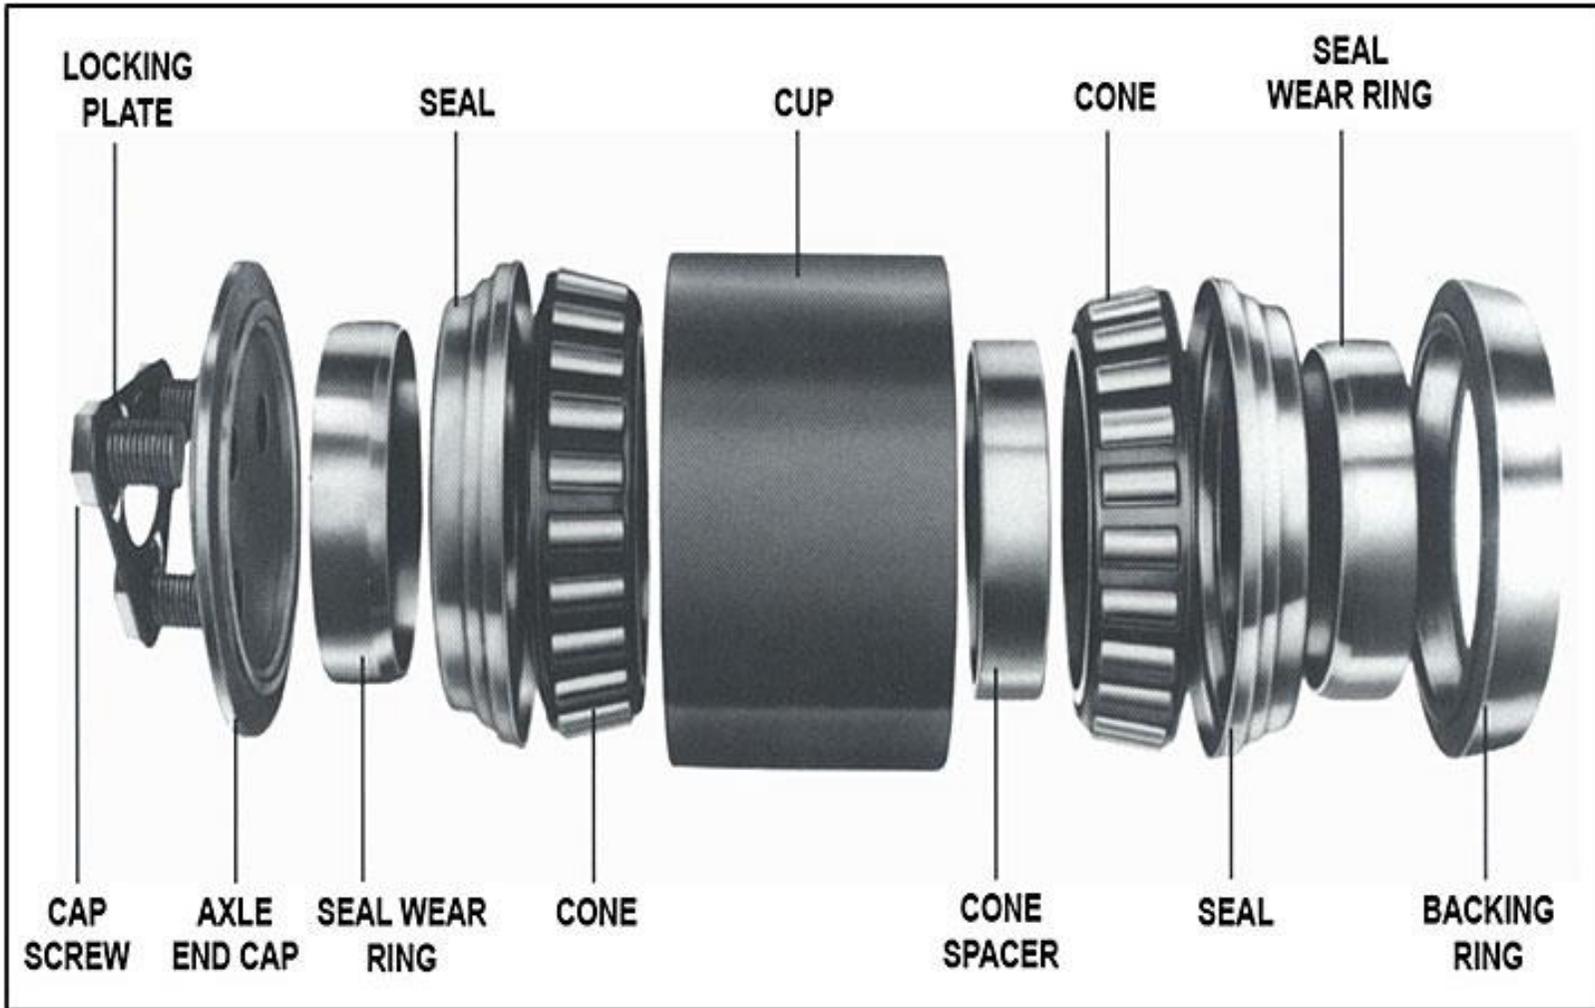
Figure 5
Wheel-bearing components
(source Timken bearing parts)

- 3.3.2. A wheel-bearing assembly consists of an outer cup which houses two tapered roller cone assemblies separated by a spacer. Each cone assembly consists of a raceway, rollers and a cage. Inboard and outboard seals, seal wear rings, a backing ring and an end cap complete the bearing assembly. The cup, rollers and cones are case hardened with precision finishes to ensure closely matched mating surfaces. The cage is essentially a spacer that retains the rollers in place within the cone assembly. The entire assembly is pressed on an axle journal, and is retained by an end cap secured with three cap screws fixed in place by a locking plate (see Figure 5).

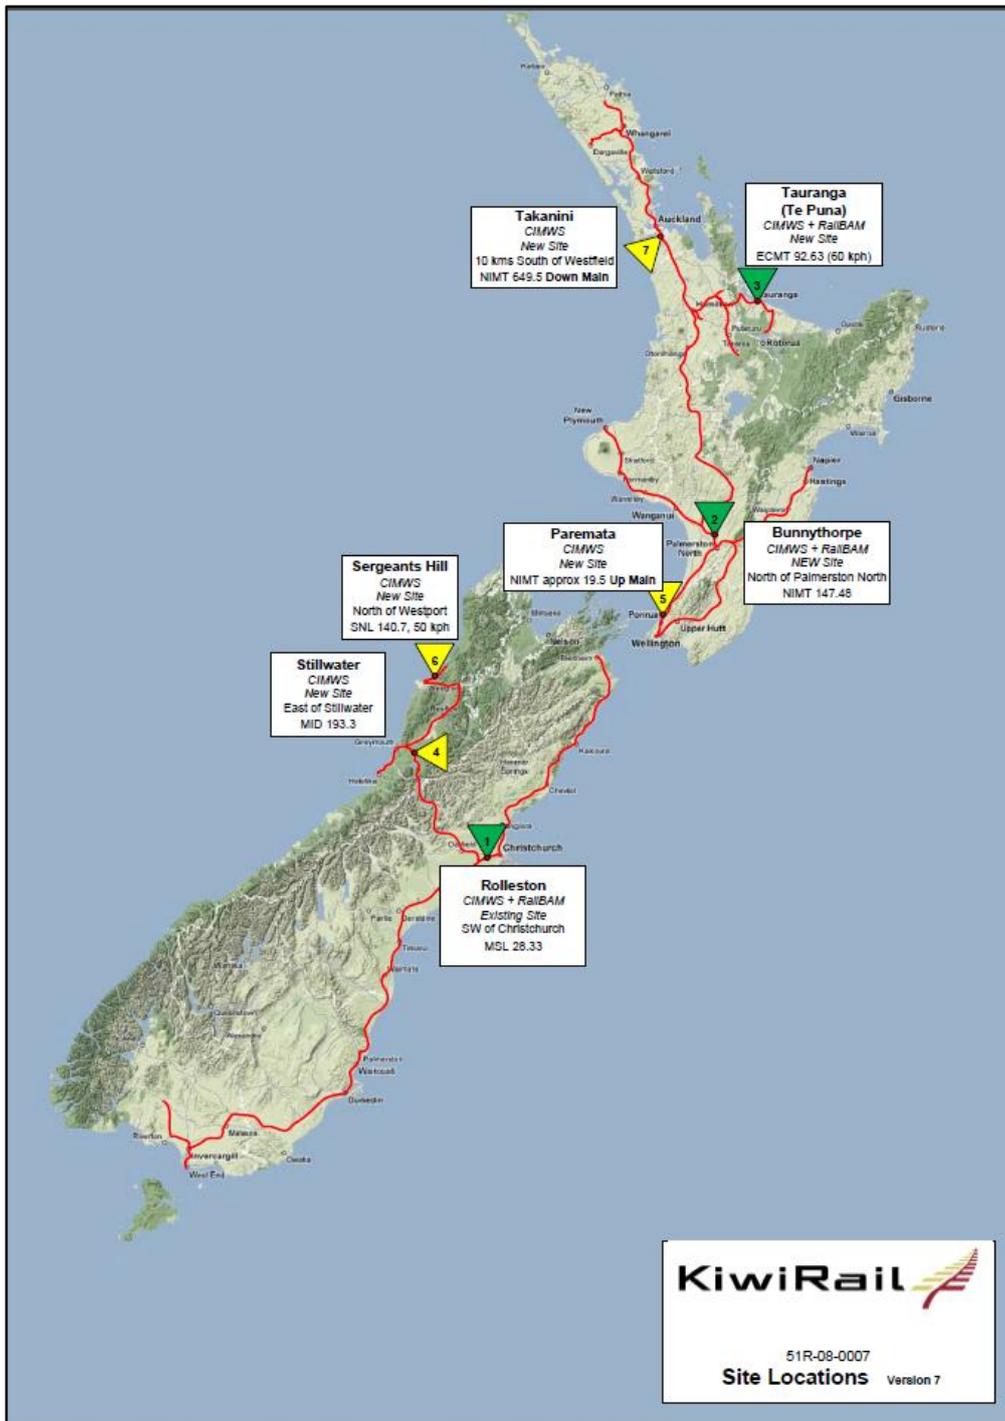
Figure 7
The location of RailBAM sites

4.4.3. Work then began on planning for a network of bearing acoustic monitors. On 12 November 2010 KiwiRail confirmed the first RailBAM system with an in-motion weighbridge had been installed at Rolleston, near Christchurch. Two other RailBAM systems were about to be installed at Te Puna, near Tauranga, and Bunnythorpe, near Palmerston North (see Figure 7). KiwiRail determined that these strategic locations had the potential to record the condition of more than 90% of the wagon fleet on a regular basis. The system relies on every wagon in KiwiRail's fleet being fitted with a unique identification tag. KiwiRail advised that about 65% of the wagon fleet had been fitted with identification tags at that time.

4.4.4. KiwiRail reported that the three RailBAM systems became fully operational from early 2012.

- 4.4.5. The RailBAM system is a condition monitor, rather than a failure detector. The system provides data for both fault trending and an immediate alert to remove a wagon from service. The system is designed to detect and rank axle bearing faults, and provide condition monitoring reports and an advance warning of potential bearing failures, unlike a “hot box” detector, which typically gives up to 60 minutes’ warning between a fault being detectable and a complete bearing failure.
