Inquiry 13-201: Accommodation fire on board the log-carrier,
Taokas Wisdom, Nelson, 11 July 2013

Marine inquiry RO-2013-201

Accommodation fire on board the log-carrier, *Taokas Wisdom*,
Nelson, 11 July 2013

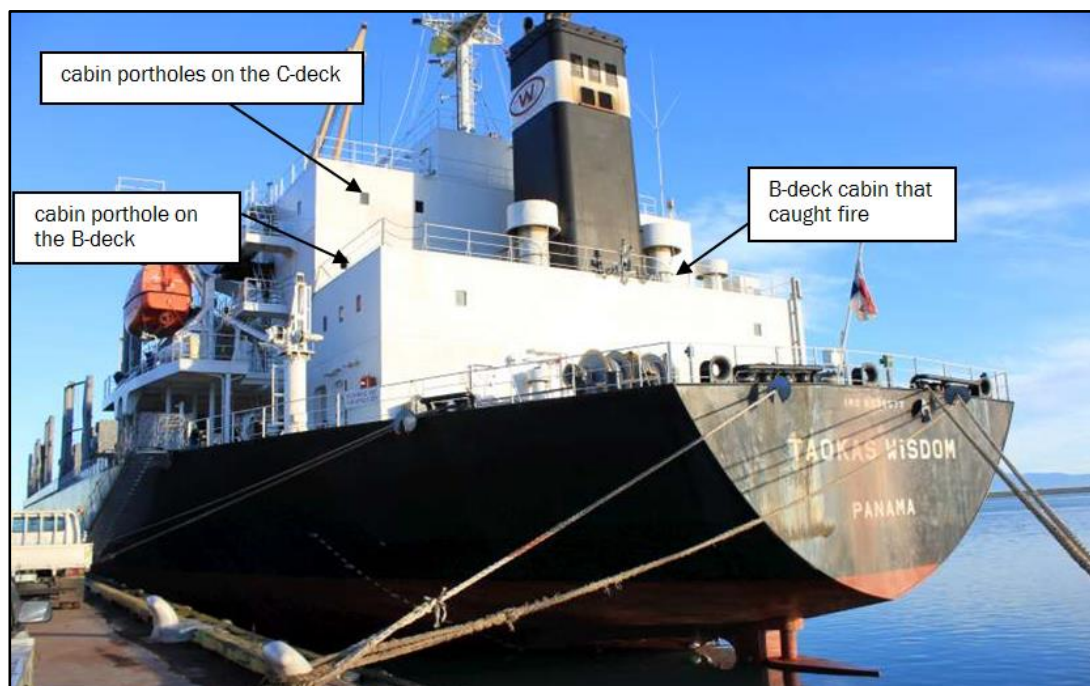
Figure 2
Location of the fire on board the *Taokas Wisdom*

- 3.1.4. The third officer decided to inspect the fire alarm panel on the bridge and was climbing up the stairs through the accommodation space when he noticed smoke near AB-3's cabin. The cabin was located on the aft starboard side of the B-deck alleyway.

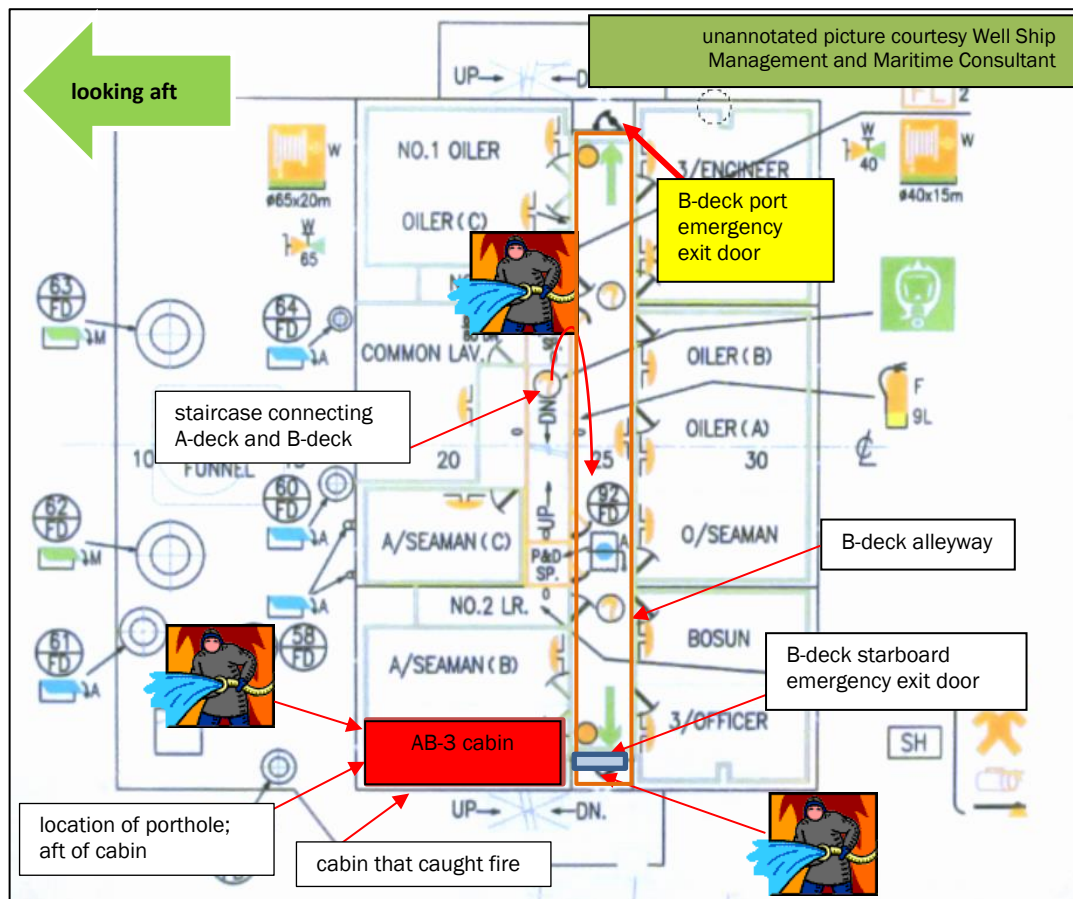
Figure 3
B-deck accommodation plan

- 3.1.10. Some crew members retreated down the internal stairwell to the A-deck, and others retreated outside via the B-deck emergency exit door located on the port side, leaving this door open as they did so (see location of door in Figure 3). Figure 4 shows smoke billowing out from this door.

- 3.1.11. The ship's crew subsequently split up into 2 firefighting teams. One team attempted to fight the fire using fire hoses connected to hydrants located in the A-deck alleyway (the deck below), but the crew found it difficult to reach AB-3's cabin through the smoke-filled B-deck alleyway (see Figure 3).

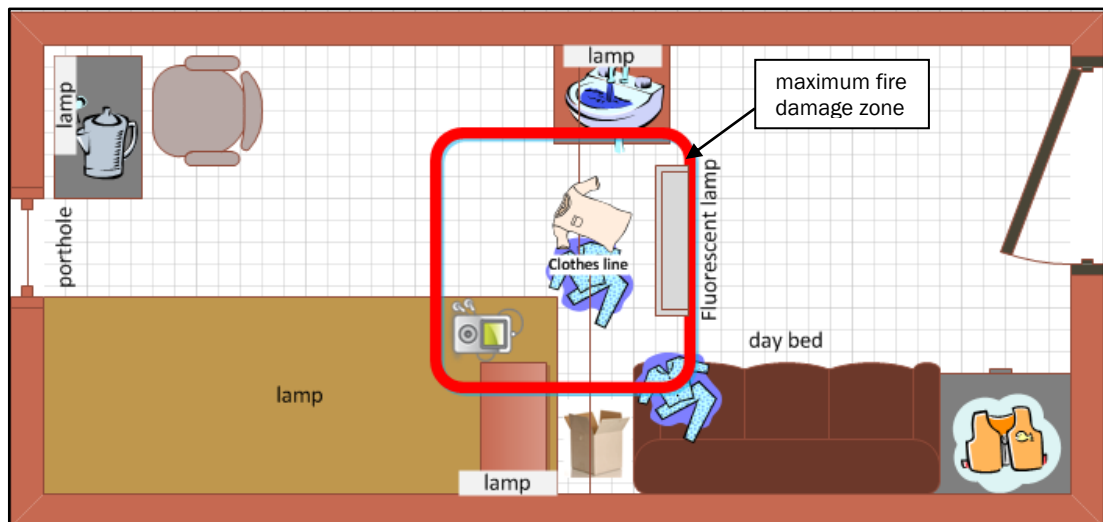
Figure 5
Schematic diagram of AB-3's cabin

- 4.2.3. The cabin was 2 metres wide and 5 metres long. The layout of the cabin and the location of the main contents are shown in Figure 5.
- 4.2.4. On the table was an automatic water-heating jug. There were some books on the table and some papers on the shelf directly above the table. The chair in the cabin was a plastic swivel type, and was located close to the table. The bed was located in the starboard aft corner of the cabin. According to AB-3, he left his MP4 player on the forward side of the bed close to the pillow. Two cardboard boxes were placed between the bed and the day bed. Inside the cardboard boxes were an old duvet and a raincoat.
- 4.2.5. A steel locker was located in the forward starboard corner of the cabin. AB-3 stored his lifejacket and survival suit on top of the locker.
