Inquiry 13-202: Bulk carrier, *IDAS Bulker*,
pilotage incident Napier, Hawke's Bay, 8 August 2013

Final Report

Marine inquiry 13-202 : Bulk carrier, *IDAS Bulker*, pilotage
incident Napier, Hawke's Bay, 8 August 2013

Approved for publication: April 2014

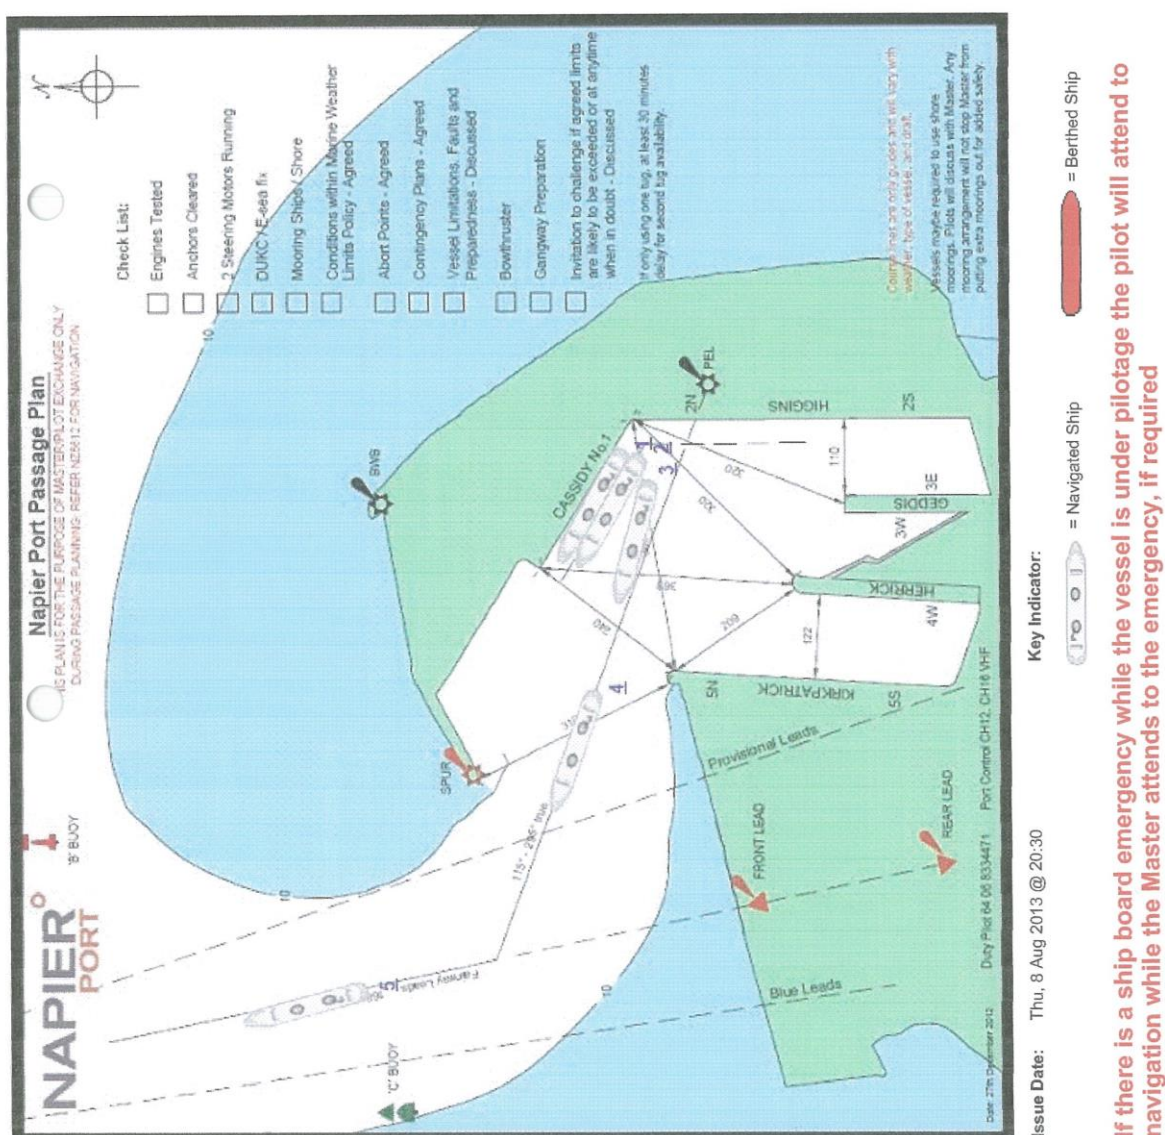
Appendix 1: Port of Napier Limited's outward passage plan for the *IDAS Bulker*

- 3.1.3. At about 21:15 the master of the *IDAS Bulker* told the pilot that the vessel was ready to leave. The pilot explained his outward passage plan (see Appendix 1) to the master, adding that there was a vessel inbound to the No.2 pilot station (see Figure 1) that the pilot was going to join after he departed from the *IDAS Bulker*.

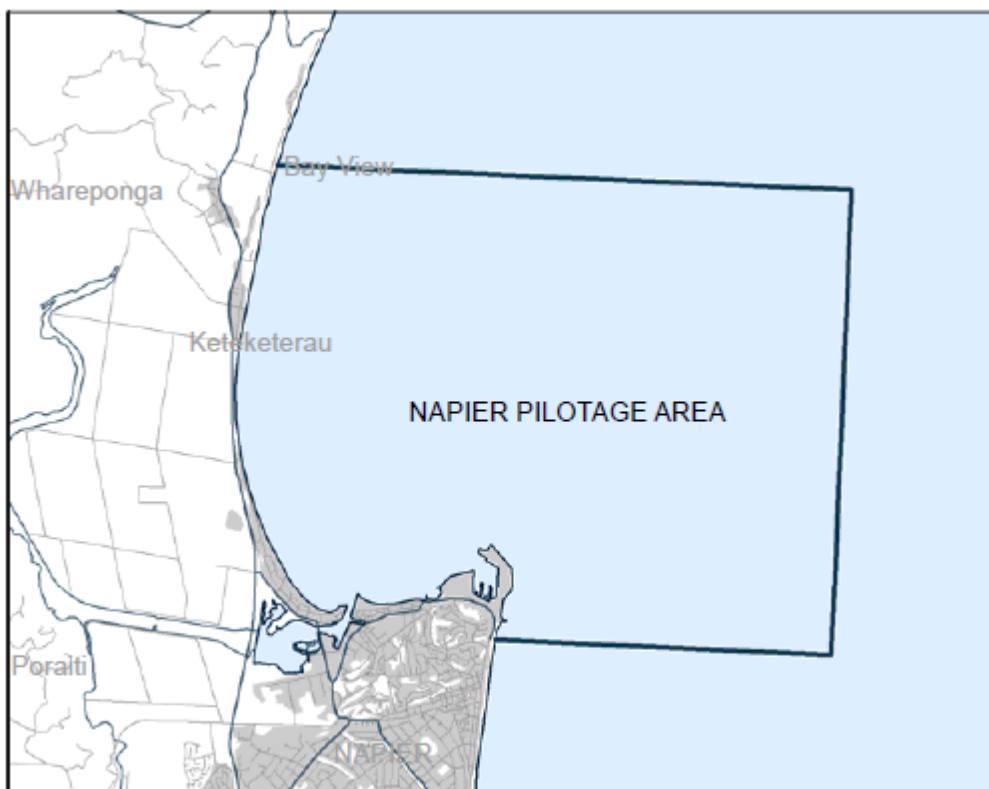
Map 1.4 Napier Pilotage Area

1.4.2 Duties of persons in charge of motor boats, yachts, launches etc. within Napier Pilotage Area

- (a) The Master of every vessel under 500 gross tons must not impede the navigation of any vessel of 500 gross tonnage or more when that vessel is navigating under pilotage within the Napier Pilotage Area.
