Final report AO-2014-005: Eurocopter AS350-B2 (ZK-HYO), collision with terrain during heli-skiing flight, Mount Alta, near Mount Aspiring National Park, 16 August 2014

Aviation inquiry AO-2014-005
Eurocopter AS350-B2 (ZK-HYO)
collision with terrain during heli-skiing flight
Mount Alta, near Mount Aspiring National Park
16 August 2014

Approved for publication: November 2017

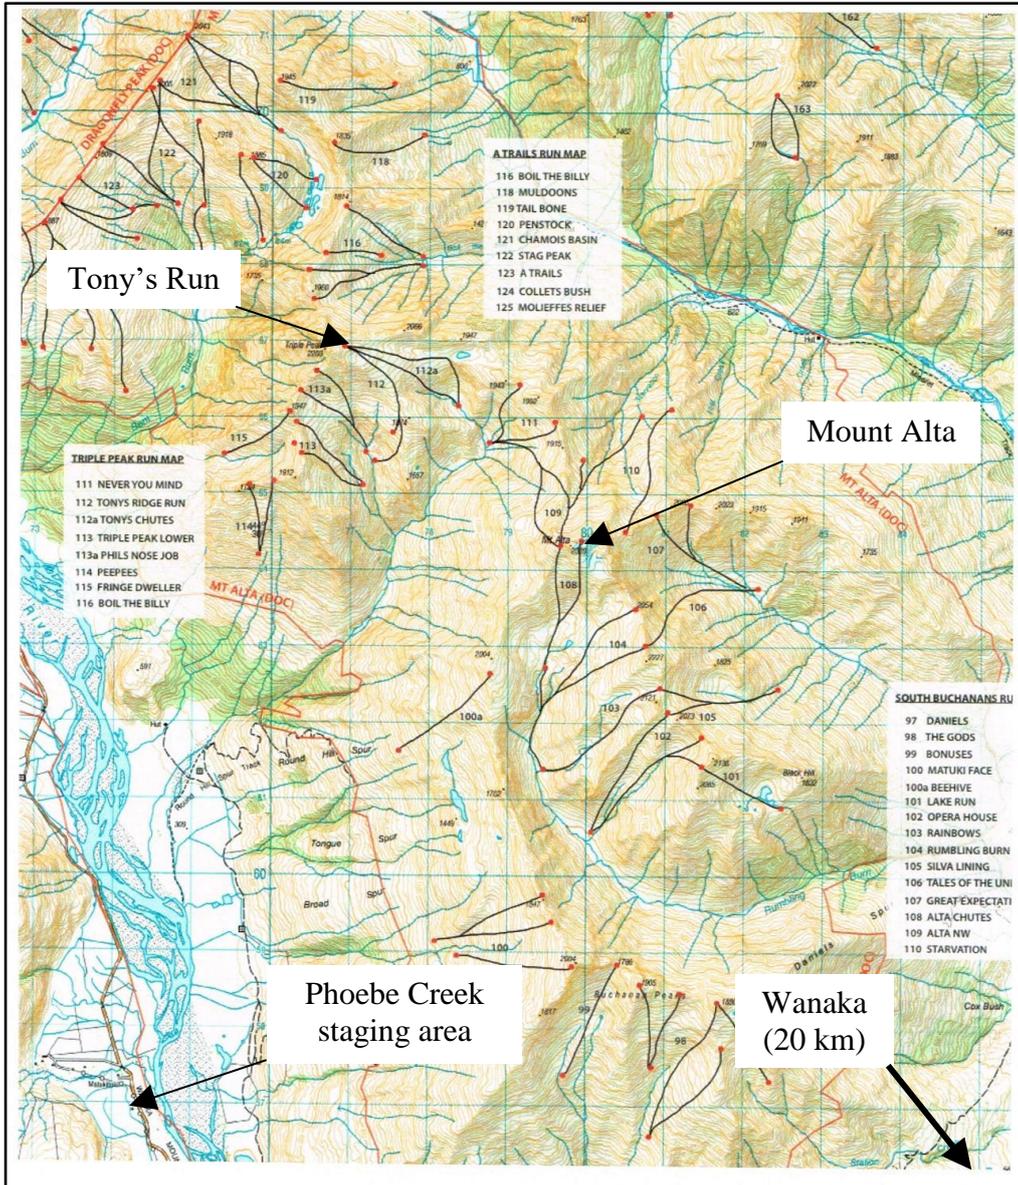
Figure 1
Ski run map
(Courtesy of The Helicopter Line)

- 3.1.5. At 1002 the pilot landed back at Queenstown and the three groups were given their helicopter safety briefing in preparation for the day's activities. A heli-ski guide loaded the first group of five, group A, and their gear onto the helicopter. Group A was to be flown to the Phoebe Creek staging area in the lower Matukituki Valley west of Wanaka (see Figure 1), while groups B and C travelled by road.

3.1.10. The pilot then flew group C to the top of Tony's Run and descended to the bottom of the run to uplift group A for their next run, which was to be from near the summit of Mount Alta. The smaller passenger returned to his allocated front-centre seat. The guide sat in the front-left seat and donned a headset to talk to the pilot and discuss the next run. The pilot then flew the helicopter in a climbing left-hand orbit around Mount Alta to enable the pilot and guide to assess the conditions. The pilot and guide agreed to land groups A and B at a designated landing site on a flat ridge near the summit and group C further down the mountain.⁶

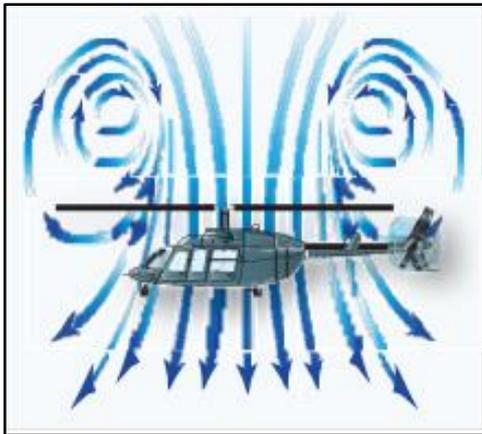
Figure 7
Typical rotor downwash flow
(Courtesy of Federal Aviation Administration)

When a helicopter is generating rotor thrust or lift, there will be some recirculation of air around the end of the blades or rotor disc.⁵⁵ The recirculation is most pronounced at high power and low airspeed, as in a hover, and reduces as the helicopter moves forward. Vortex ring state occurs when the tip vortex becomes more energised and a secondary inner vortex is established towards the centre of the rotor disc because the rate of descent exceeds the induced downward flow (see Figures 7 and 8).⁵⁶

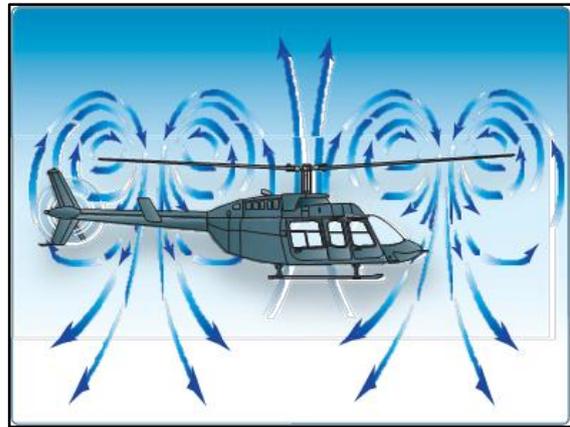
Figure 8
Vortex ring state
(Courtesy of Federal Aviation Administration)

The onset of vortex ring state can be sudden, resulting in the helicopter descending at a very high rate. Any increase in rotor thrust in an attempt to reduce the high rate of descent energises the vortices further and increases the rate of descent. Rates of descent of more than 3,000 feet per minute are not unusual. A United States National Transportation Safety Board report into an AS350-B2 accident cited rates of descent between 4,000 feet and 6,000 feet per minute (National Transportation Safety Board, 2001). This is significantly faster than the 1,500 to 2,000 feet per minute rate of descent experienced in an autorotation following a total power loss.
