Inquiry MO-2014-202: lifting sling failure on freefall lifeboat,  
general cargo ship *Da Dan Xia*, Wellington, 14 April 2014

Marine inquiry MO-2014-202  
lifting sling failure on freefall lifeboat,  
general cargo ship *Da Dan Xia*, Wellington  
14 April 2014

Approved for publication: February 2015

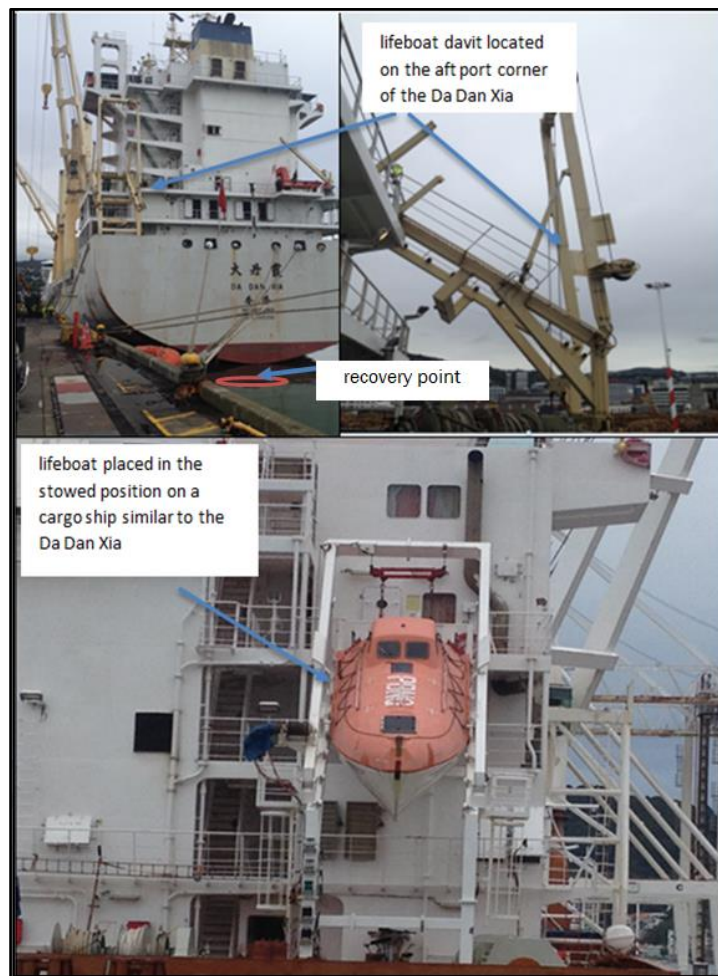
**Figure 2**  
**General arrangement of davit and freefall lifeboat**

- 3.1.7. The wire slings were attached to the lifeboat and connected to a spreader bar connected to the ship's lifeboat davit. The ship's boatswain<sup>7</sup> was assigned to operate the lifeboat davit, which would swing the lifeboat clear of the ship side (see the location of the davit in Figure 2). This method did not require any crew members to be on board until the lifeboat was floating in the water.
- 3.1.8. Before the operation commenced the master inspected the launching equipment, including the wire slings, recovery hook and high-pressure piping of the hydraulic davit.
- 3.1.9. At about 1100 the lifeboat was lowered into the water. The chief officer, third officer, fourth engineer and an able-bodied seaman then climbed down the embarkation ladder and boarded the lifeboat.

- 3.1.10. The lifeboat was manoeuvred within the harbour for about 10 minutes then returned to the recovery point (see Figure 2). Once the wire slings were connected to the lifeboat davit, the chief officer radioed the master and informed him that the crew were secured by their restraints and that the lifeboat was ready to be hoisted.
- 3.1.11. The boatswain then raised the lifeboat just clear of the water. The master made a final check to ensure that the wire slings and davit hooks were all properly connected before instructing the

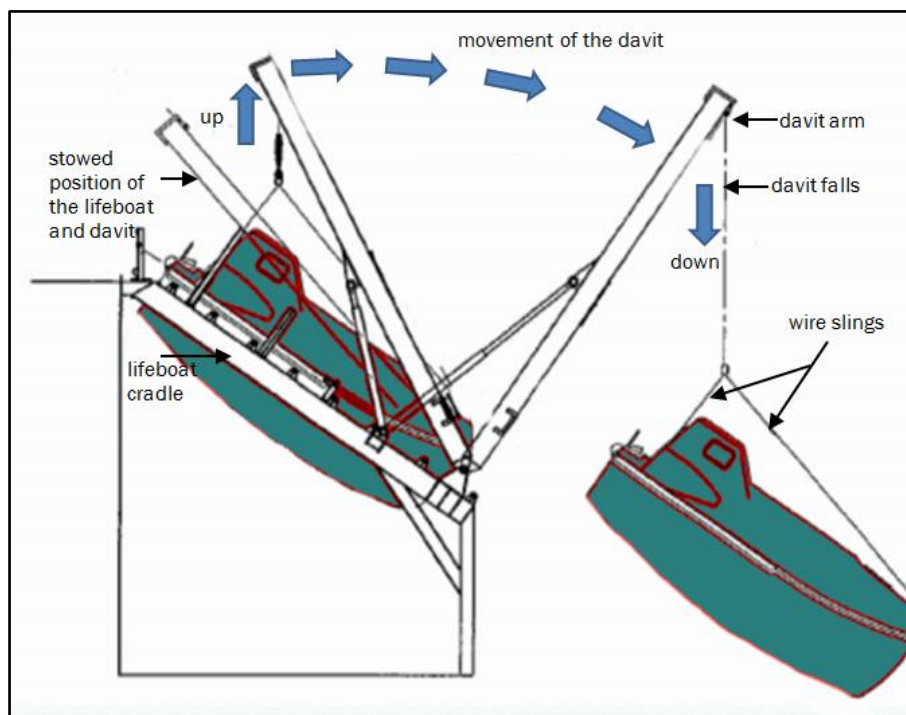
Figure 3  
Lowering a freefall lifeboat by the secondary means of launching

- 4.2.5. As can be seen in Figure 3, the angle at which the lifeboat sat when being lifted required the components of the lifting sling to be different lengths. The vector of forces on the lifting sling when supporting the fully loaded lifeboat meant that the forces were greater on the longer components of the lifting sling. Calculations and drawings provided by the lifeboat manufacturer showed that the maximum load on the longer components of the lifting sling was about 22.9 kilonewtons<sup>8</sup> (refer to Appendix 3 for the manufacturer's calculations). The Defence Technology Agency report said that a reduction of two millimetres in wire rope diameter equated to about a 20% reduction in breaking load. The 20-millimetre wire rope for which a test certificate was supplied had an (as tested) breaking load of 232 kilonewtons. This meant that the smaller-diameter (18 to 18.5 millimetres) wire rope would have had a breaking strain of 185.6 kilonewtons, assuming the two wire ropes were of the same or similar grade and quality of steel<sup>9</sup>.

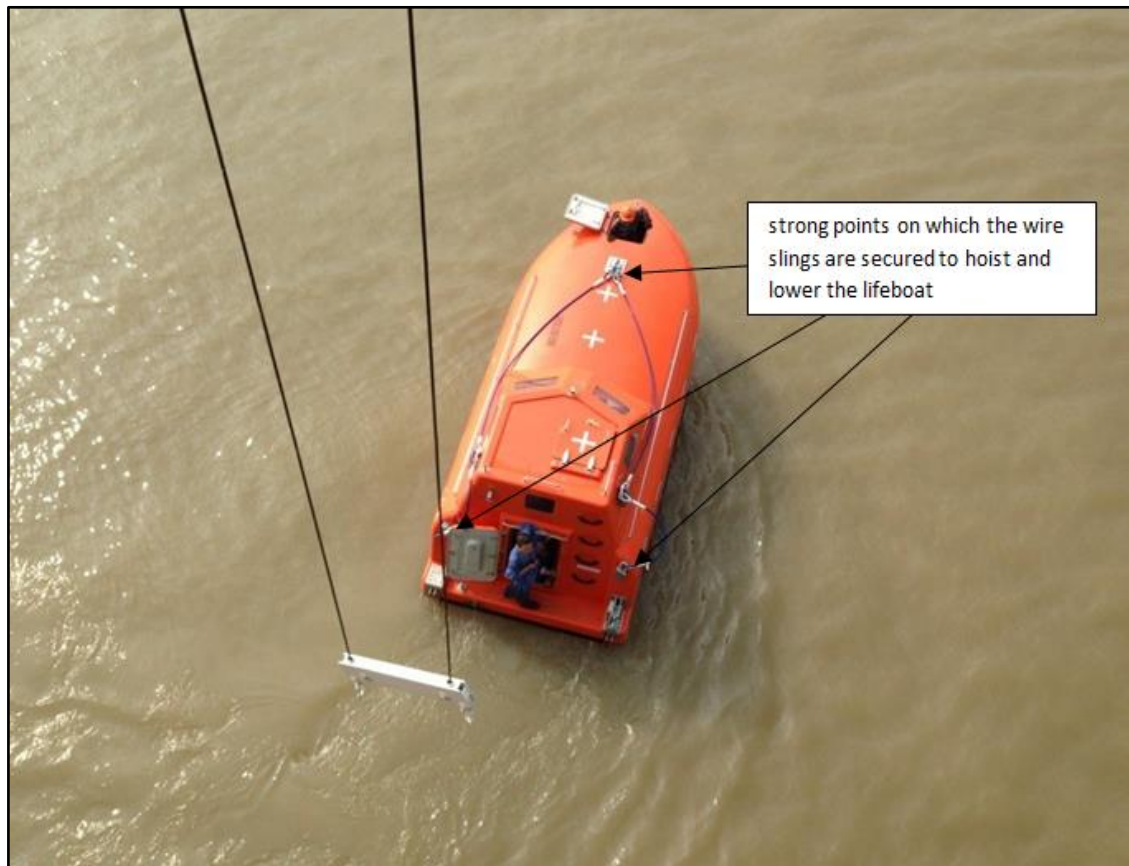
Figure 4  
Location of strongpoints on the lifeboat  
(photo courtesy of Jiangyinshi Beihai LSA Co., Limited, China)

- 3.2.4. This operation required four wire slings to be attached to three strongpoints on the lifeboat, two on the aft and one on the forward of the lifeboat. The wire slings would then be hooked on to the lifeboat davit spreader bar, which could be hoisted and lowered by the davit winch. Once the lifeboat connections had been made ready, the hydraulically operated davit would pivot about its fulcrum, swinging the lifeboat clear of the ship's stern. The procedure for recovering the lifeboat was the same in reverse (Figures 3 and 4).

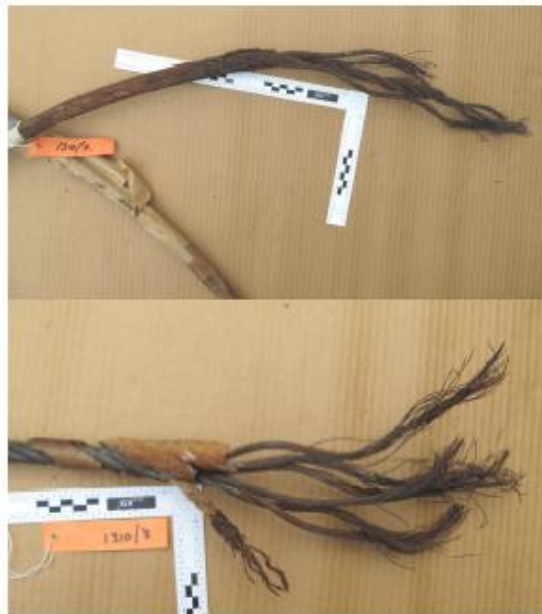
Figure 3. Failed ropes as received.

4. Corrosion in each portion was immediately evident extending a minimum of 200mm from the failure locations. Wires had been galvanised, as evidenced by the lower rope in figure 2. However, there was none remaining on any rope in the immediate vicinity of the failures. Each rope was sheathed with a polymeric material which was discoloured, cracked and brittle. Grease was evident around each thimble eye but none was evident beneath the sheathing.

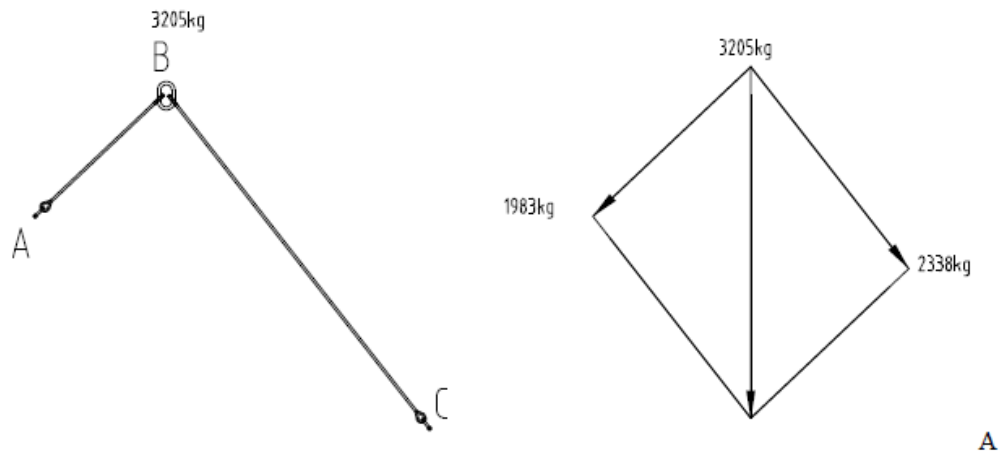
#### 1、受力分析（平行四边形法） Stress analysis for parallelogram law

Pull for AB(wire rope)  $F_1 = 1983kg = 19.4kN$

Pull for BC(wire rope)  $F_2 = 2338kg = 22.9kN$
