Final report AO-2015-001: Pacific Aerospace Limited 750XL, ZK-SDT,  
Engine failure, Lake Taupō, 7 January 2015

Aviation inquiry A0-2015-001  
Pacific Aerospace Limited 750XL, ZK-SDT  
Engine failure

Lake Taupō  
7 January 2015

Approved for publication: June 2017

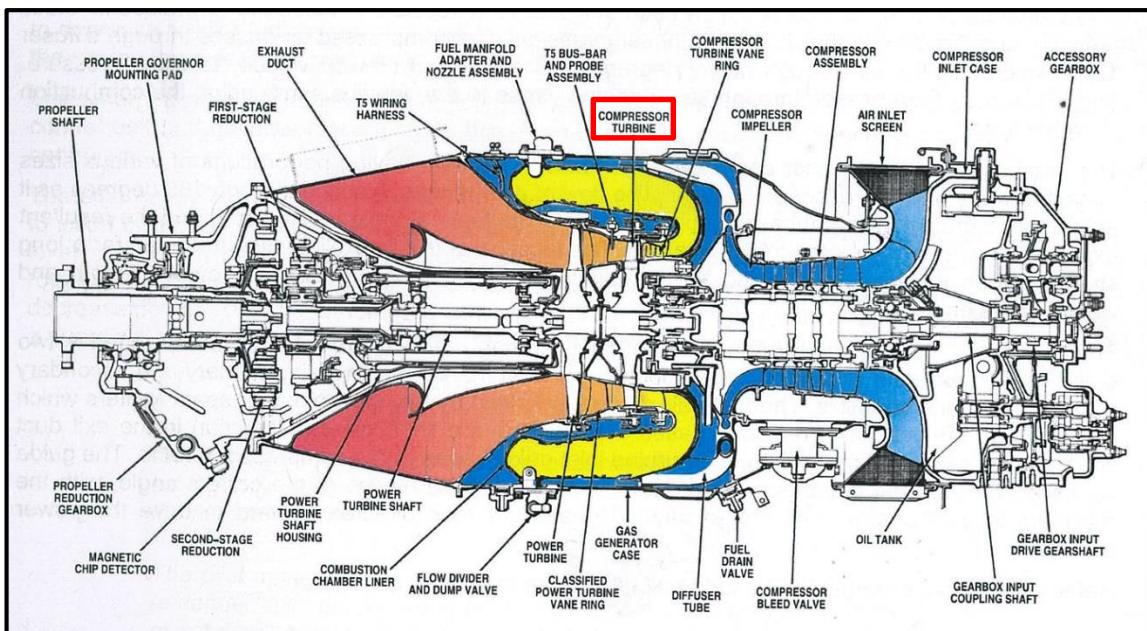
**Figure 1**  
**Schematic of PT6A-34 turboprop engine**

- 3.3.3. The standard engine is the P&WC PT6A-34 turboprop (see Figure 1). The airflow through the engine is from back to front. The air passes through a four-stage compressor section, is combined with fuel and burnt in the combustion chamber. The combustion gases pass through two turbines. The first is the compressor turbine, which drives the compressor section and the accessories gearbox at the rear of the engine. The second turbine is the power turbine, which drives the propeller through a reduction gearbox.
