Final Report AO-2015-002: Mast bump and in-flight break-up,
Robinson R44, ZK-IPY, Lochy River, near Queenstown, 19 February 2015

Aviation inquiry AO-2015-002
Mast bump and in-flight break-up,
Robinson R44, ZK-IPY
Lochy River, near Queenstown,
19 February 2015

Approved for publication: July 2016

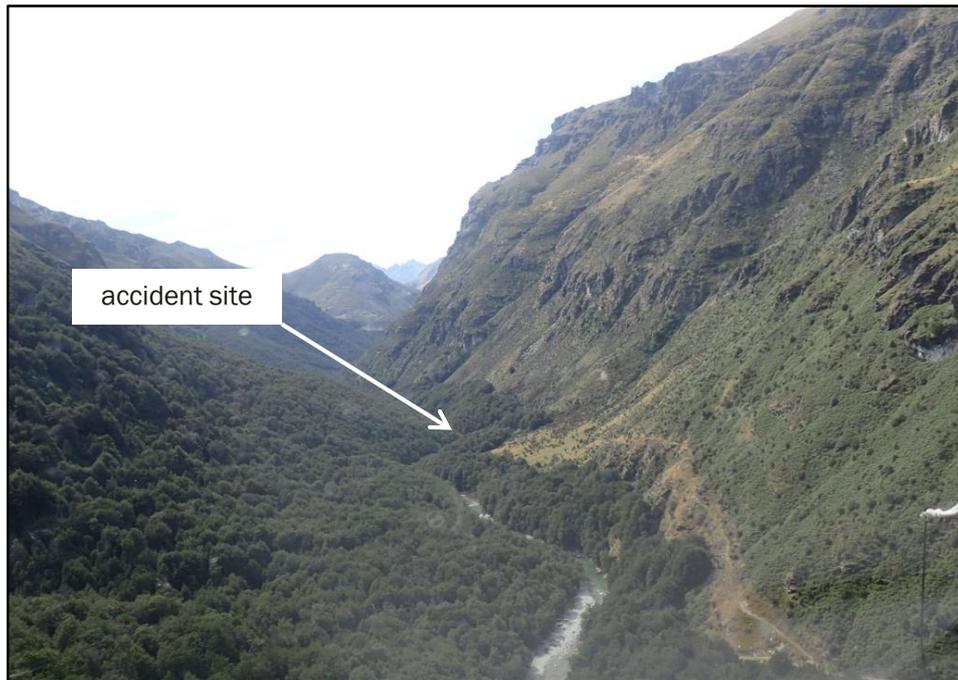
Figure 3
Lochy River – looking downstream (northeast)

- 3.2.1. The accident site was 12 nautical miles (21 km) southwest of Queenstown airport (see Figure 3). The site was on the western side (true left) of the Lochy River, in a narrow section of the valley at an altitude of approximately 1,450 feet (440 m). The immediate area was covered in beech trees approximately 80 feet (25 m) high. The wreckage was spread over an area approximately 200 m by 200 m (see Figure 4). A farm track ran through the centre of the accident site.

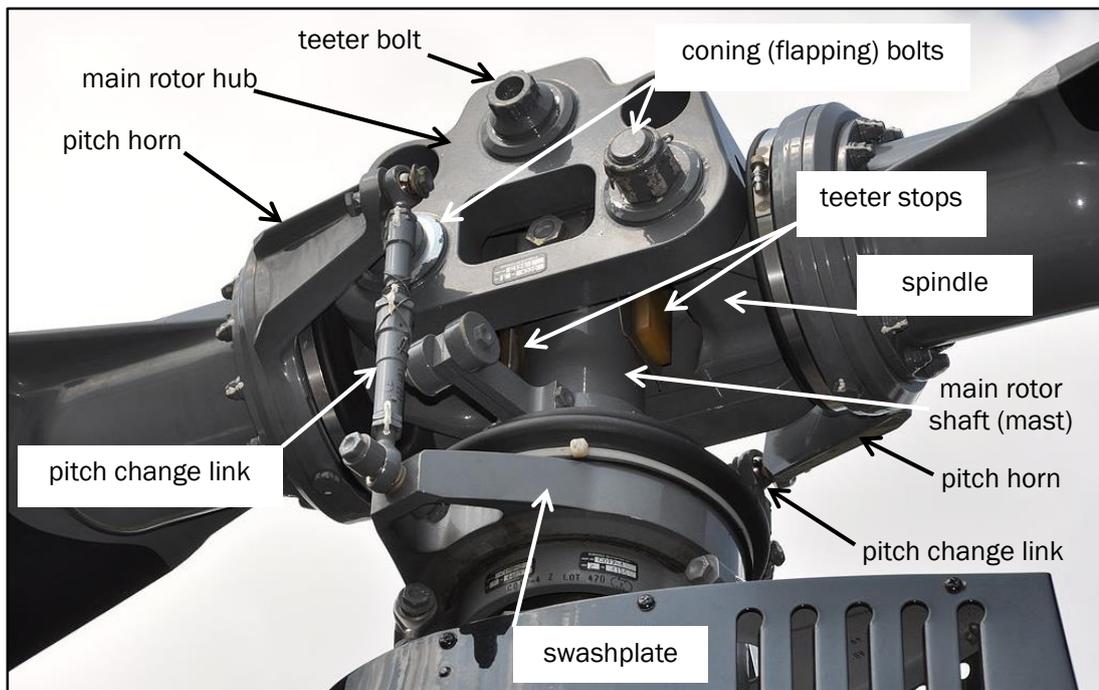
Figure 7
R44 rotor head
(Courtesy of English Wikipedia)

- 3.7.7. The Robinson rotor head design is unique in that it incorporates coning or flapping hinges³¹ as well as a teeter hinge (see Figure 7). The teeter hinge allows the rotor system to tilt in a particular direction, thus inclining the rotor thrust in that direction. The coning hinge allows individual blades to flap up and down. Flapping³² is a normal function of flight and is the result of the lift of a blade changing in response to changes in airspeed and angle of attack as the blades rotate. It is also common during start-up and shutdown in windy conditions, where the slow rotation of the blades provides insufficient centrifugal force and stability to maintain the blades in the same plane of rotation. Static or teeter stops are used to control excessive teeter and prevent damage to the mast during this time.

3.7.10. Low-G flight is a situation when the occupants feel a sensation of reduced weight. It can be induced by a pilot moving the cyclic control stick forward. In a helicopter with a teetering rotor head, because of the position of the helicopter's centre of gravity and the tail rotor thrust line, if the pitch forward is sufficiently strong enough and the tail rotor thrust line moves high enough, a roll to the right can be induced.³⁴ Because of the teetering rotor head design and the gyroscopic stability of the main rotor, the disc attitude will remain stationary or slowly lag behind the fuselage roll. In effect, the pilot will observe the helicopter starting to roll right, but the disc may still be about level. If the pilot applies left cyclic to counter the apparent roll, the angle between the disc and the mast on the left side will be reduced even further – possibly to the point where the spindle (see Figure 7) contacts the mast (mast bumping).
