Final report R0-2015-102: Electric locomotive fire at
Palmerston North Terminal, 24 November 2015

Rail inquiry R0-2015-102

Electric locomotive fire at Palmerston North
Terminal
24 November 2015

Approved for publication: February 2017

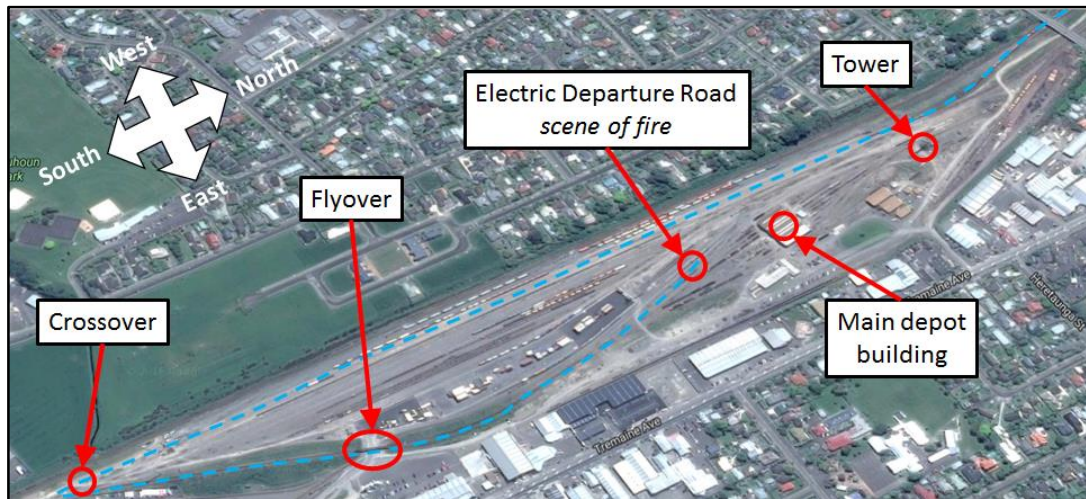
Figure 2
Palmerston North Terminal aerial view

- 3.1.1. On Tuesday 24 November 2015 at about 1800, a southbound freight train consisting of a single electric locomotive and 12 wagons stopped near the tower in the KiwiRail Palmerston North Terminal (see Figure 2).

- 3.1.2. The train driver was relieved by a local depot driver before six wagons were detached. The train was then moved beyond the 'crossover' (see Figure 2) where the locomotive was detached from the remaining wagons. The depot driver, assisted by a pilot⁴, drove the locomotive over the 'flyover' before it was parked on the electric departure road (see Figure 2) in preparation for a northbound service.

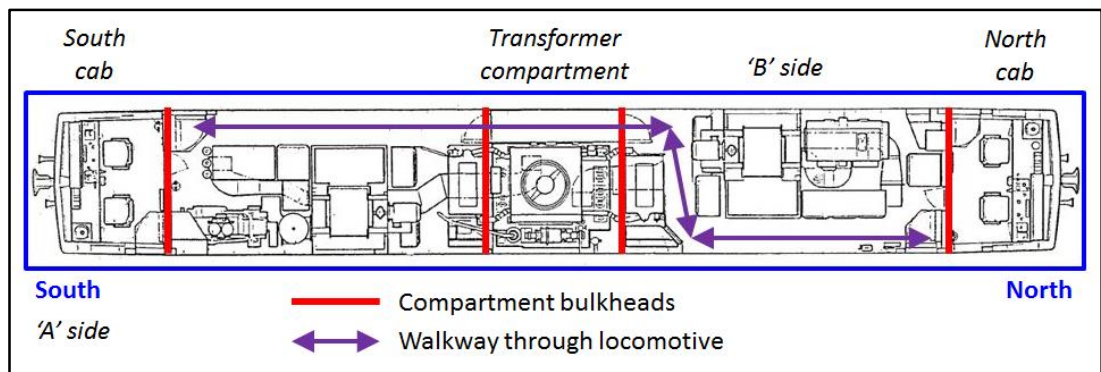
Figure 3
Layout of an electric locomotive (see Appendix 1 for more detail)

- 3.1.4. At 1837 CCTV footage confirmed that a puff of smoke emanated from the locomotive transformer⁵ compartment.
- 3.1.5. At 1838 the depot driver alighted from the 'south end' locomotive cab and walked along the eastern side of the locomotive towards the main depot building (see Figure 2). As he did so flames shot out of the side grille of the transformer compartment (see Figure 3).

- 3.1.12. In response, firefighters equipped with breathing apparatus entered the internal walkway of the locomotive (see Figure 3) and applied foam directly to the source of the fire inside the transformer compartment.

- 3.6.2. The EF loco is divided into five compartments to minimise the possible spread of fire (see Figure 3).
- 3.6.3. Electric locomotives are fitted with 4.5-kilogram dry powder type fire extinguishers in each of the cabs.

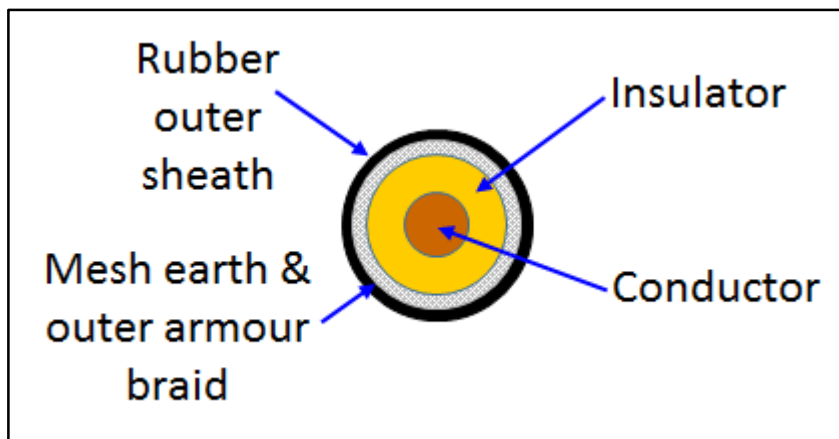
Figure 5
Cross-section of high-voltage cable

- 3.2.1. Power is transferred from the overhead power line to the locomotive through the pantograph and down into the transformer compartment by a high-voltage cable assembly. The cable terminates in the transformer housing using a plug and socket arrangement. The socket is an oil-filled reservoir.
- 3.2.2. The high-voltage cable has a conductive core that is surrounded by insulation, an earth mesh screen, and an outer rubber sheath (see Figure 5).

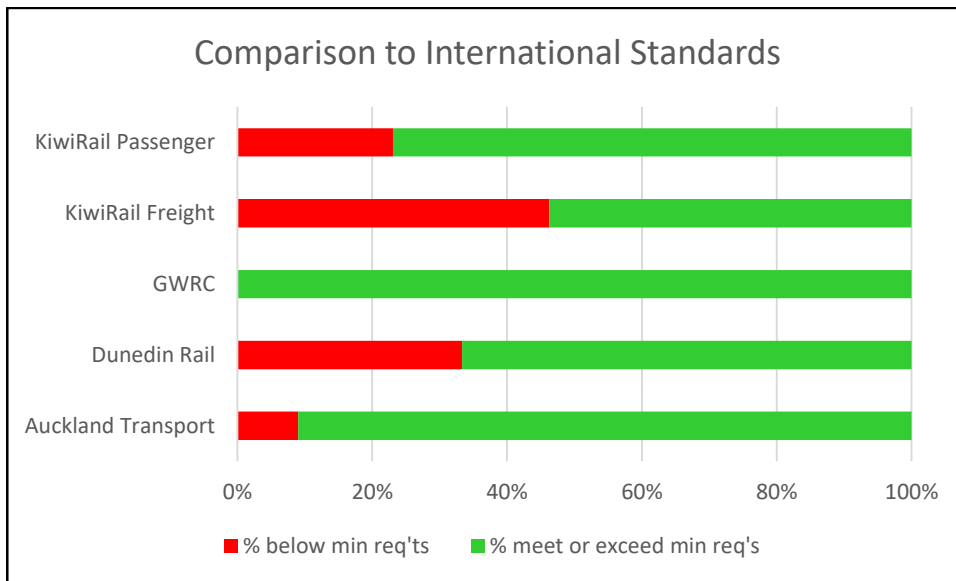
Figure 12
Percentage of operators' fleets compliant with international standards EN45545 and AS7529

- locomotives used for shunting operations only, due to their being low risk and non-mainline operations.
- 4.5.6. Overall, only 48 out of a total 286 locomotives (see Appendix 3), or 16%, did not meet the minimum requirements of the international standards. A breakdown of this by owner/operator and function shows (see Figure 12):

- Greater Wellington Regional Council – 100% compliant
- Dunedin Rail – passenger – four out of 13 locomotives, or 30%.

The owners/operators of these locomotives have plans in place to address some of the shortfalls. An economic solution for the remaining locomotives is under consideration.

4.5.7. Presently only 16% of the major New Zealand rail operators' fleets do not meet the requirements of the international standards for fitting fire detection and suppression systems. Where such systems are fitted, there is currently no consistency across the different operators. Adopting or developing a New Zealand national standard would provide consistency.

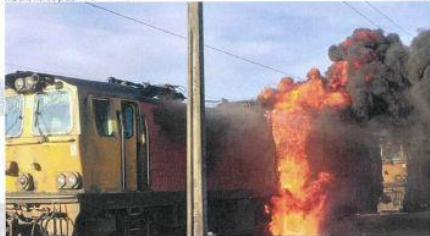
Background: EF 30157 caught fire in Palmerston North yard. As precaution all other EF locomotives will have a safety inspection.

Action:
Inspect each EF locomotive before it returns to service.

Carry out a visual inspection of the transformer compartment from the walkway, looking through protection grill, for the following.

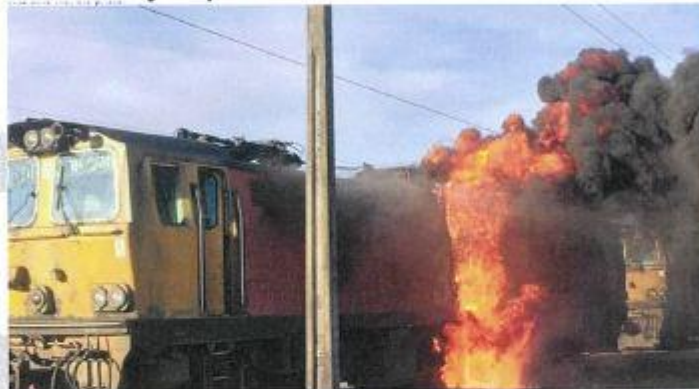
Background: EF 30157 caught fire in Palmerston North yard. As precaution all other EF locomotives will have a safety inspection.

Action:
Inspect each EF locomotive before it returns to service.

Carry out a visual inspection of the transformer compartment from the walkway, looking through protection grill, for the following.
