Final report MO-2015-201: Passenger ferry *Kea*, collision with Victoria Wharf,
Devonport, 17 February 2015

Marine inquiry MO-2015-201
Passenger ferry *Kea*,
collision with Victoria Wharf, Devonport,
17 February 2015

Approved for publication: August 2017

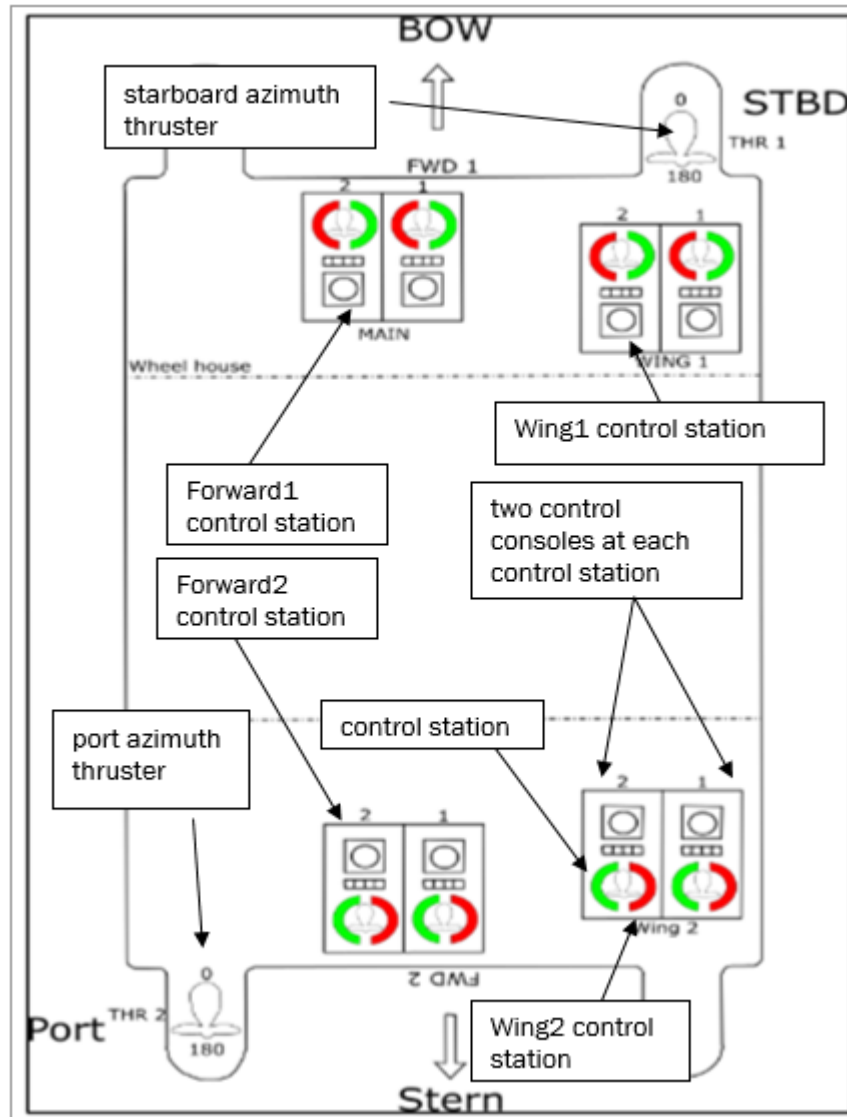
Figure 1
Schematic diagram of the Kea's propulsion and steering control system

- 3.2.1. The Kea was a twin-hulled vessel with an identical bow¹ and stern.² Propulsion and steering were provided by two azimuth thrusters,³ one fitted on the forward end of the starboard hull and the other on the aft end of the port hull. The azimuth thrusters comprised a fixed-pitch propeller enclosed in a shroud that could be rotated 360°.
- 3.2.2. Two sets of identical steering control stations were used to drive the vessel in either direction, without the need to turn around off the berth. Each control station had two control consoles⁴ (see Figure 1). Each console was fitted with a control lever and graphic display panel⁵ to operate the azimuth thruster units (see Figure 4). Two control stations were located on the

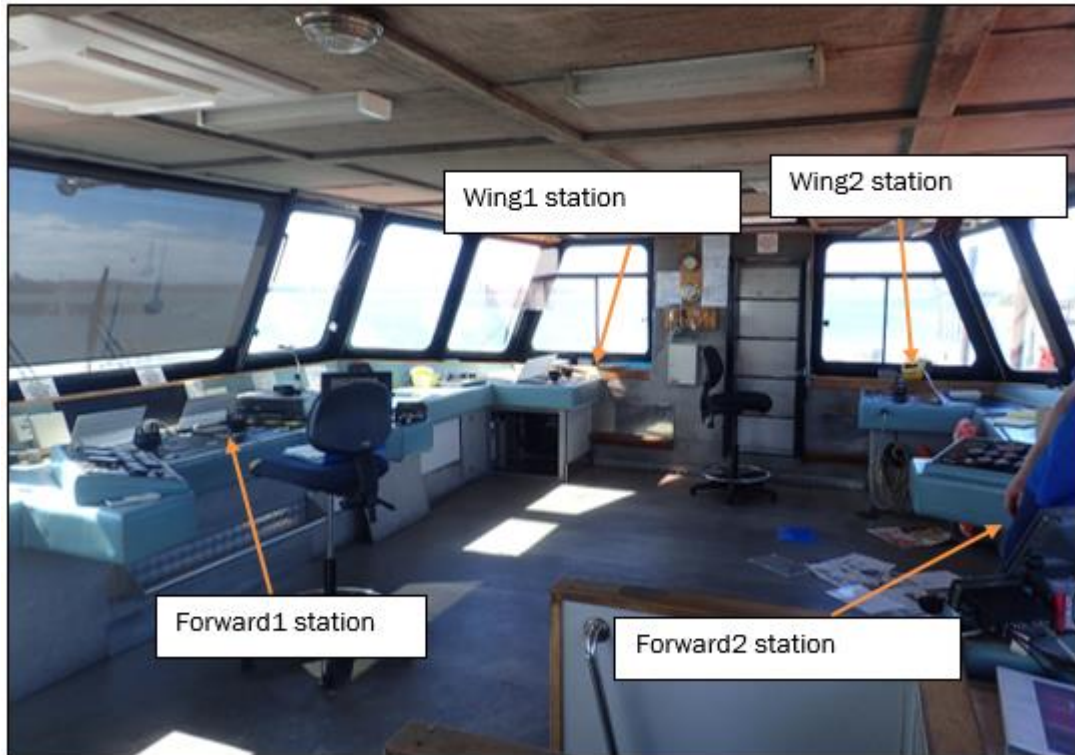
Figure 2
The Kea's wheelhouse layout

forward side of the wheelhouse:⁶ Forward1 station and Wing1 station (see Figure 1). Two stations on the aft side, Forward2 station and Wing2 station, were located symmetrically opposite and identical to the forward stations (see Figure 2). The Kea was normally controlled from the wing stations when manoeuvring off the wharf. Once clear of the wharf the normal option was to transfer control to the forward control station on the centreline for better visibility and access to navigational equipment.

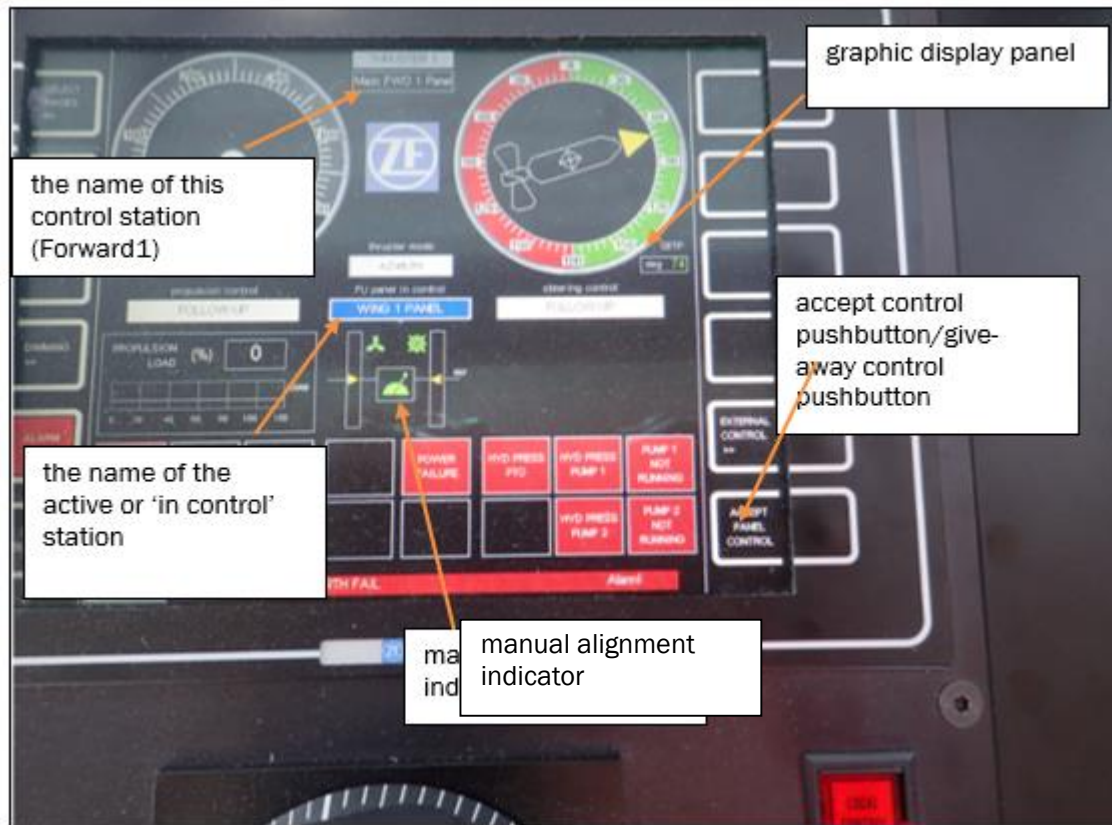
Figure 4
Graphic display panel

- 3.2.3. Each control station was fitted with two control levers, one for each azimuth thruster. The levers both controlled the propeller revolution speed and rotated to control the thruster steering angle. Each console had a graphic display panel showing various propulsion and steering parameters (see Figure 4).

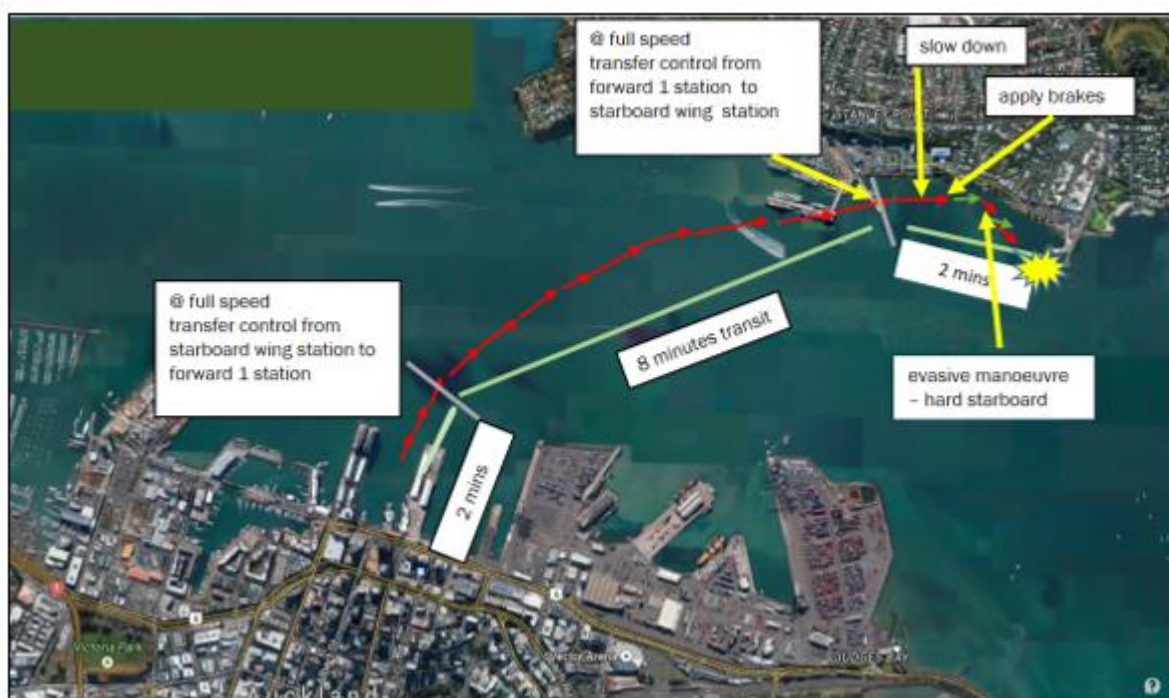
Figure 5
The *Kea*'s route from Auckland's CBD to Devonport

3.6.5. For the first couple of runs prior to sunrise, the relief master controlled the ferry from the wing stations. Shortly after sunrise the master decided to transfer control to the centre control stations after clearing the harbour basin, to avoid being blinded by sun-strike through the starboard wheelhouse window.
