Final report MO-2015-202: Containership *Madinah*, loss of person overboard,
Lyttelton Harbour entrance, 2 July 2015

Marine inquiry MO-2015-202
Containership *Madinah*, loss of person overboard,
Lyttelton Harbour entrance
2 July 2015

Approved for publication: September 2016

Transport Accident Investigation Commission

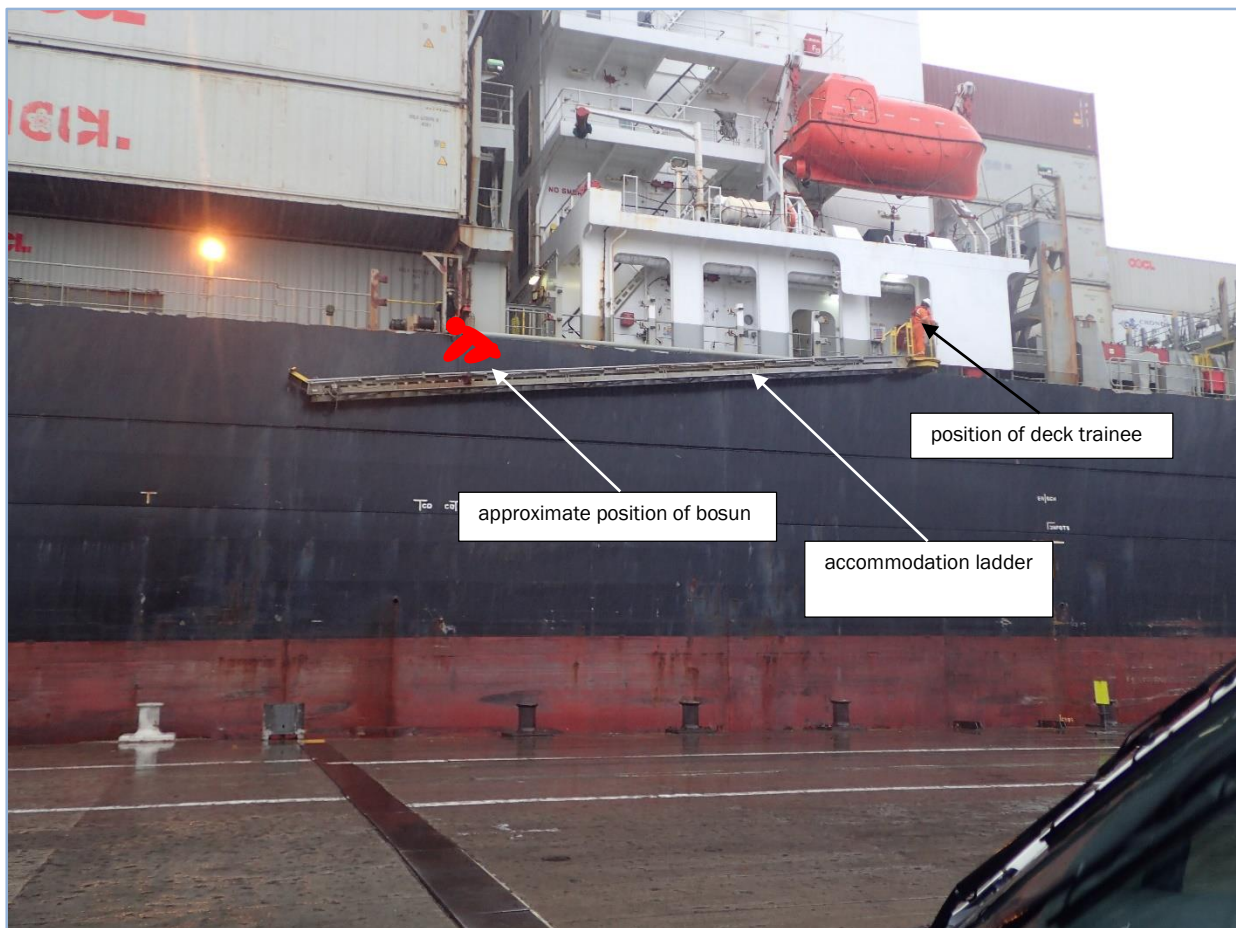
Figure 2
Positions of bosun and deck trainee on accommodation ladder when bosun fell
(starboard accommodation ladder shown)

- 3.1.6. The deck trainee returned from the changing room wearing his own buoyancy vest and carrying one for the bosun. However, the bosun had already removed the lashings and lowered the accommodation ladder to below the main deck level. The deck trainee stood on the top platform of the accommodation ladder, from where he saw that the bosun had walked more than halfway down it and was crouched down trying to lift the outboard handrail from its stowage position (see Figure 2).

- 3.1.7. As the deck trainee watched, the handrail snapped back into its stowage position, causing the bosun to lose his balance and fall into the sea. The bosun was wearing a safety harness connected to a wire, but as his body weight came on the safety harness line the wire parted and the bosun fell into the sea.

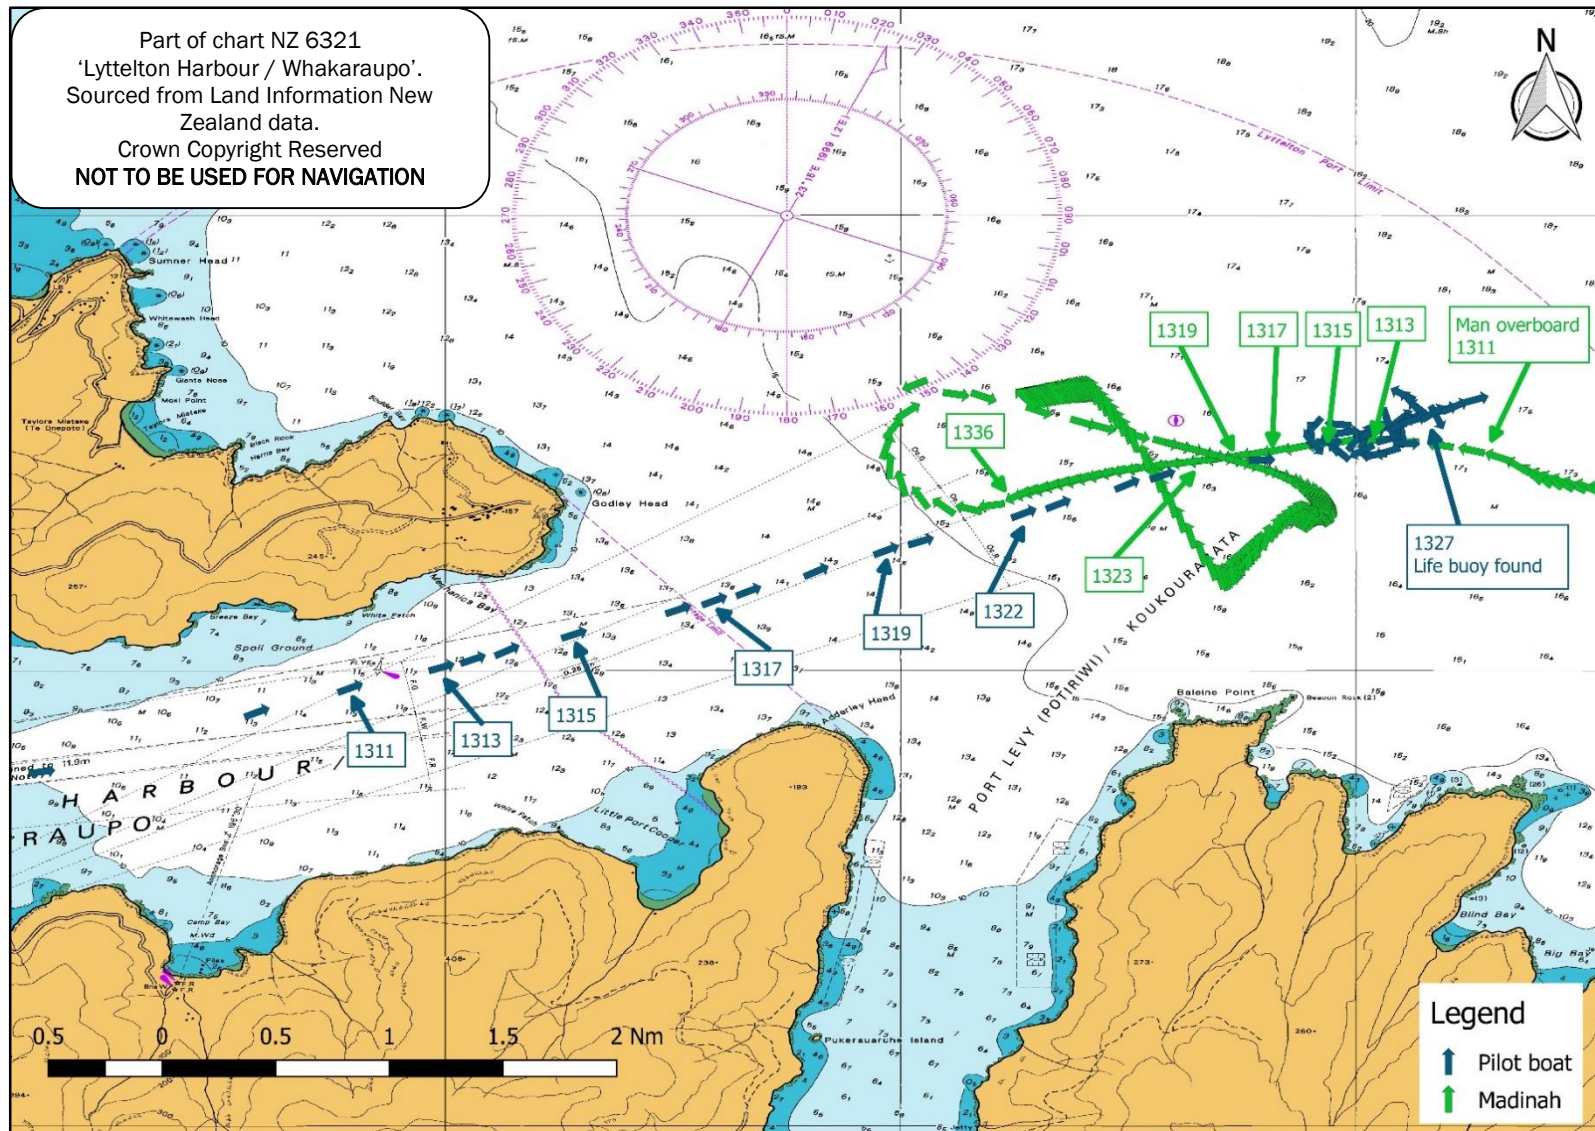
Figure 3
 Tracks of the *Madinah* and the pilot boat during the accident

3.1.17. On the way to the accident site the crew of the pilot vessel were unable to locate the lifebuoy or the bosun, so they asked the *Madinah* to direct them. The *Madinah*'s crew had kept the lifebuoy and bosun in sight for as long as possible, but by the time they were asked by the crew of the pilot vessel for guidance they had lost sight of the bosun and the lifebuoy and were only able to direct the pilot vessel to an approximate area. At about 1333, about 20 minutes after the bosun had been lost overboard, they found a hard hat and a pair of working gloves belonging to him.

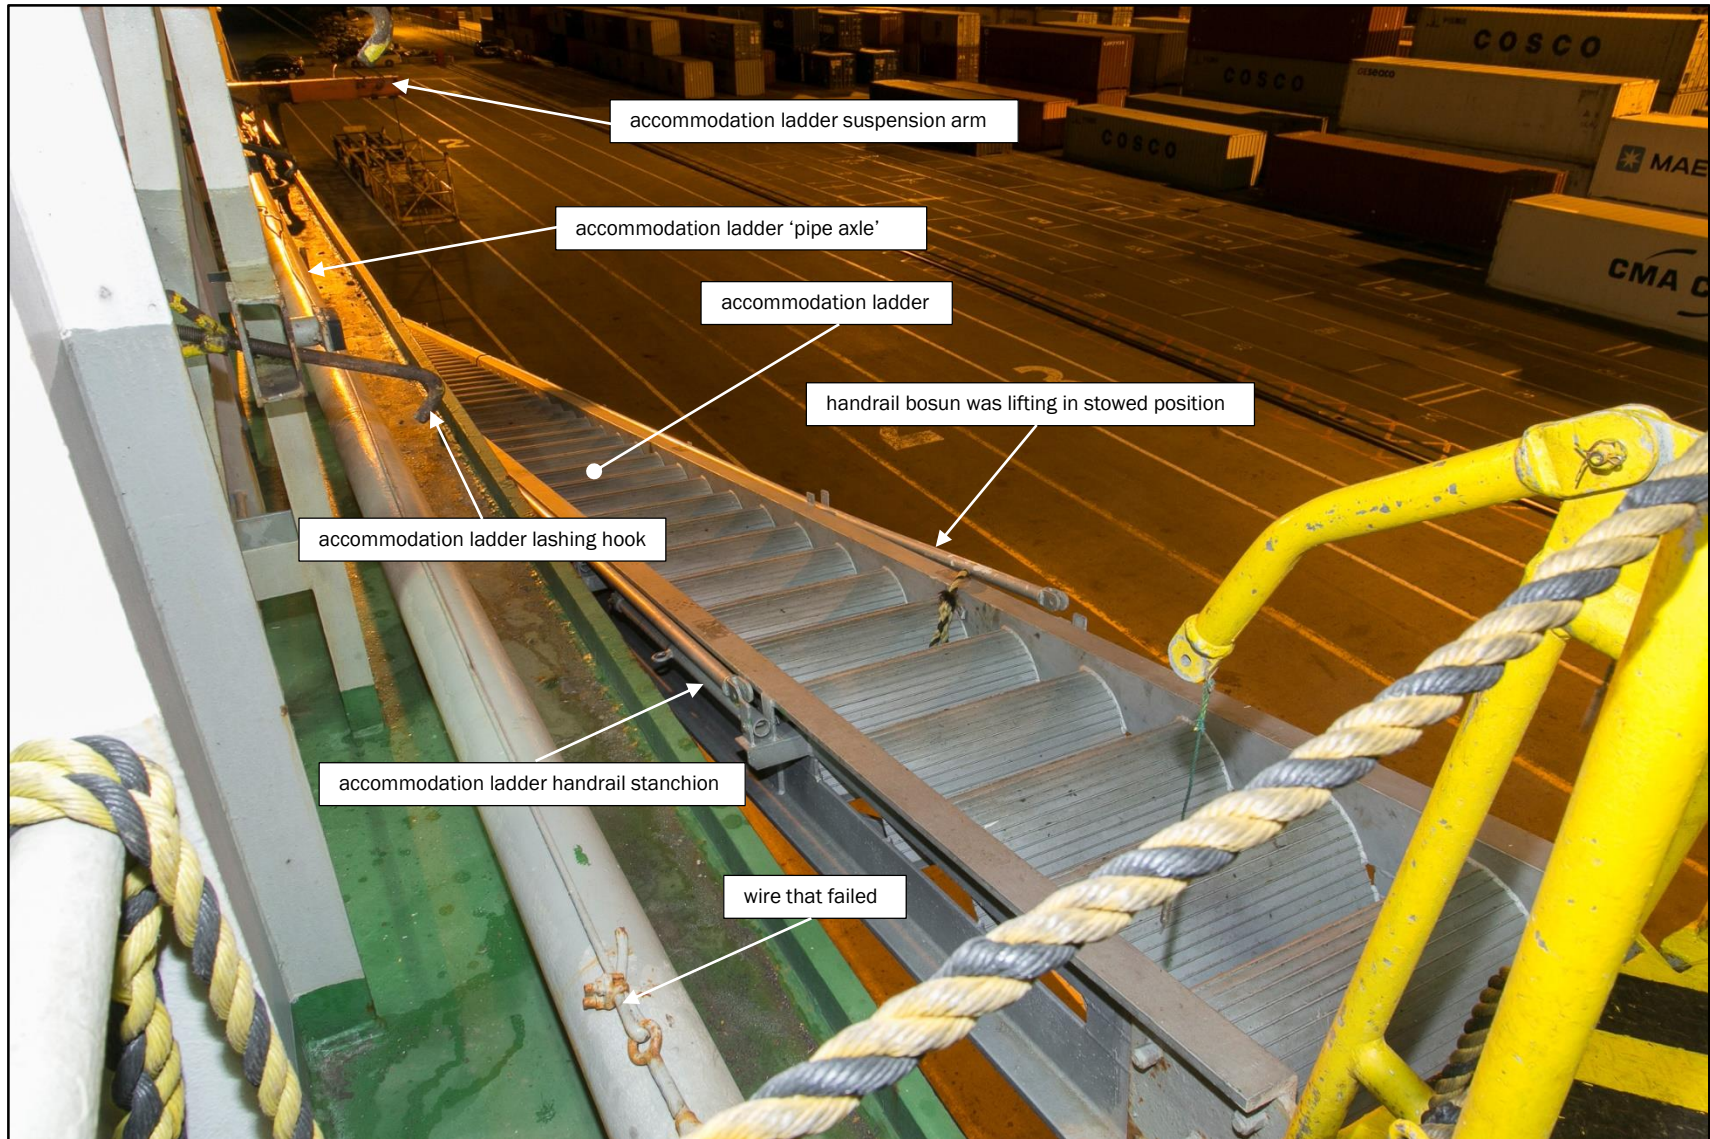
Figure 4
Parts of the port-side accommodation ladder

4.3.1. The wire to which the bosun attached his safety harness was plastic coated. It was rigged between two eye bolts that had been fitted to the accommodation ladder suspension arrangement (see Figures 4 and 5).
