Final report AO-2016-004: Guimbal Cabri G2, ZK-IIH, In-flight fire,
near Rotorua Aerodrome, 15 April 2016

Aviation inquiry A0-2016-004
Guimbal Cabri G2, ZK-IIH
In-flight fire
near Rotorua Aerodrome
15 April 2016

Approved for publication: October 2017

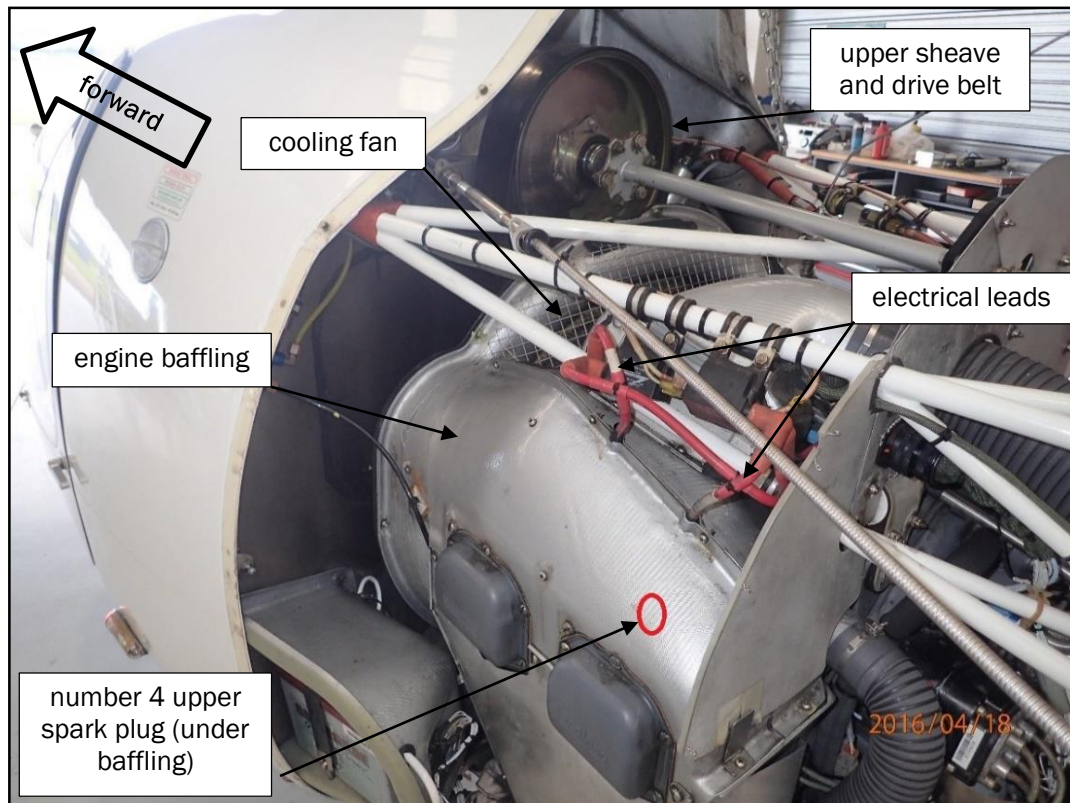
Figure 5
Engine configuration

- 3.3.1. The Cabri was a two-seat light helicopter, powered by a Lycoming O-360-J2A four cylinder piston engine, first certificated in late 2007. Engine power was delivered to the main gearbox by a single, 70-millimetre (mm) wide, heavy-duty rubber drive belt connecting lower and upper sheaves⁸ (see Figure 5). The upper sheave transmitted power through a free-wheeling unit to the main and tail rotor gearboxes. Belt tension was controlled by a hydraulic actuator that used engine oil pressure to move the engine, and therefore the lower sheave, about a pivot point.
