Final report MO-2016-203: Bulk log carrier *Mount Hikurangi*, Crew fatality
during cargo securing operation, 27 February 2016

Marine inquiry MO-2016-203
Bulk log carrier *Mount Hikurangi*
Crew fatality during cargo securing operation
27 February 2016

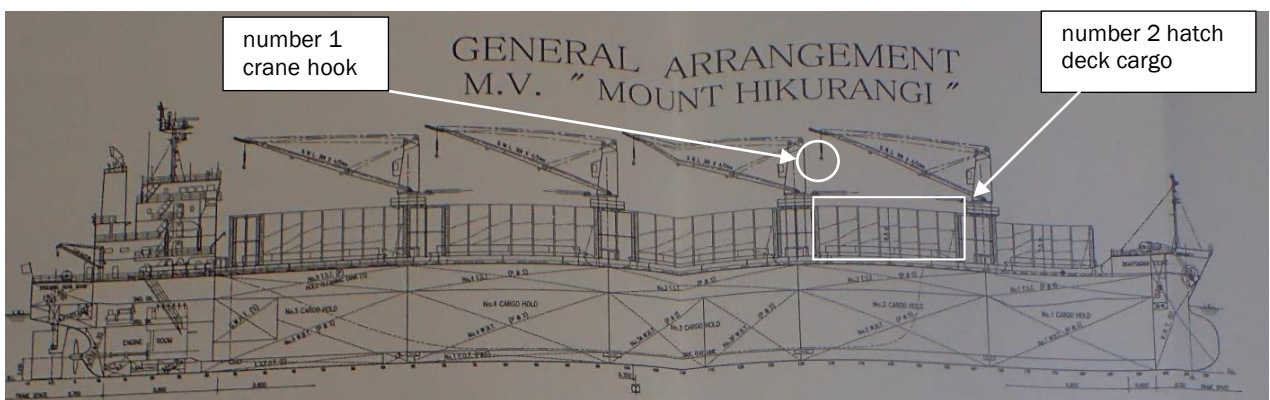
Figure 3
General arrangement of Mount Hikurangi

- 3.2.6 At about 0900 on 27 February 2016, all cargo loading operations had been completed. The crew that had secured the log cargo above number 5 hatch commenced securing the log cargo above number 2 hatch, using number 1 crane to haul the chains across the logs (see Figure 3).

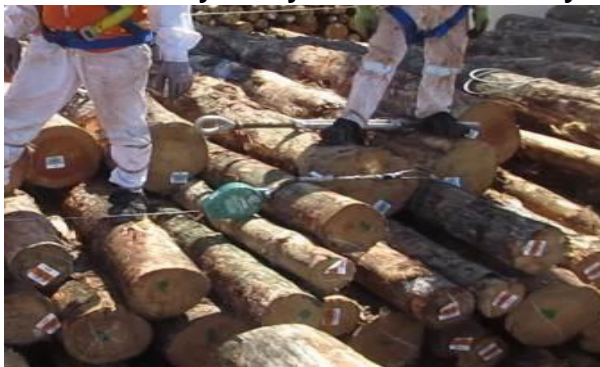
FPD secured to logs using wire sling

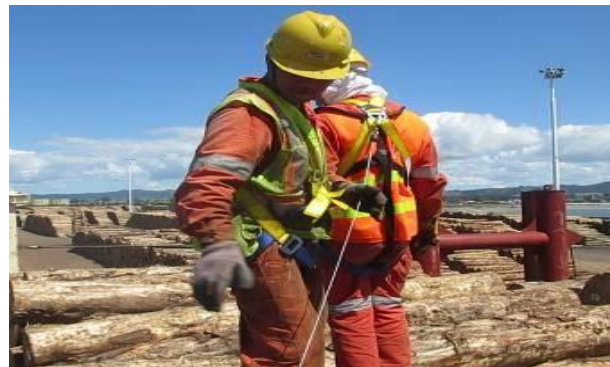
FPD wire end hooked on to safety harness

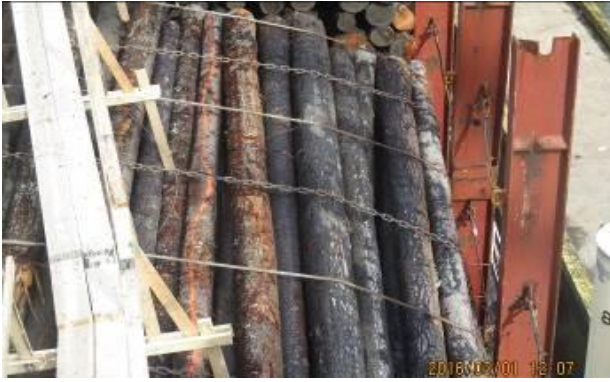
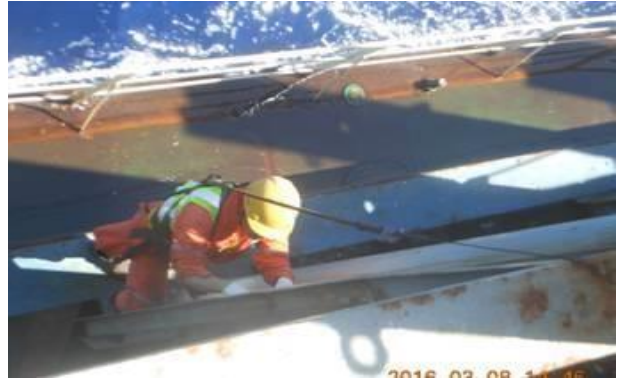
Red Zone (less than 3 meters or 2 man heights from ship sides) Fall arrestor fixed at hatch center, with self-retracting life line connected to safety harness for working on logs.

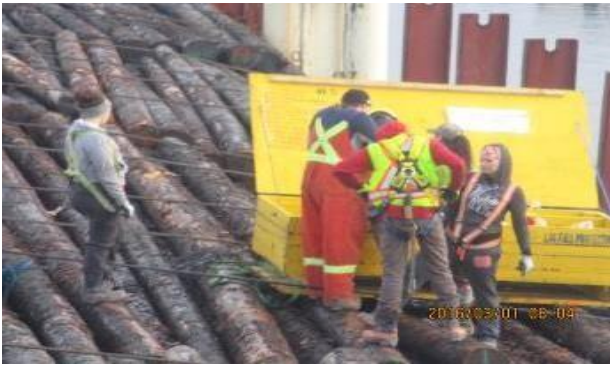
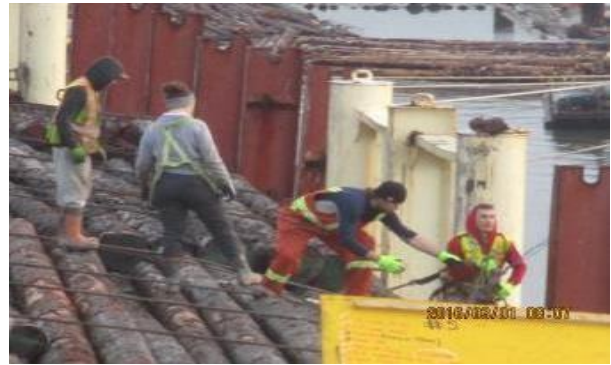
View of longshoreman donned with FPD & safety harness 3 Longshoremen teamed up to pull up lashing chain

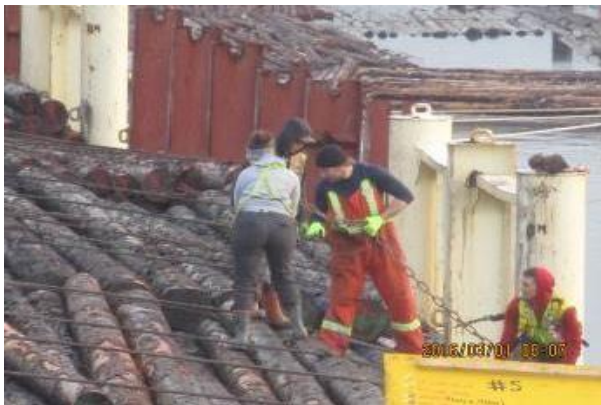
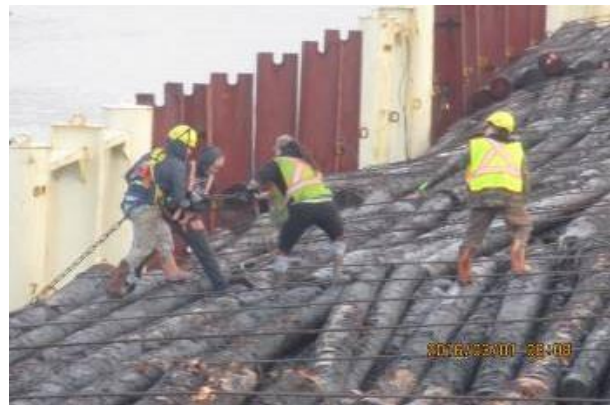
Only one longshoreman stands in Danger zone to pull up View of longshoremen teamed up & pulling lashing chain foot wire and lashing chain. Others are helping to pull it up inboard and secure logs.
