Interim Report AO-2017-001: collision with terrain, Eurocopter AS350-BA, ZK-HKW,
Port Hills, Christchurch, 14 February 2017

Interim Report

Aviation inquiry AO-2017-001
collision with terrain
Eurocopter AS350-BA, ZK-HKW
Port Hills, Christchurch
14 February 2017

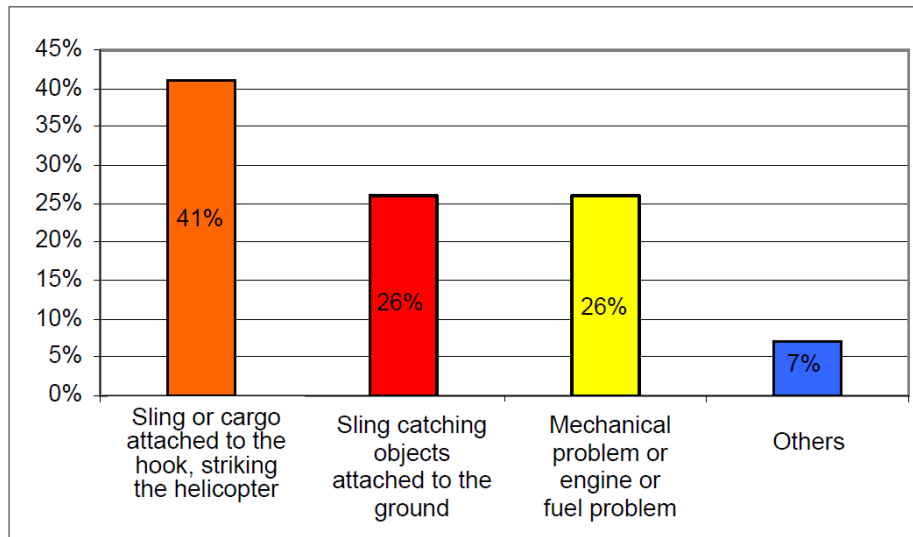
Types of accidents:

In most of the cases (41%), the sling contacts the tail rotor, which may cause the TGB and parts of the fin to be damaged. The two main reasons are either an abrupt dive maneuver or bursting of the bag which behaves like a parachute when empty. In both cases, the cable and its cargo are subject to airstream loads which prevail over the weight of the cable and cargo. Consequently, the sling or load follows the airstream into the tail rotor area.
