Final report MO-2017-201: Passenger vessel *L'Austral* contact with rock Snares Islands,
9 January 2017

Marine inquiry MO-2017-201
Passenger vessel *L'Austral* contact with rock Snares Islands,
9 January 2017

Approved for publication: February 2018

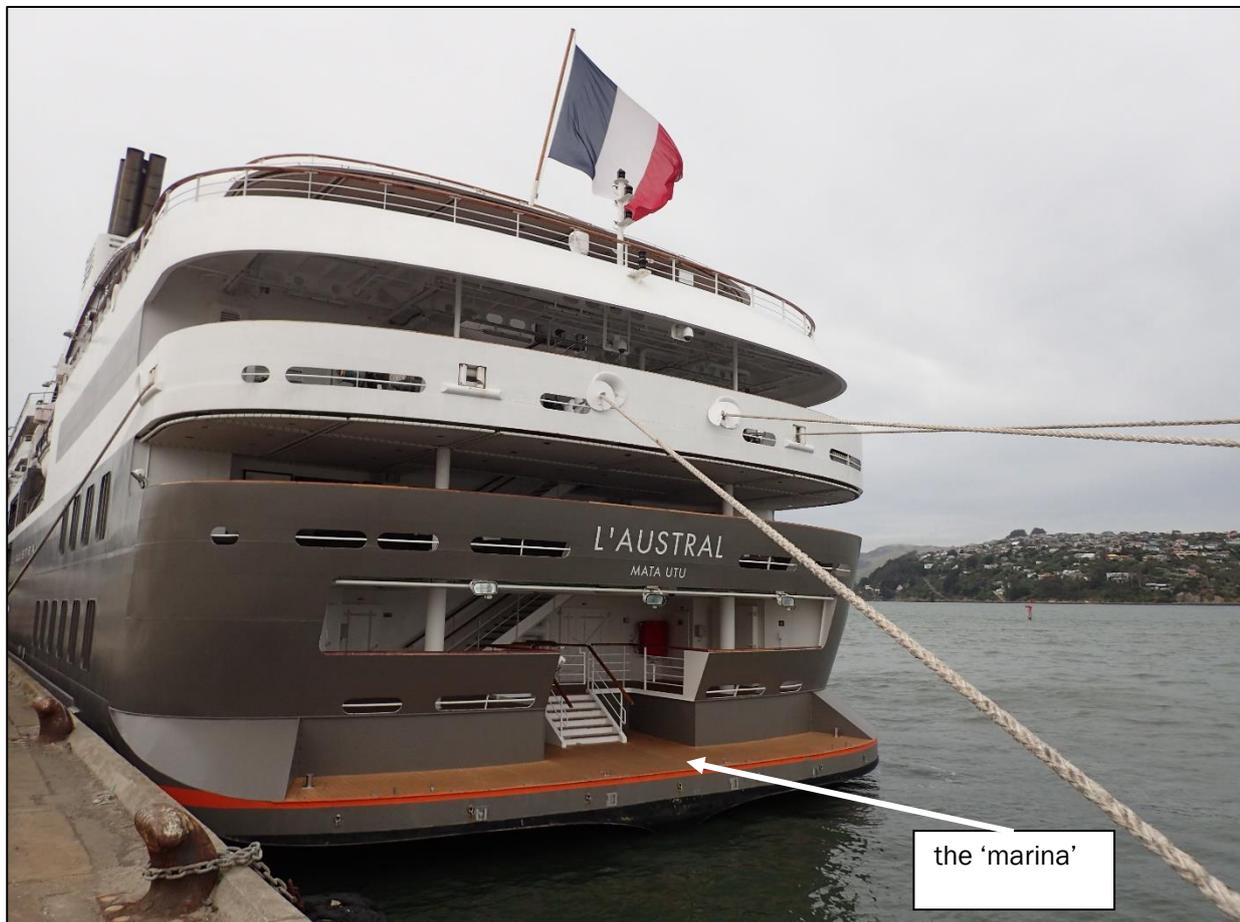
Figure 2
Stern of *L'Austral* showing the 'marina'

- 3.2.3. *L'Austral* arrived off North East Island in the Snares Islands group at about 0600 on 9 January 2017. Whilst the vessel manoeuvred close inshore, the passengers embarked onto the RHIBs from the stern platform (referred to on board as the marina – see Figure 2). The RHIBs then cruised around the east coast of the island, allowing the passengers to view the wildlife.

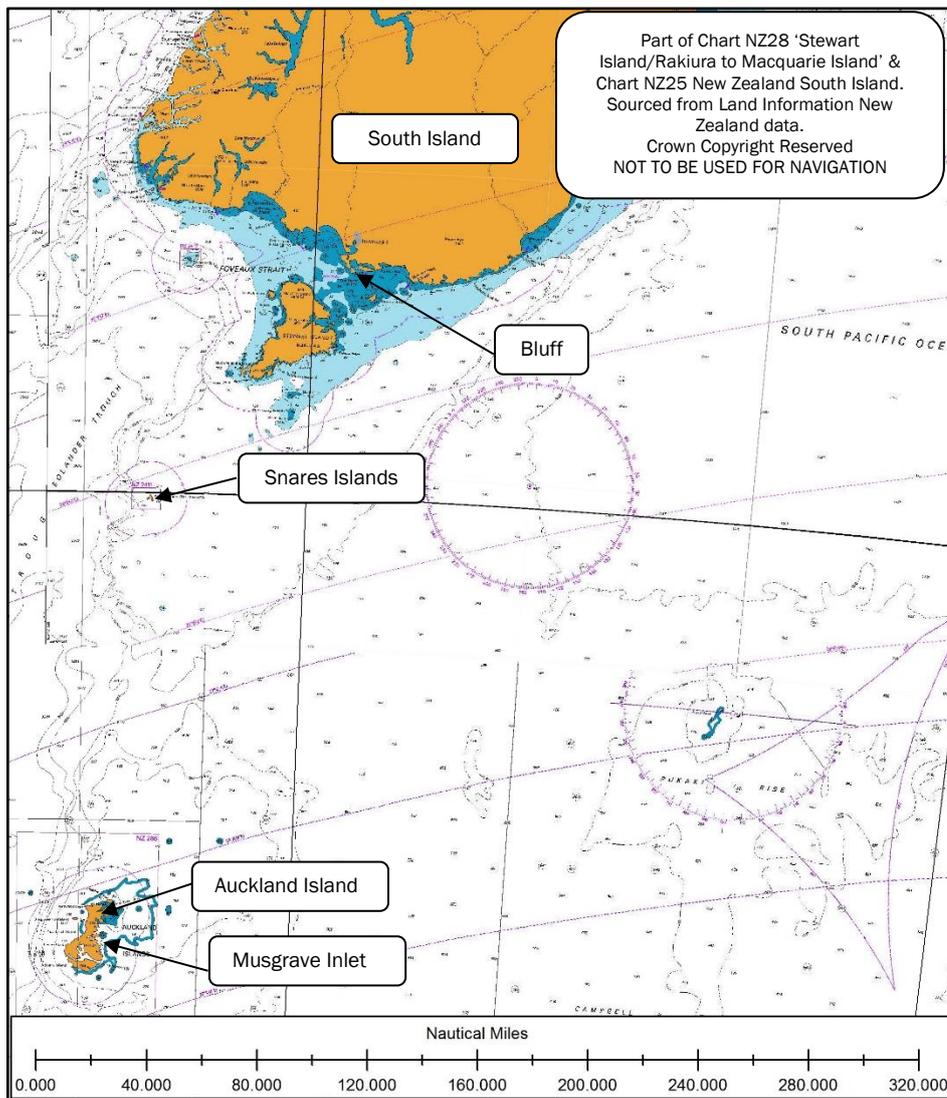
Figure 4
Chart showing location of Auckland Island

- 3.2.14. At about 1630 the damage control team briefed the master. They confirmed that the adjacent compartments were dry and that flooding had been contained to just one void space. They recalculated the stability of the vessel, which confirmed that the ship’s stability was not adversely affected by the flooded void space. The master contacted the vessel’s operator, Compagnie du Ponant (Ponant), to report the damage and it in turn contacted the French authorities. The master then decided to continue the passage to Auckland Island, about 140 nautical miles south of the Snares Islands (Figure 4).

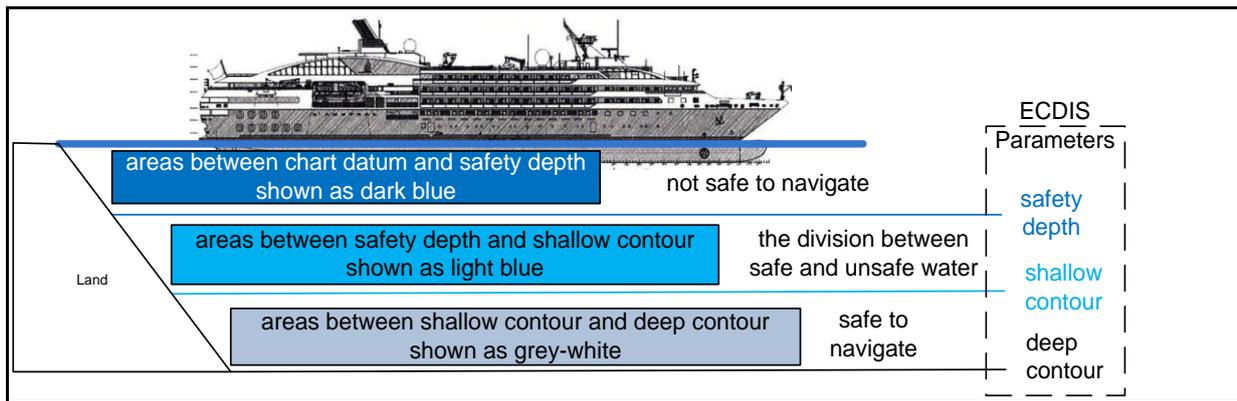
Figure 10
Description of ECDIS depth parameters

- 4.4.12. Alarms are configured by using a number of parameters, which are explained in Figures 10 and 11. They are triggered when a 'virtual region' defined by time, distance or depth around a ship is predicted to cross a charted danger.

- 4.4.13. An ECDIS automatically rounds depth parameters to the next-deepest contour. As depth contours are usually in 10 m increments, setting the shallow contour at 6 m would have rounded up to 10 m on the ENC in use at the time of the accident. With this configuration the shallow contour did not show, as it was effectively the same as the safety depth. The shallow contour could have added a good visualisation that the ship was heading towards shallower water and could have been configured to alarm prior to the accident.
