Final report MO-2017-202: Passenger vessel *L'Austral*, grounding,
Milford Sound, Fiordland, 9 February 2017

MO 2017-202
Passenger vessel *L'Austral*,
grounding,
Milford Sound, Fiordland
9 February 2017

Approved for publication: June 2018

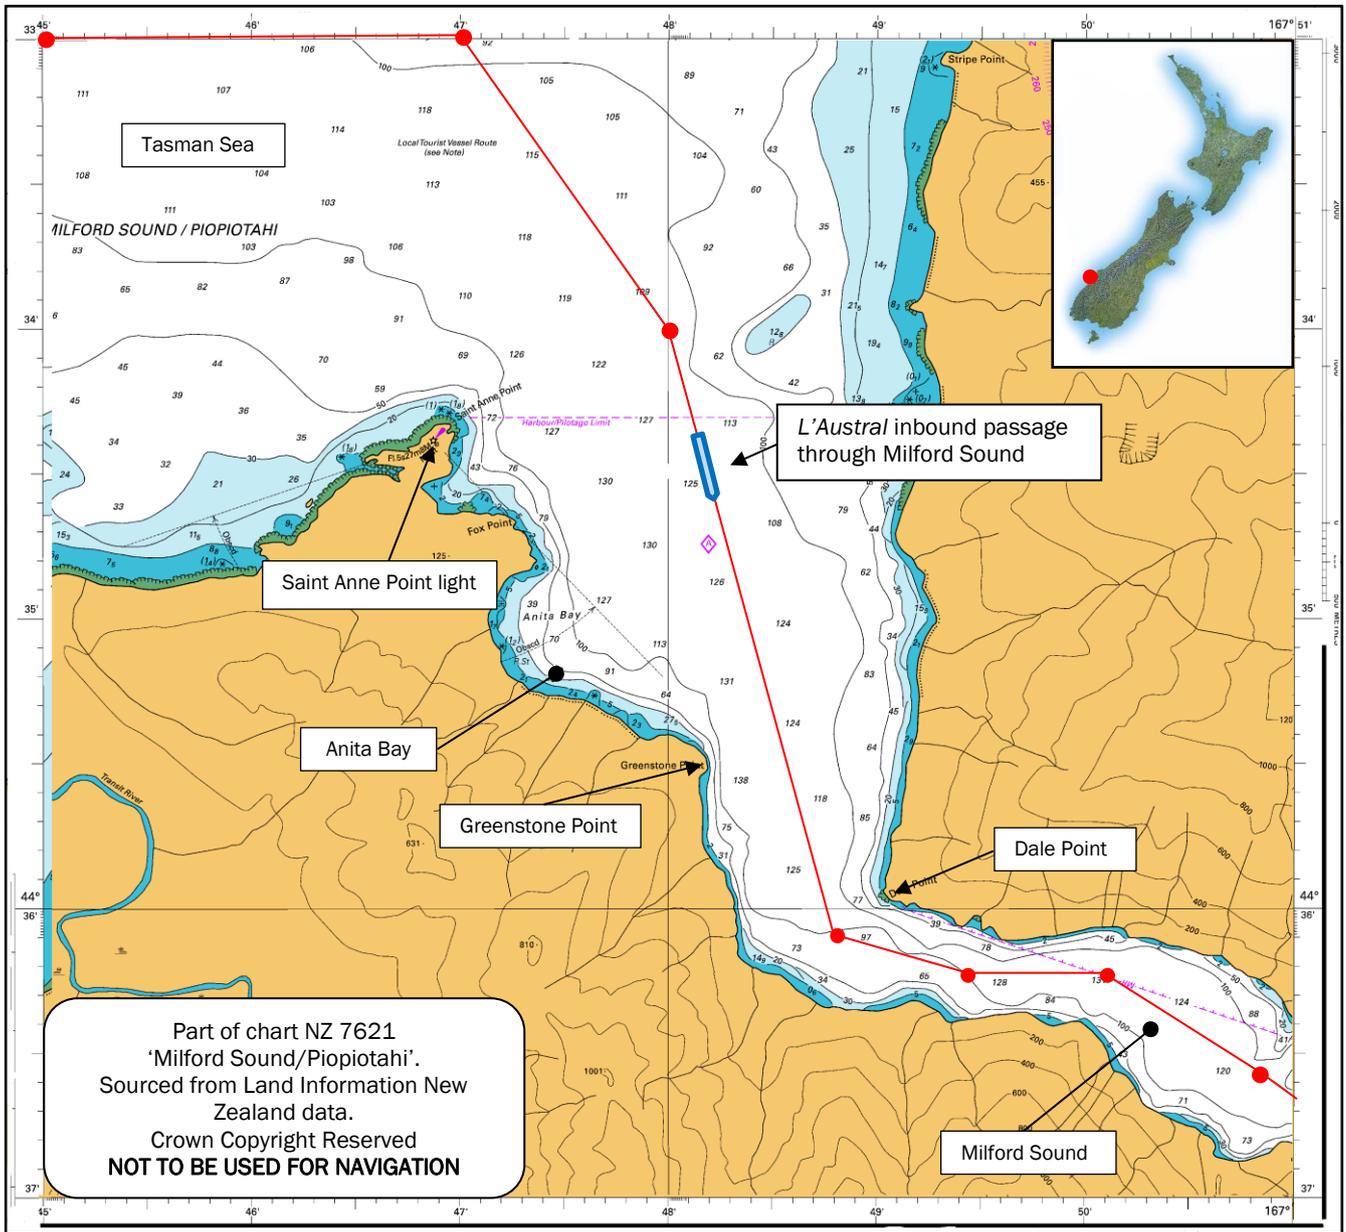
Figure 1
General area of the accident

- 3.2.1. At about 0525 on 9 February the pilot arrived on the navigating bridge as the *L'Austral* was rounding Saint Anne Point (see Figure 1). The pilot discussed with the officer of the watch the speed required and rate of turn⁴ as the ship rounded Dale Point. At 0531 the master arrived on the navigating bridge and the pilot and master, together with the officer of the watch, conducted their information exchange and agreed on the passage plan for entering Milford Sound.

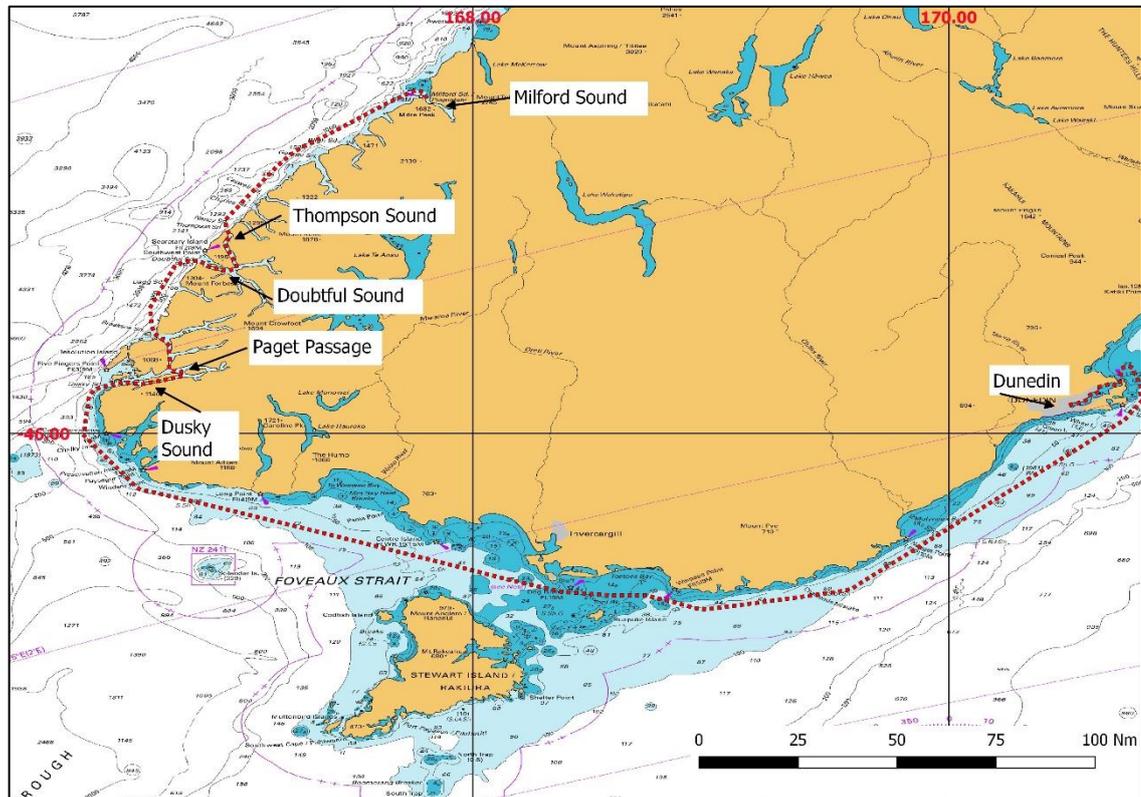
Figure 2
Extract of chart showing route of the *L'Austral*

3.1.1. The *L'Austral* is a French-registered passenger cruise ship that was operating a nine-day cruise from Auckland to Milford Sound. The ship stopped at several ports on the east coast of New Zealand, the last of which was Dunedin. From Dunedin the ship travelled through Foveaux Strait to Fiordland, where it transited several other prominent sounds before arriving off Milford Sound, which is part of the Te Wāhipounamu – South West New Zealand World Heritage Area, a UNESCO world heritage site² (see Figure 2).

- 4.2.8. At about 0536 the pilot assumed the con of the vessel from the officer of the watch and continued on track as the speed of the vessel increased to the requested 12 knots. At approximately 0550 the pilot ordered a rate of turn of 2° to port when the vessel was still about 2.3 cables¹⁶ from the designated wheel-over¹⁷ position for the turn off Dale Point (see Figure 2). The helmsman acknowledged the order and confirmed once he had the ship at the correct rate of turn.

- 4.2.11. By the time the pilot ordered the 15° rate of turn to port the ship was at the designated wheel-over position, but it was slightly starboard of the planned track in spite of the turn to port having been initiated more than one minute earlier (see Figure 2). One explanation for this is that the easterly wind, which was gusting up to 25 knots, was pushing the ship towards the southern shoreline.
