**NO 94-127**

**TRAIN 901**

**DERAILMENT**

## RAIL OCCURRENCE REPORT NO. 94-127

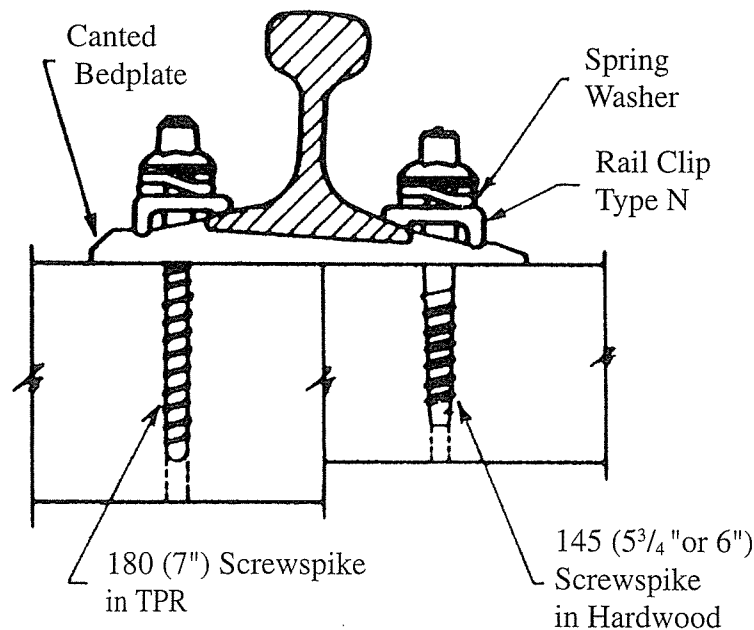
Fig 2: N-type fastening

- 1.23 The track along the six kilometre straight consisted of 91 pound/yard continuous welded rails on bedplates fastened to jarrah (Australian hardwood) sleepers with screwspikes, a spring washer, and a steel clip. This fastening detail, known as the “N-type” is shown in Fig 2.
