NO 94-129

COLLISION WITH MOTOR VEHICLE

NEAR OMIHI

23 DECEMBER 1994

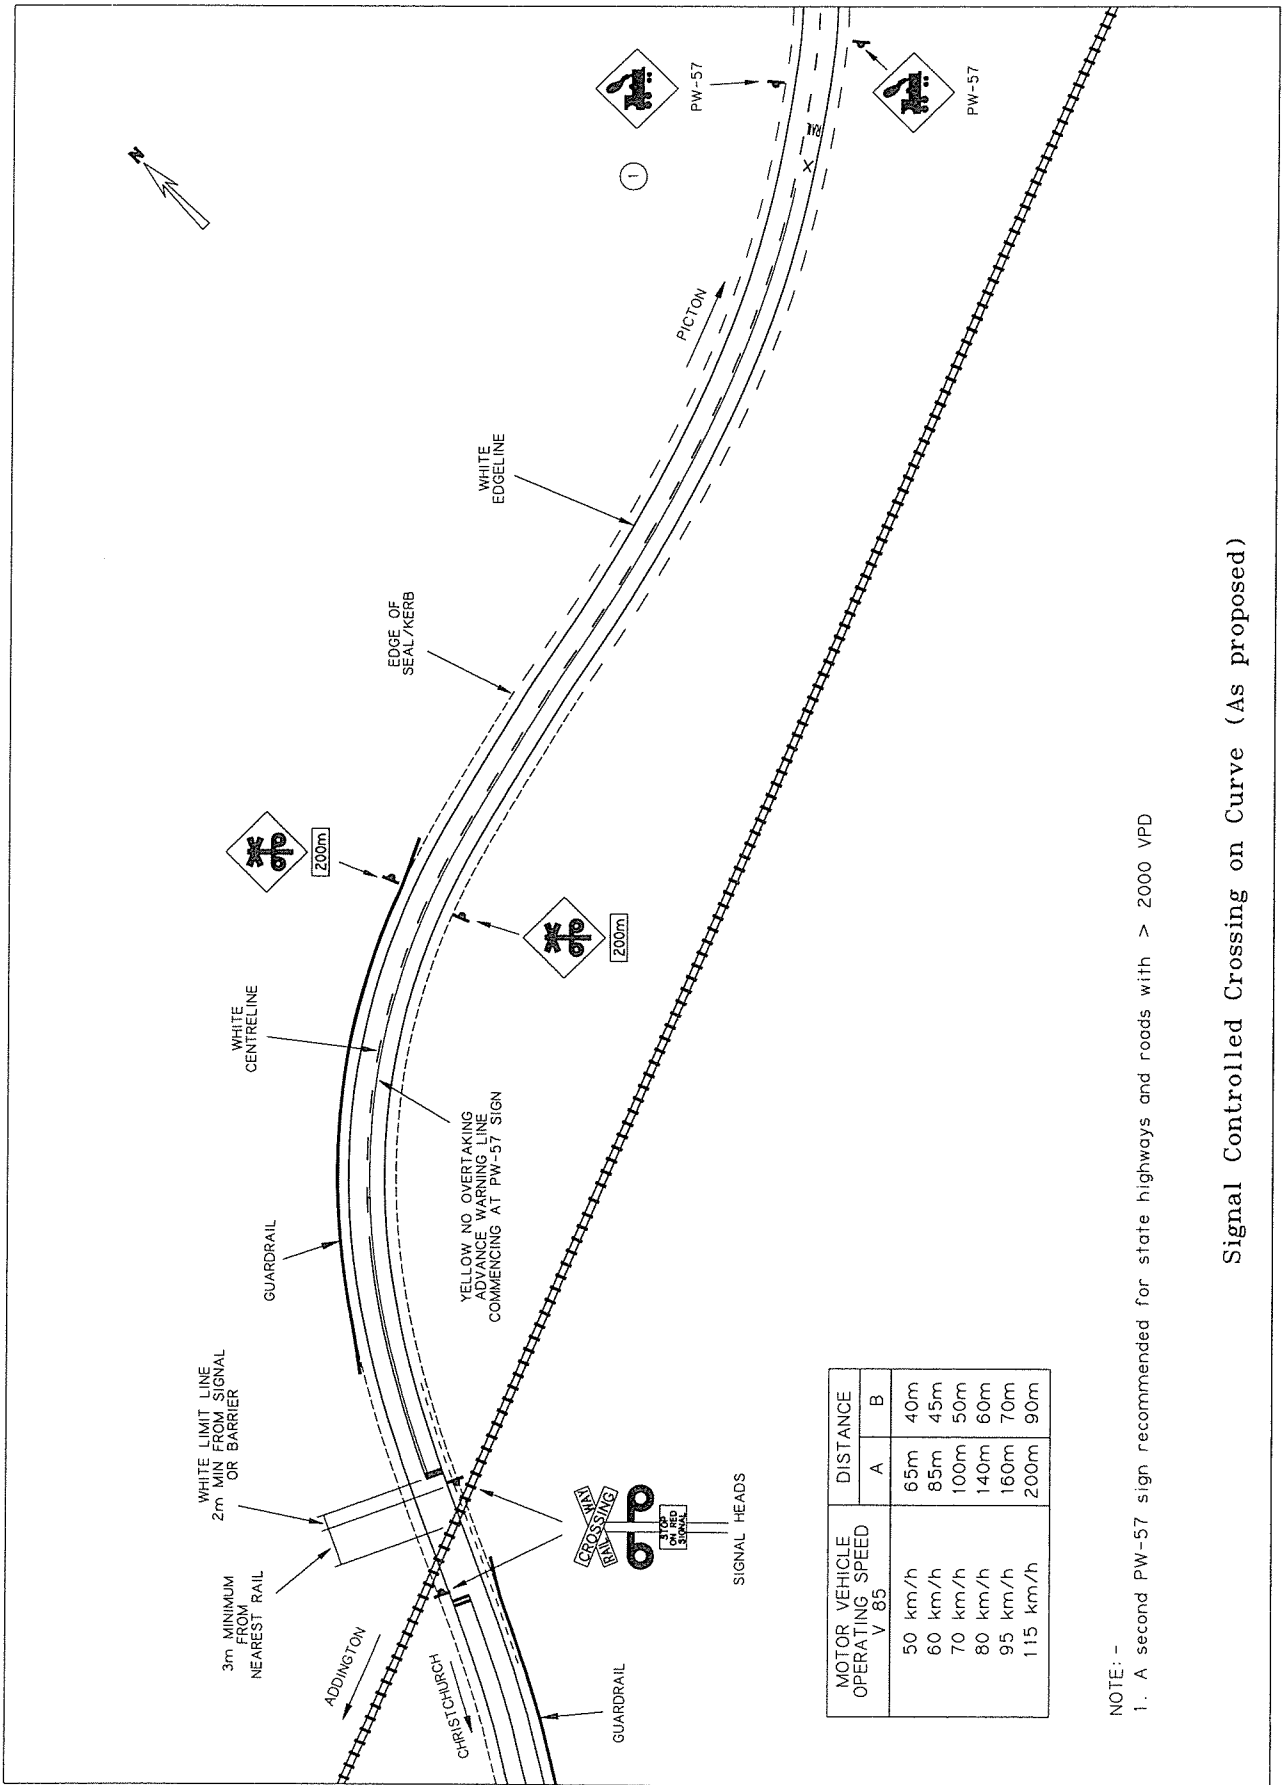
Signal Controlled Crossing on Curve (As proposed)

- the existence of the curved approach to the crossing at the scene is within the safe stopping sight distance (about 175 m at 100 km/hr). The curve continues to within about 60 m of the crossing. The safe stopping sight distance is the distance taken to sight the crossing warning light and stop before reaching the intersection at the maximum speed permitted on the road. (Although the approach to this crossing was subject to 75 km/h advisory speed signing the motorists interviewed indicated that on a dry road they found it practicable to maintain 100 km/h).
- the absence of a “no overtaking line” in the centre of the road on the approach to the crossing. The new code proposes a no overtaking centre line commencing 200 m from the crossing stop line.
- the absence of painted information on the road surface. The word “rail” and a large white “X” are proposed in the approach lanes.

- the alignment of the white “Stop” limit lines on the road, with the mast for the bells and flashing lights. LTSA and Transit recommend these lines precede the crossing alarms by a minimum of 2 m.

NOTE: -
 1. A second PW-57 sign recommended for state highways and roads with > 2000 VPD
