Report 96-108

Train 404

Hamilton

31 May 1996

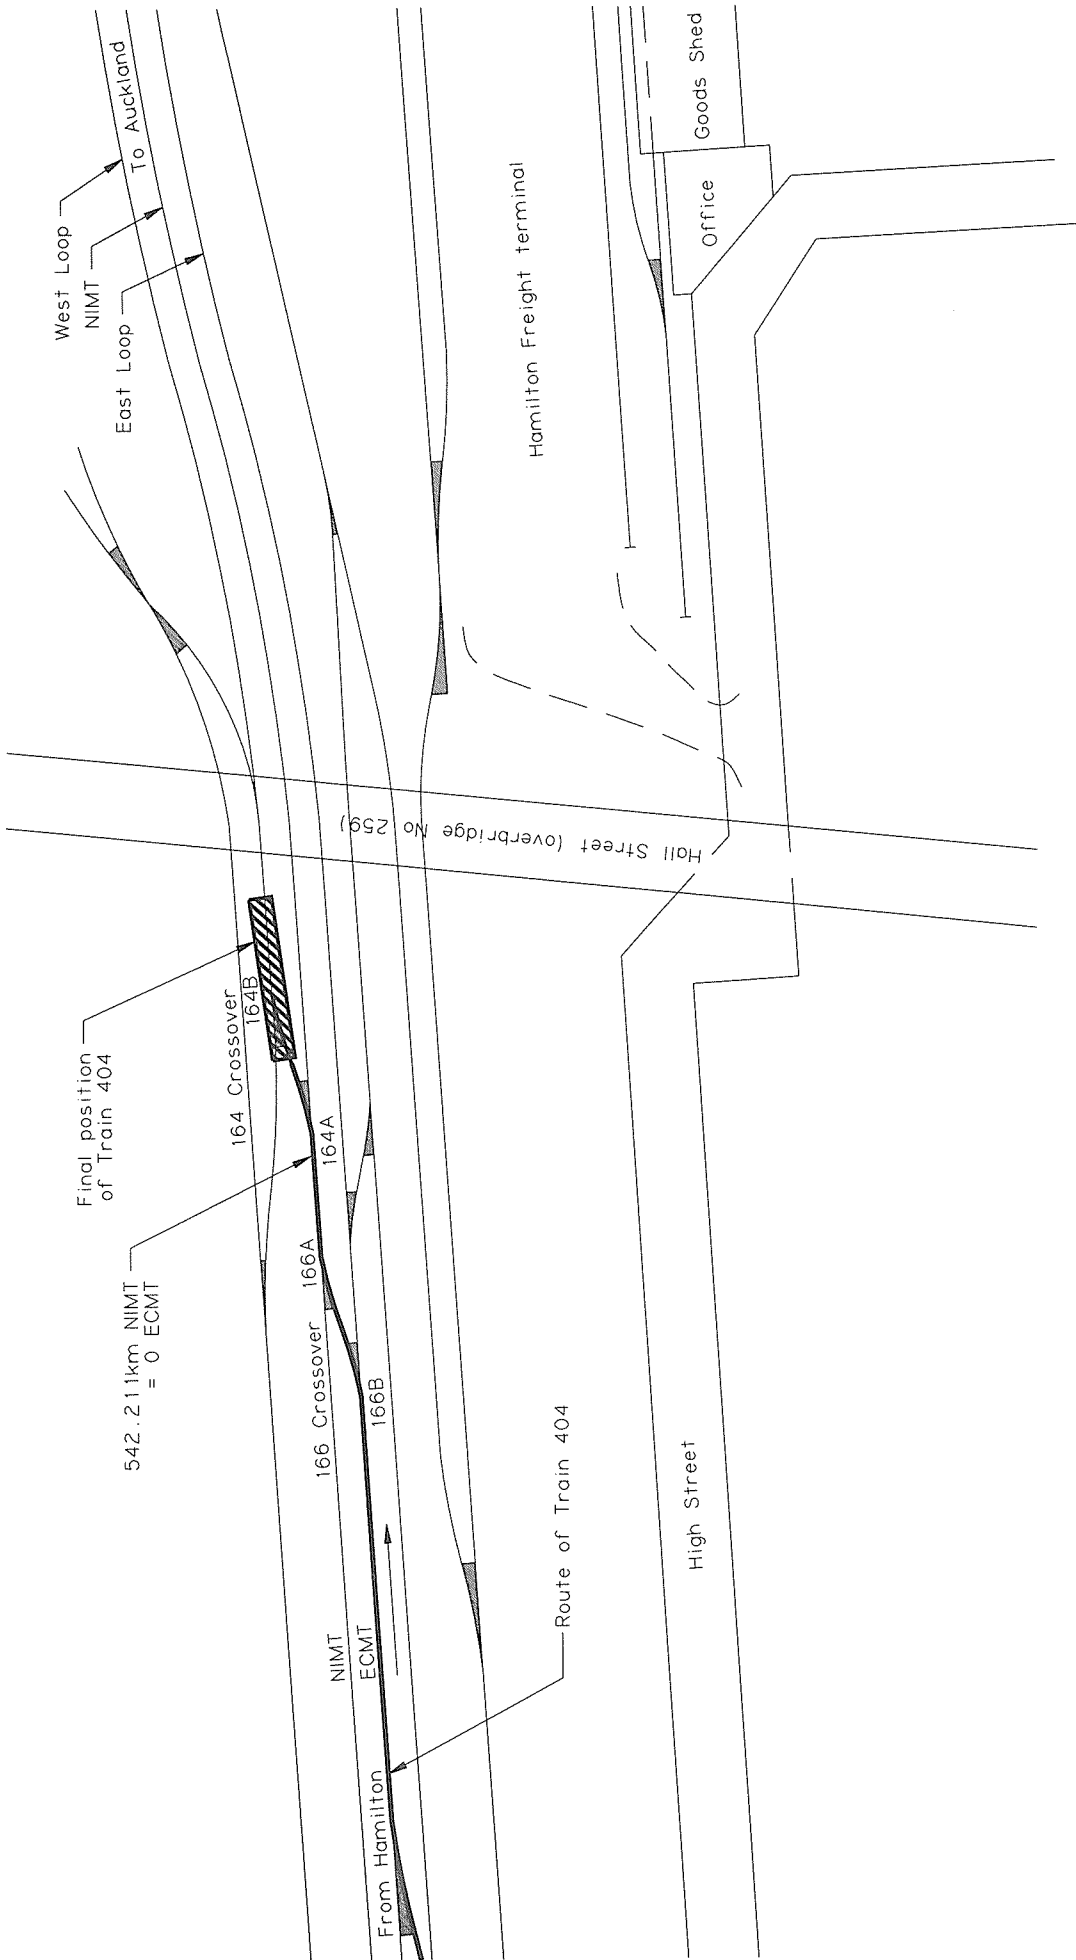
Figure 1
Locality diagram, (not to scale)

- 1.3 At approximately 2034 hours the train was leaving the East Coast Main Trunk (ECMT) via the East Passenger Loop and entering the North Island Main Trunk (NIMT) through crossovers 166 and 164 to the West Loop (refer Figure 1 for locality diagram). The LE estimated the train speed to be 10 km/h. The first unusual indication to the LE was when he felt a “dragging effect” on his train when his driver’s position was at approximately 164 A points. He stated he throttled back from notch 1 to idle (notch 0), his first thought being that he may have a hand brake problem. He returned to notch 1 to evaluate his assessment, but then some 15 to 20 seconds following the first indication he felt a further and more pronounced dragging effect. He immediately throttled back to idle and applied the train brakes. The train stopped, “approximately 15 to 18 metres” from where he felt the second dragging effect, with the rear bogie at approximately 542.24 km NIMT¹.
