Report 96-110

Train 401

Huntly

Rail Accident Report 96-110

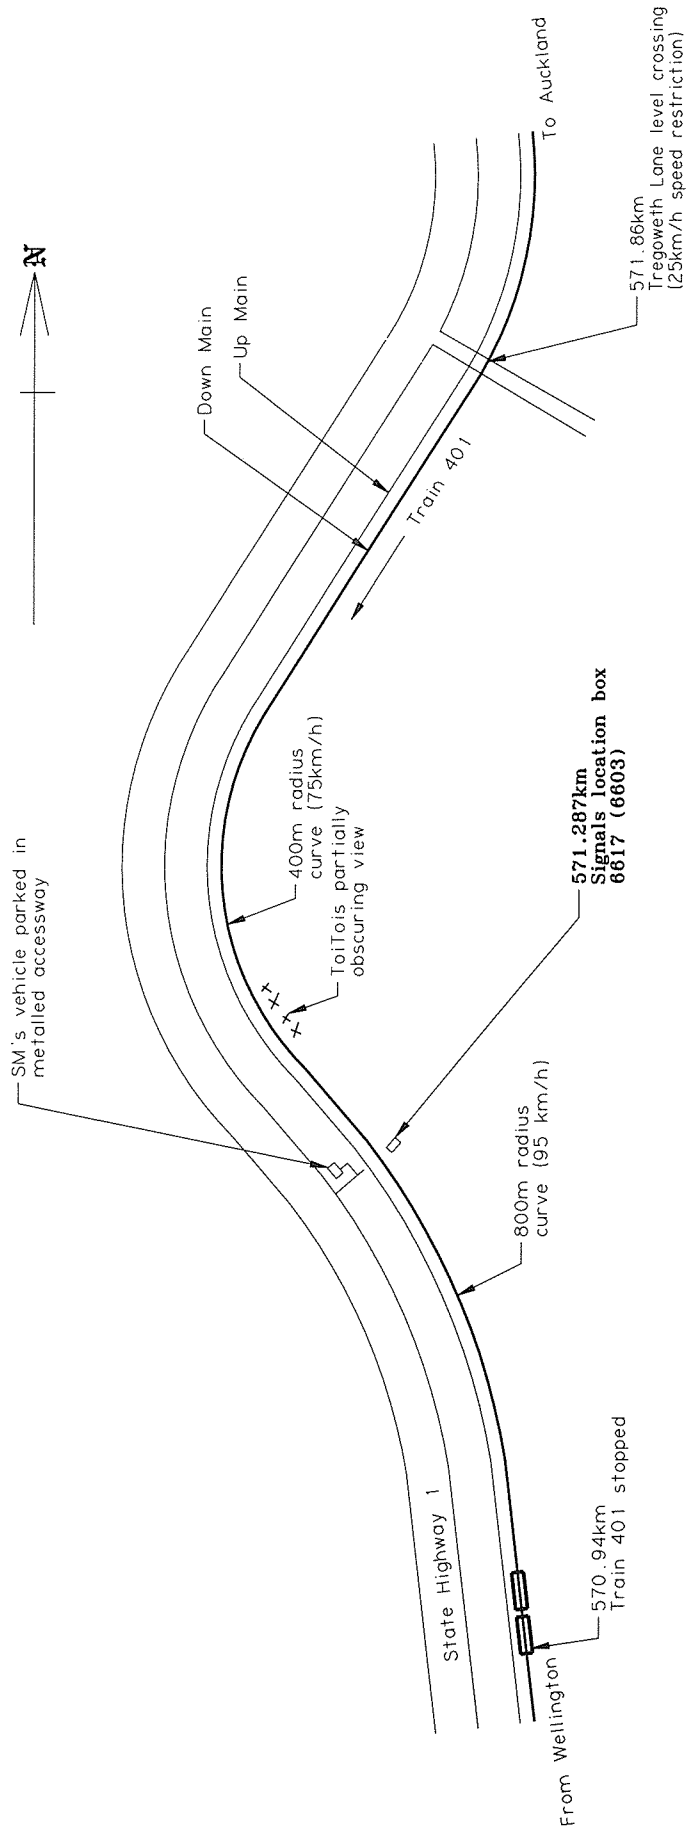
Figure 1
Locality diagram, (not to scale)

- 1.15 The accident occurred at signal location box 6617 at 571.287 km (although officially recorded as signal location box 6617 the box was stencilled with the number 6603 from a previous location). Figure 1 shows the features in the accident locality.
