**Report 96-201**

**Fishing Trawler *San Manukau***

**off Cape Karikari**

**28 January 1996**

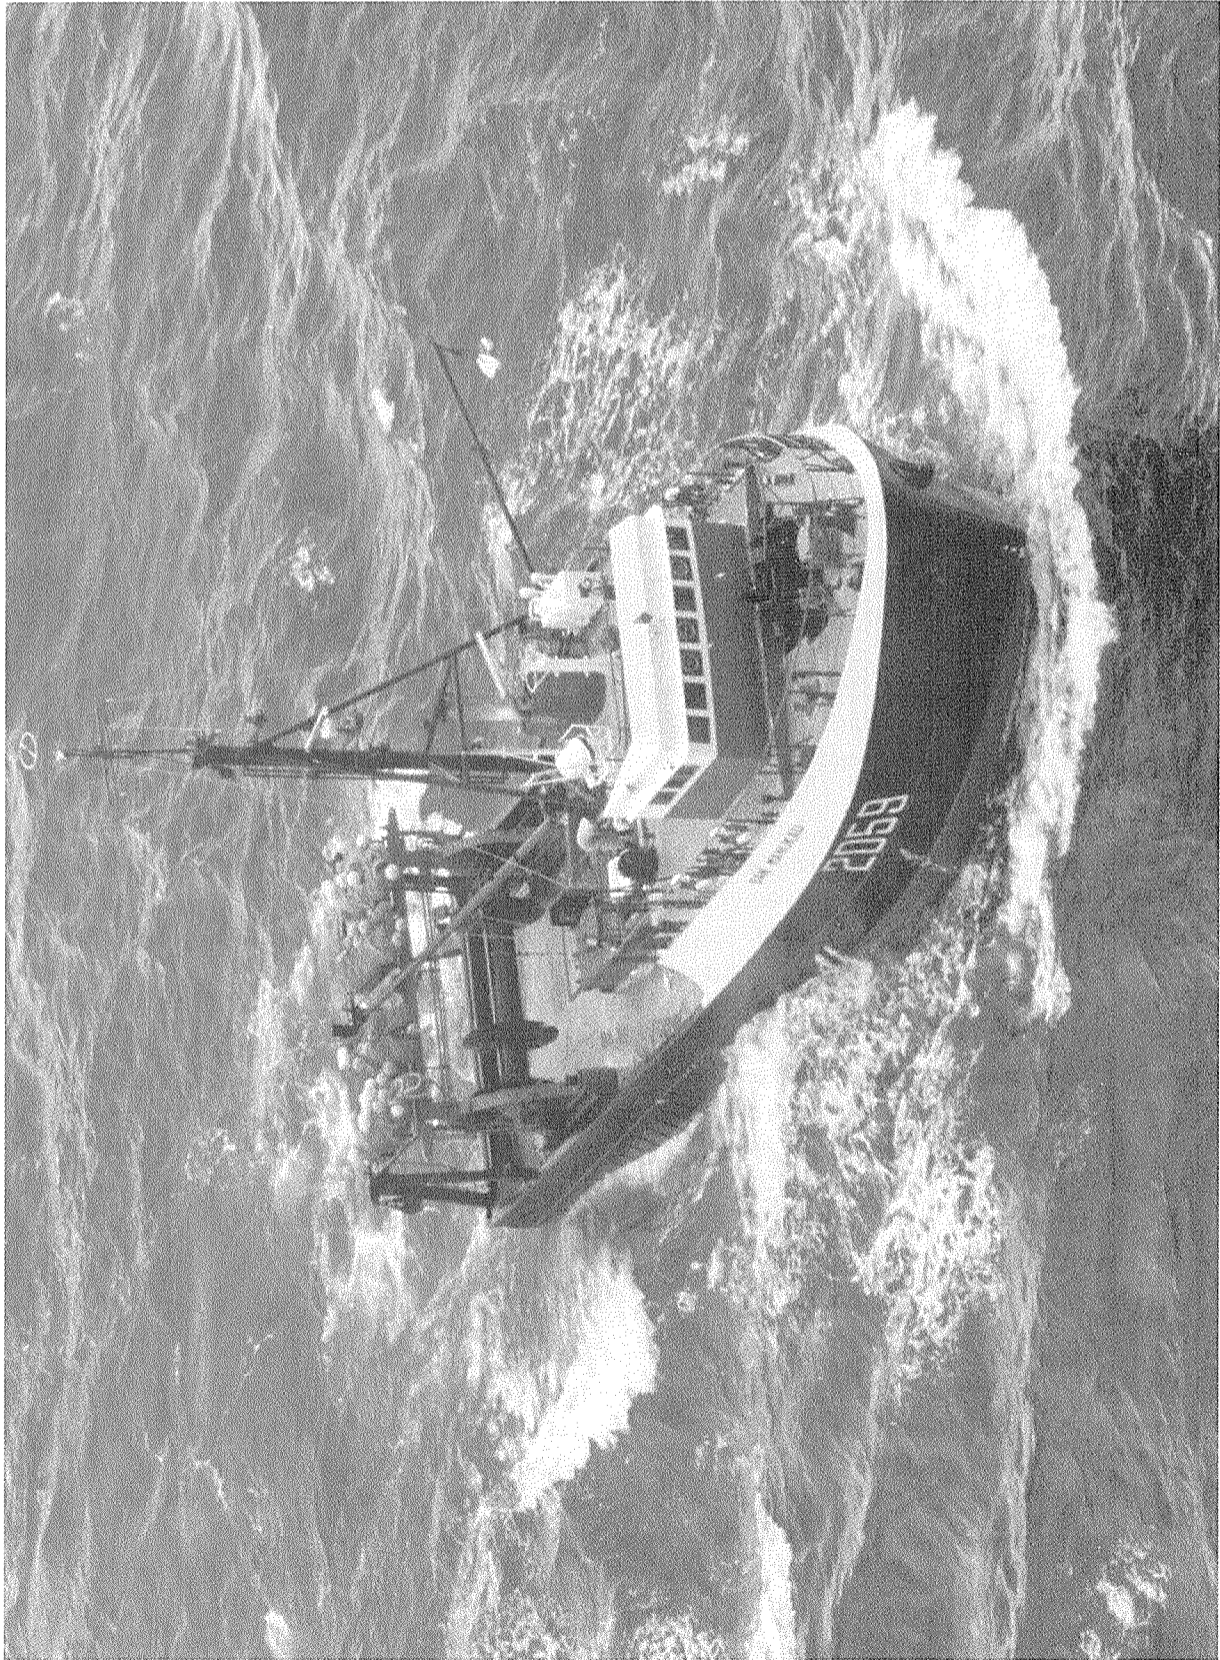
**Figure 1**  
**Fishing Trawler *San Manukau***

- 1.1.2 The *San Manukau* (see Figure 1) had been moored for a number of days at the Western Viaduct while the vessel was unloaded and maintained by Sanford's shore staff. As was the usual arrangement, the Master and crew were on leave over this period.

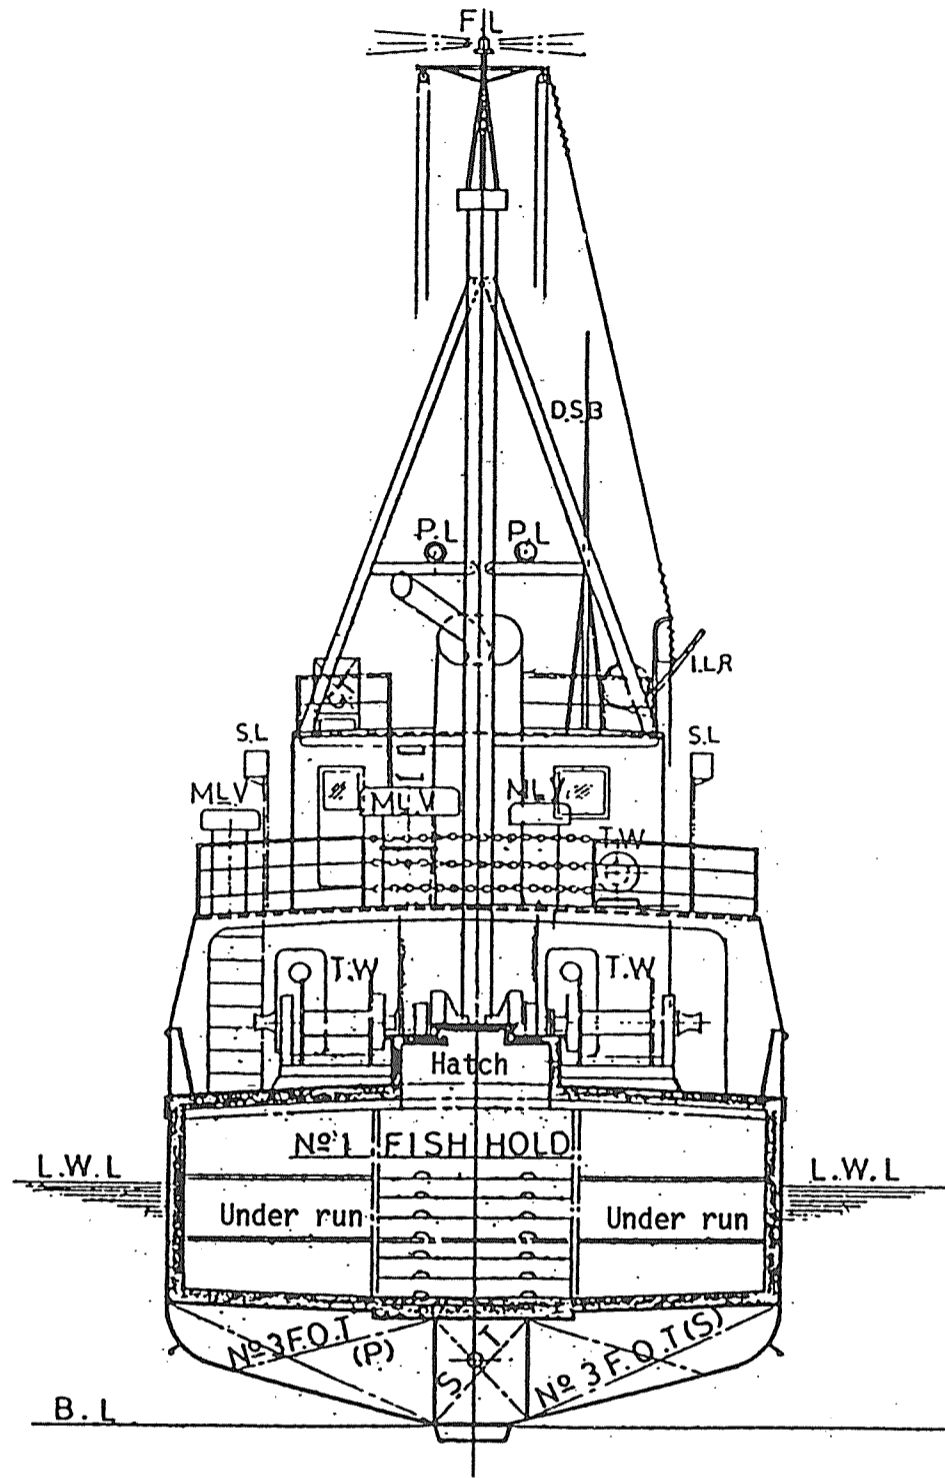
Figure 3  
*San Manukau, midship section*

- 1.2.5 The fish hold construction consisted of a layer of high density foam insulation sandwiched between layers of marine plywood and covered by a 10 mm layer of glass reinforced plastic (GRP). Timber bearers transferred the weight on the GRP floor of the hold through to the solid steel floors beneath. The wings (under-runs) of the fish holds were compartmentalised by solid GRP bulkheads into nine "bins" each side but the centreline run was common throughout (see Figure 4). Each compartment in the under-runs could be divided vertically by placing loose wooden boards into steel channel supports at two different levels. Using the same system of boards a working platform was usually constructed approximately one metre above the fish hold floor in the centre run. The platform usually extended from the forward end of number one fish hold back to where the floor of number two fish hold angled up to follow the line of the hull and provided a work area for sorting fish during loading. The space under this platform was often used to store lower grade fish in large bins (slurry tanks). Removable corrugated aluminium shifting plates held the fish bins, or ice, in the under-run compartments. There were no fore and aft watertight bulkheads to counter the effects of liquid free surface in the fish holds, although when the wooden boards and aluminium plates were in place, they would reduce any wave action caused by free liquid in the hold. The total volume of the two fish holds was 196.88 cubic metres. (See Figures 2, 3 and 4.)

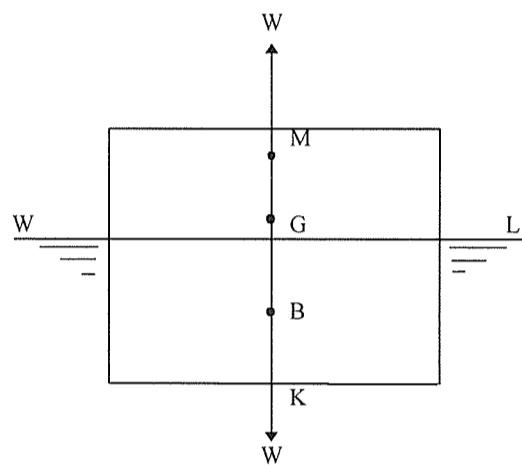
Figure 1

3. To float at rest in still water, a vessel must displace a volume of water equal to the weight of the vessel, and the centre of gravity "G" must be in the same vertical line as the centre of buoyancy "B" (see Figure 1). The letter "K" denotes the keel.

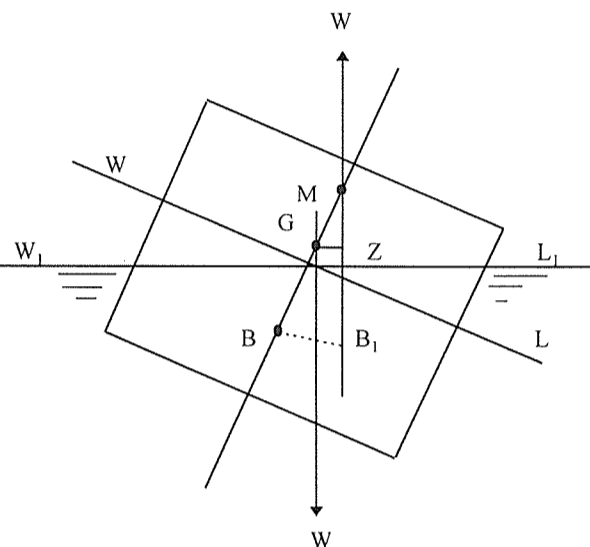
4. If the vessel is inclined by an external force to a small angle as shown in Figure 2 the centre of gravity G will remain static (assuming there is no internal shifting of weights) and the weight of the vessel "W" is considered to act vertically through this point. The centre of buoyancy "B", being the centre of gravity of the underwater volume, will move from B to B<sub>1</sub>.

8. A ship is in stable equilibrium if, when inclined, it tends to return to the initial position. For this to occur G must remain below M.
9. Figure 2 shows the vessel inclined at a small angle. The centre of buoyancy moves from B to  $B_1$  to take up a new centre of gravity of the underwater volume and the force of buoyancy is considered to act vertically upwards through  $B_1$  and the metacentre M. If the forces acting around G are summed, then there is a force or moment acting to return the vessel to the upright position. This force or moment is referred to as "the moment of statical stability" and is equal to the product of the force W and the length of the imaginary righting lever GZ.

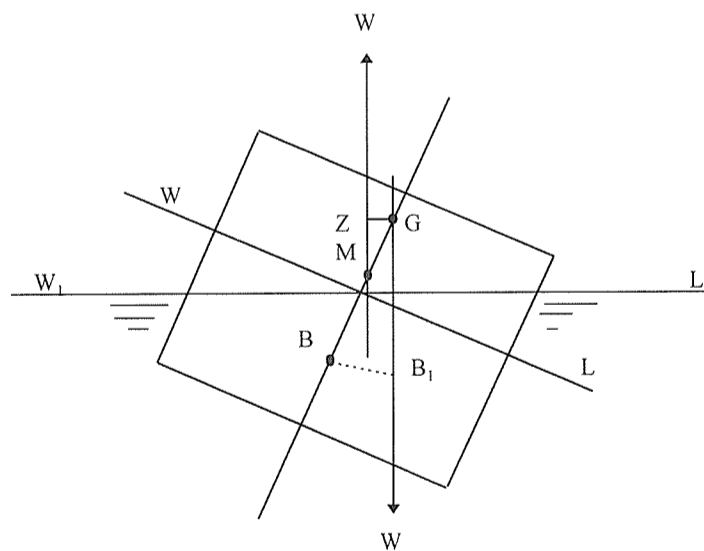
Figure 3

10. When a vessel, which was inclined to a small angle of heel tends to heel still further, it is in "unstable equilibrium" where the centre of gravity is above the metacentre and has a negative GM. The ship will not stop inclining until G and M coincide (see Figure 3). While G stays above M, the imaginary lever GZ now forms a capsizing lever.
