Report 96-210

Longline Fishing Vessel *Amigo*

17 nautical miles south-west of Hokitika, West Coast

Marine Accident Report 96-210

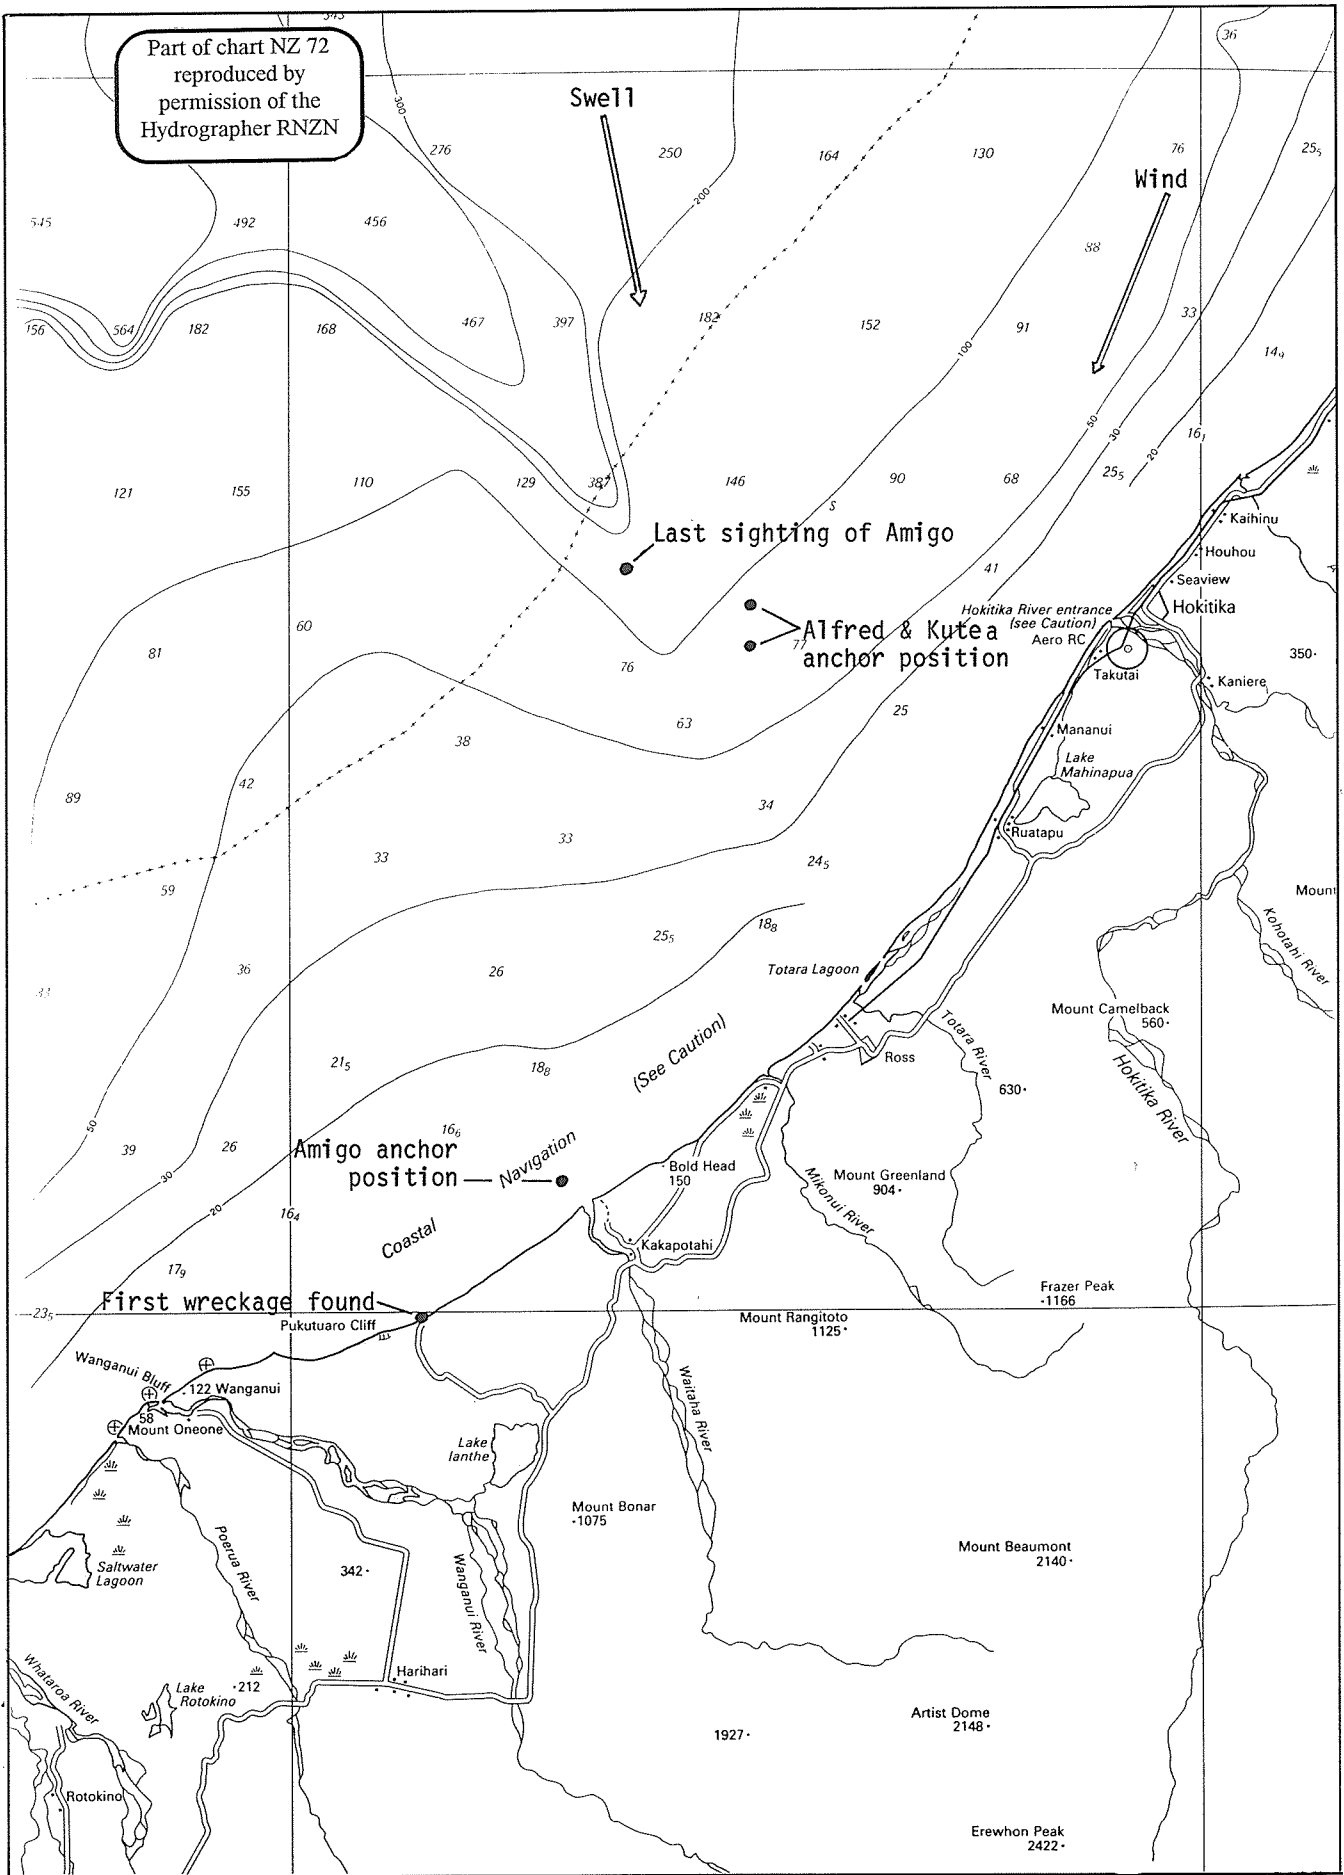
Figure 1
Chart showing key locations

- 1.1.3 During that day the wind increased to approximately 30 knots from the north-east. The forecast was for the wind to increase further and back to the north-west that evening with the passing of a cold front. Two other fishing vessels, the *Alfred* and the *Kutea*, were fishing in the area also. All three vessels, having set their lines, were riding out the gale at anchor in the vicinity of the Hokitika Trench. (Refer to Figure 1.)

- 1.1.4 As the wind increased all three vessels began to drag their anchors, so their Masters decided to move in to shallower water. The Masters of the *Alfred* and the *Kutea* opted to anchor approximately eight nautical miles off Hokitika in 80 m depth of water.
