Report 98-109

Train 482

near collision

Rail Incident Report 98-109

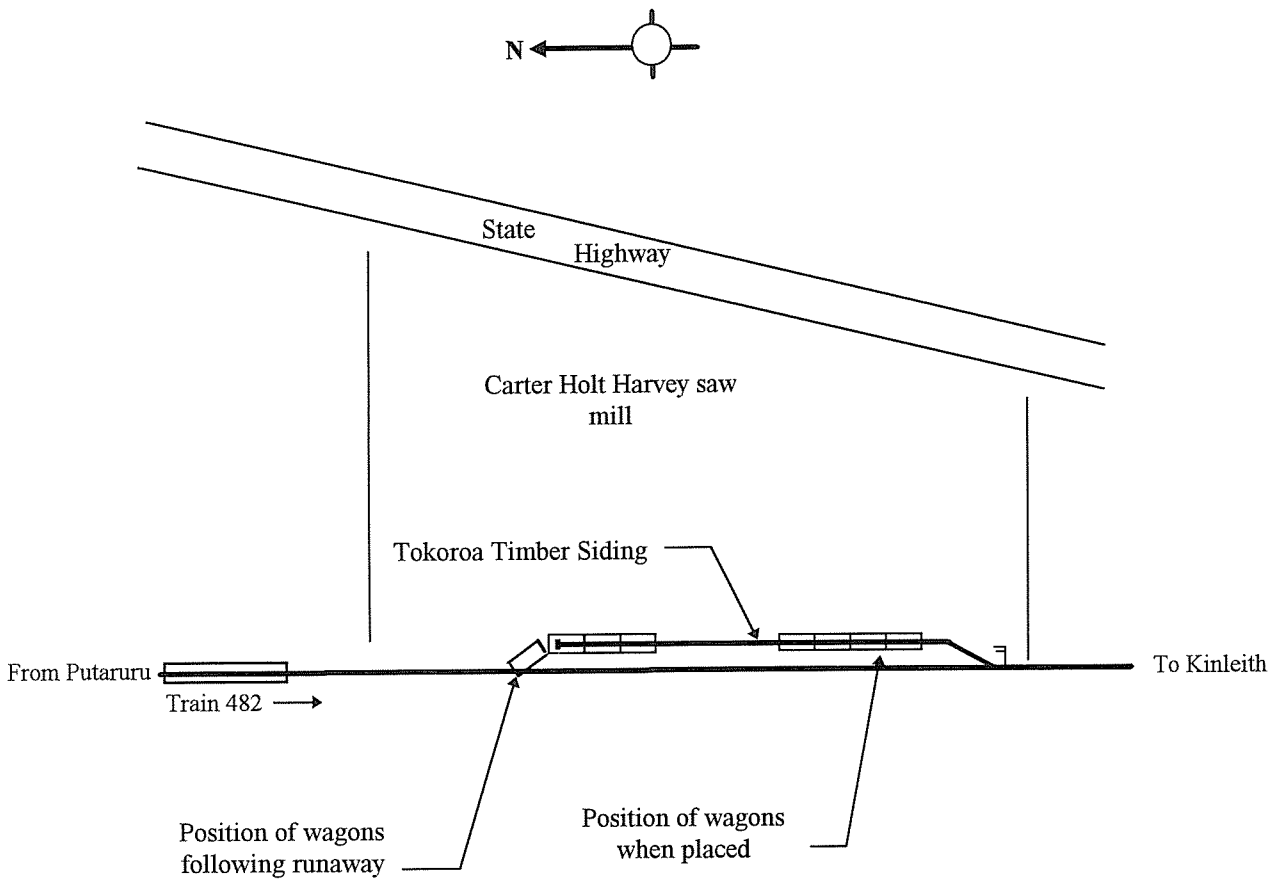
Figure 1
Locality plan (NTS)

- 1.1.6 The torch was being held by a truck driver who had been operating from the Carter Holt Harvey Tokoroa saw mill. The truck driver had been making a series of trips from the saw mill to Kinleith Mill. He had noticed wagons stored at the south end of the Tokoroa timber siding (see Figure 1) at approximately 0130 hours that morning. At approximately 0330 hours when he returned to the saw mill he noticed when driving down the internal mill road parallel to the siding (see Figure 2) that the wagons had moved to the north end of the siding and, despite the poor visibility, he noted one was derailed at the end of the siding. The wagon had derailed into some timber stacks that were behind the stop block (see Figure 3).
