Report 98-110

Train 902

derailment

28 June 1998

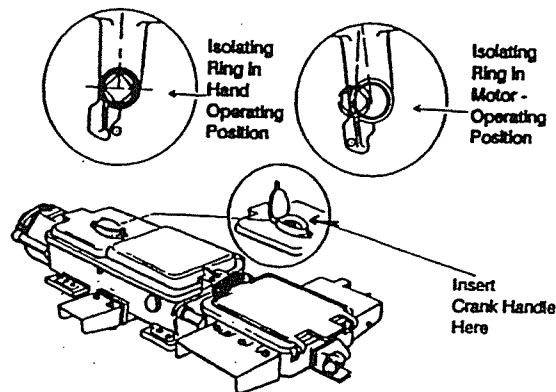
Type GRS, SGE and Nippon, top winding

Power is isolated by moving aside a guard ring before it is possible to insert the crank handle.

When instructed by Train Control to leave the points in the isolated position leave the isolating ring in the hand operating position.

The GRS and SGE points can then have the weather proof covers relocked and the crank handle placed in the bottom of the box.
