## **Report 98-204**

### **Wave-piercing catamaran ferry *Condor 10***

#### **heavy weather damage**

#### **Wellington Harbour entrance**

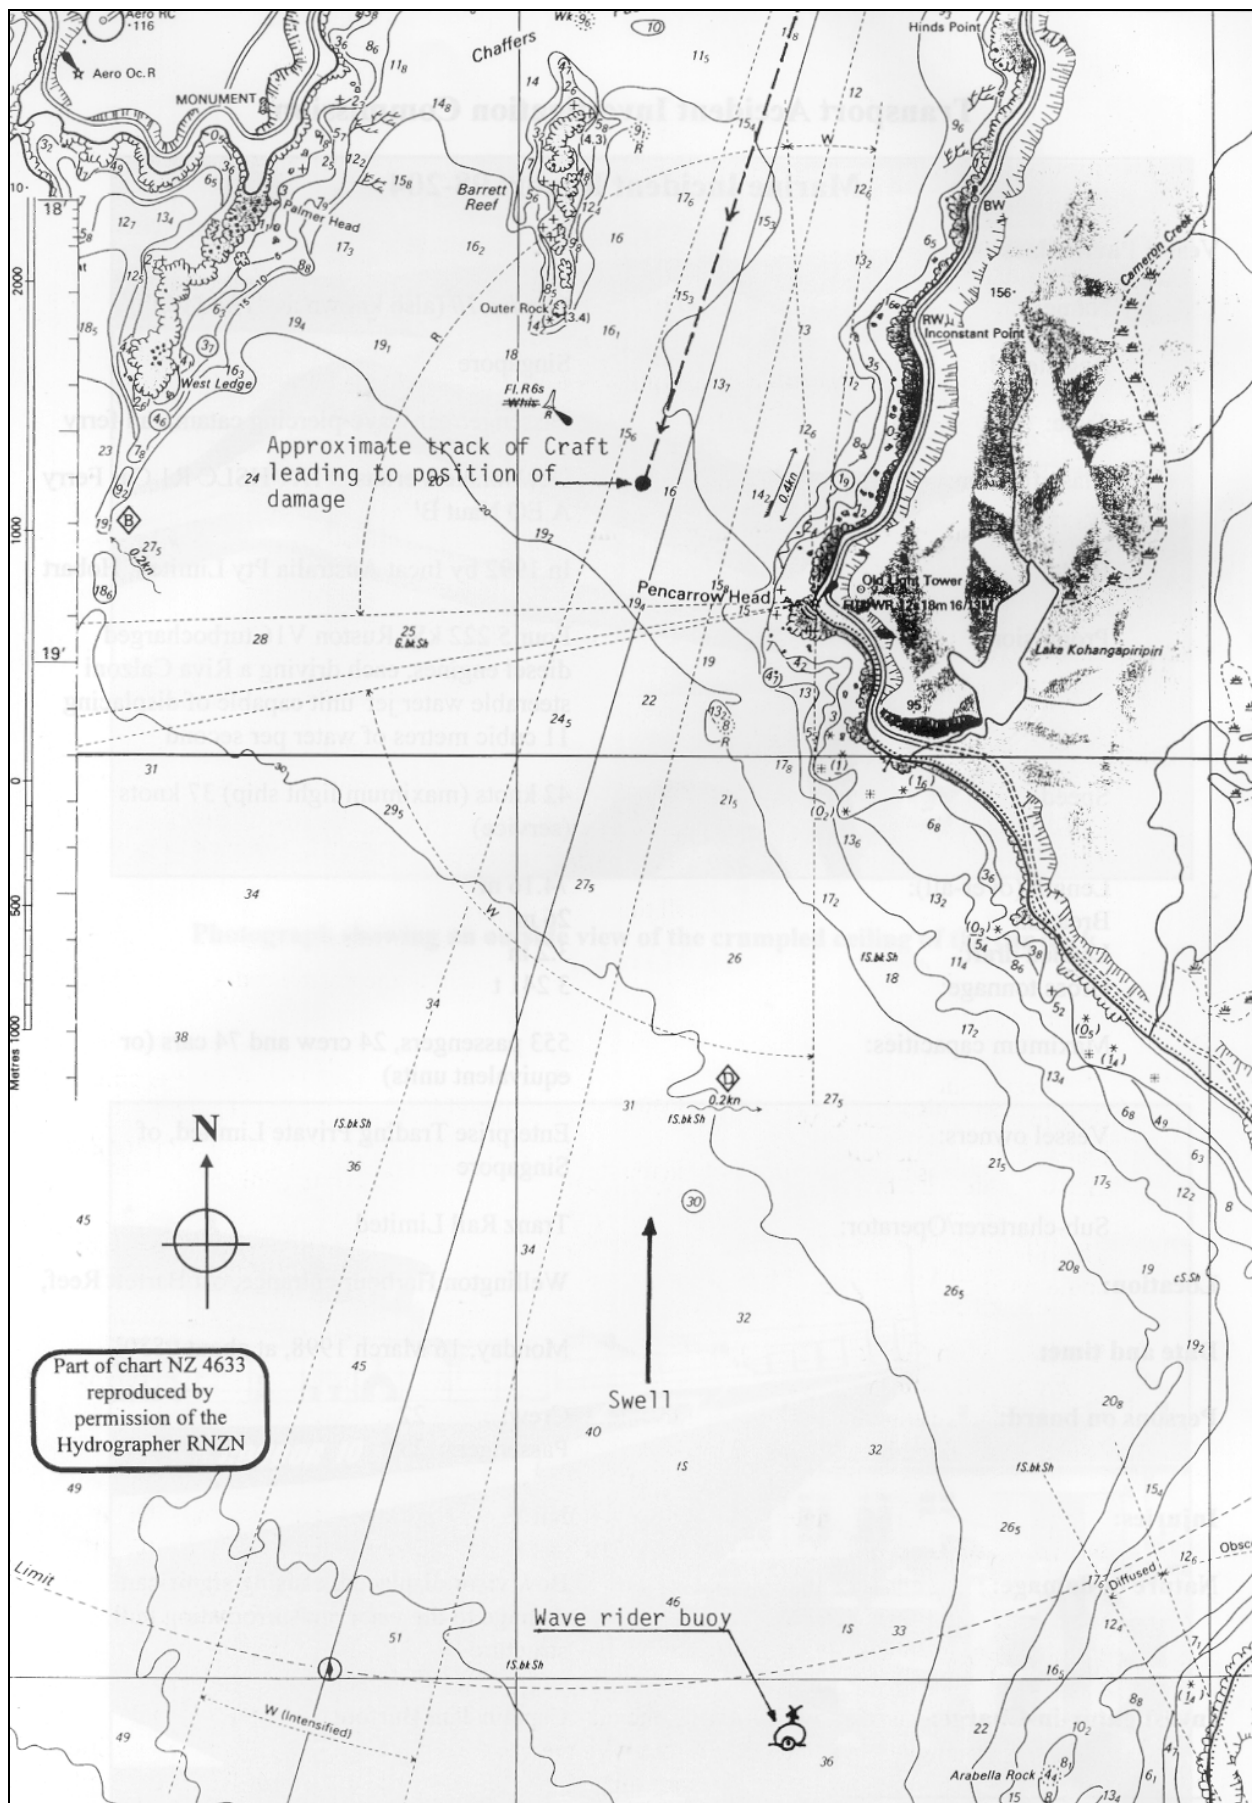
**Figure 1**  
**Part of chart NZ 4633 showing key information**

- 1.1.9 For the ensuing three minutes, *Condor 10* continued out past Barrett Reef (see Figure 1) at what the master described as a “quite comfortable” ride through a 2 to 2.5 m swell. As the wind had fallen away to a five knot breeze, the sea surface was calm with only an occasional white cap. On passing Barrett Reef Buoy, the master and first mate saw two larger swells immediately in front of the vessel.
