## Report 98-208

### Ro-Ro cargo vessel *Union Rotoma*

#### shift and loss of cargo

29 July 1998

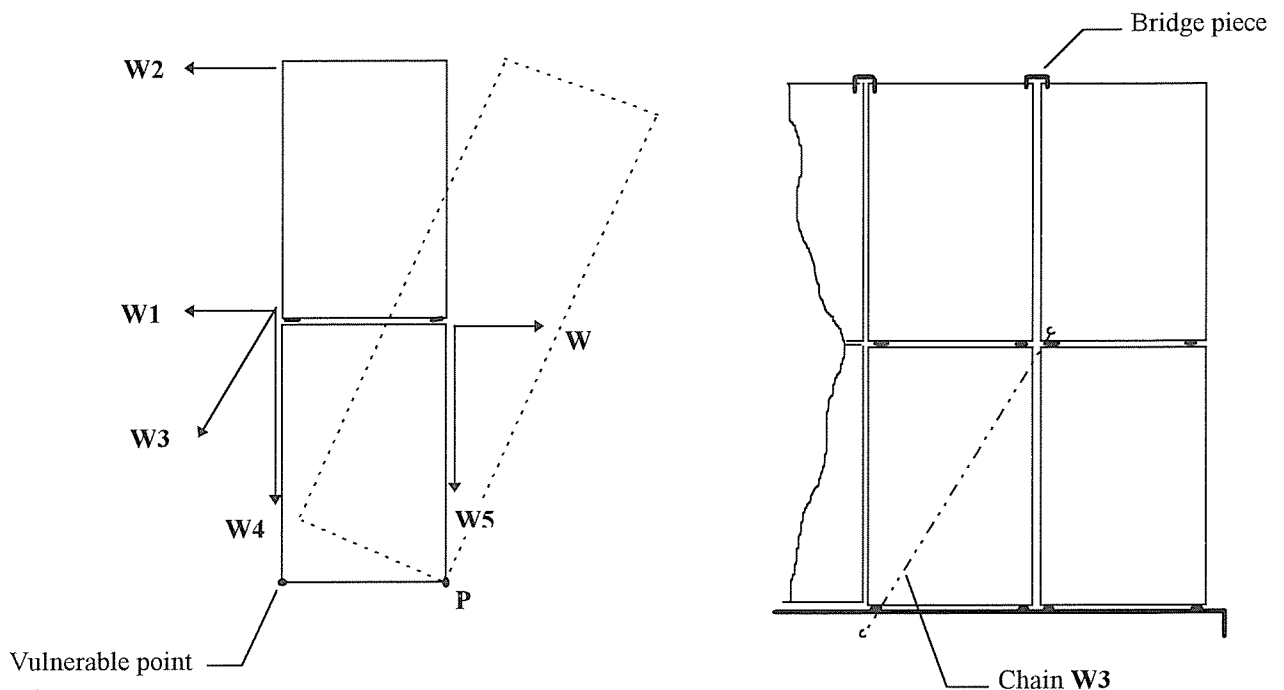
**Figure 7**  
**Preferred lashing system**

2.4.2 If stacking cones and twistlocks are serviceable and fitted correctly, the whole stack becomes integral with the deck. When the vessel rolls there will be a tendency for the outside stack in a block stow to topple about its pivot point P in Figure 7 above. Chains should be fitted to alleviate the tension at the most vulnerable points, the deck fittings on the inboard side. The most efficient lashing to counter the toppling force W would be a chain in direction W1 or a bridge piece at W2. As W1 would not be practicable, the next best option would be a chain in direction W3, as shown in the cargo securing manual. A less effective direction is W4, the method used on *Union Rotoma*. A chain in position and direction W5, also used on *Union Rotoma*, serves little purpose unless the stack is free-standing.
