Report 99-101

Express freight Train 230

derailment

25 February 1999

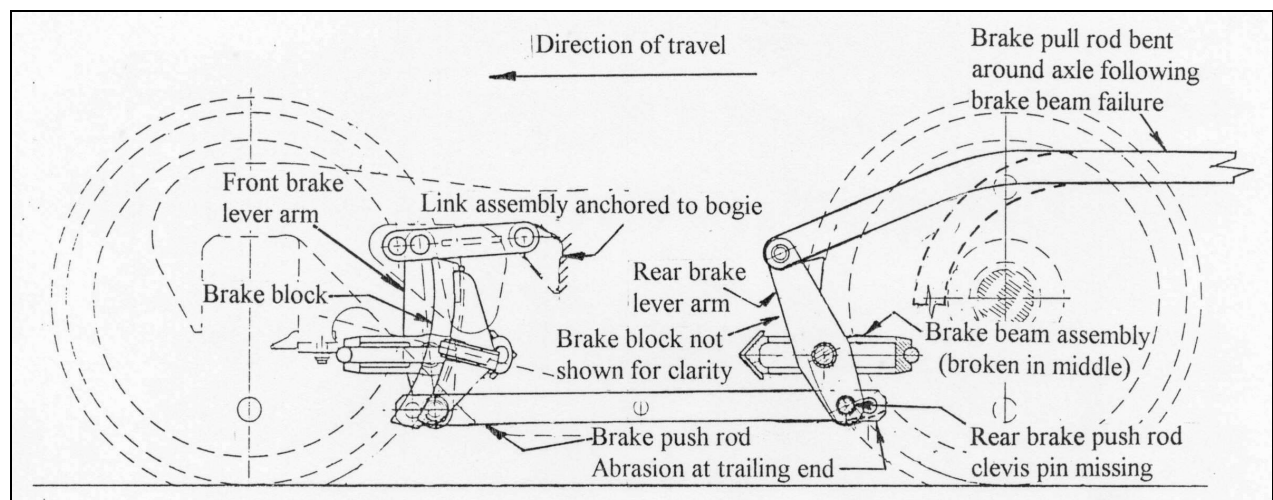
Figure 3

1.3.2 The general braking configuration for the Type 14 bogie is shown in Figure 3. The brakes were applied through the action of the brake pull rod linked to the top of a lever arm which pivoted about a brake push rod at the bottom and carried the centrally pivoted brake beam. With the application of the brakes the action and reaction of the forces on these 2 pivots caused the brake beams to be forced apart and apply the brakes to each set of wheels in the bogie .

Diagrammatic section of the leading bogie showing the position of the brake components
