**Report 99-122**

**express freight Train 938 and**

**intercity express freight Train 919**

**collision**

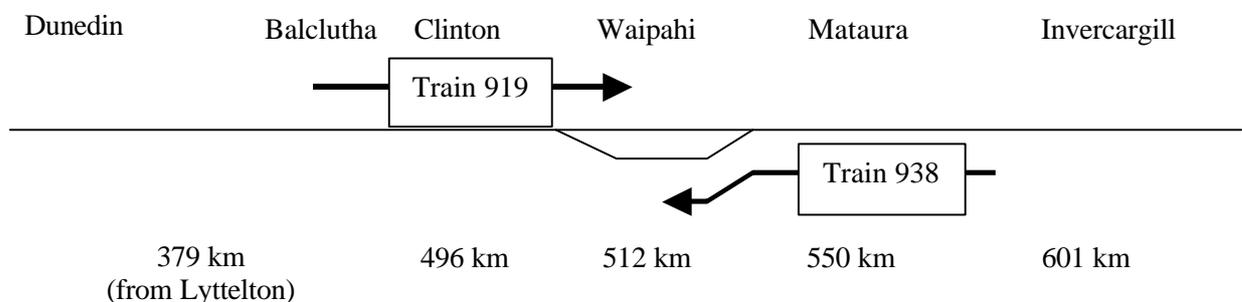
**Figure 1**  
**Relationship of localities to the planned crossing**

1.2.1 Operations on the MSL south of Dunedin on the day included a planned crossing of a northbound express freight, Train 938, with southbound ICE Train 919 at Waipahi. Such planned crossings were standard procedure on the single line track operated under the track warrant control (TWC) system. Figure 1 shows the relationship of localities to the planned crossing.

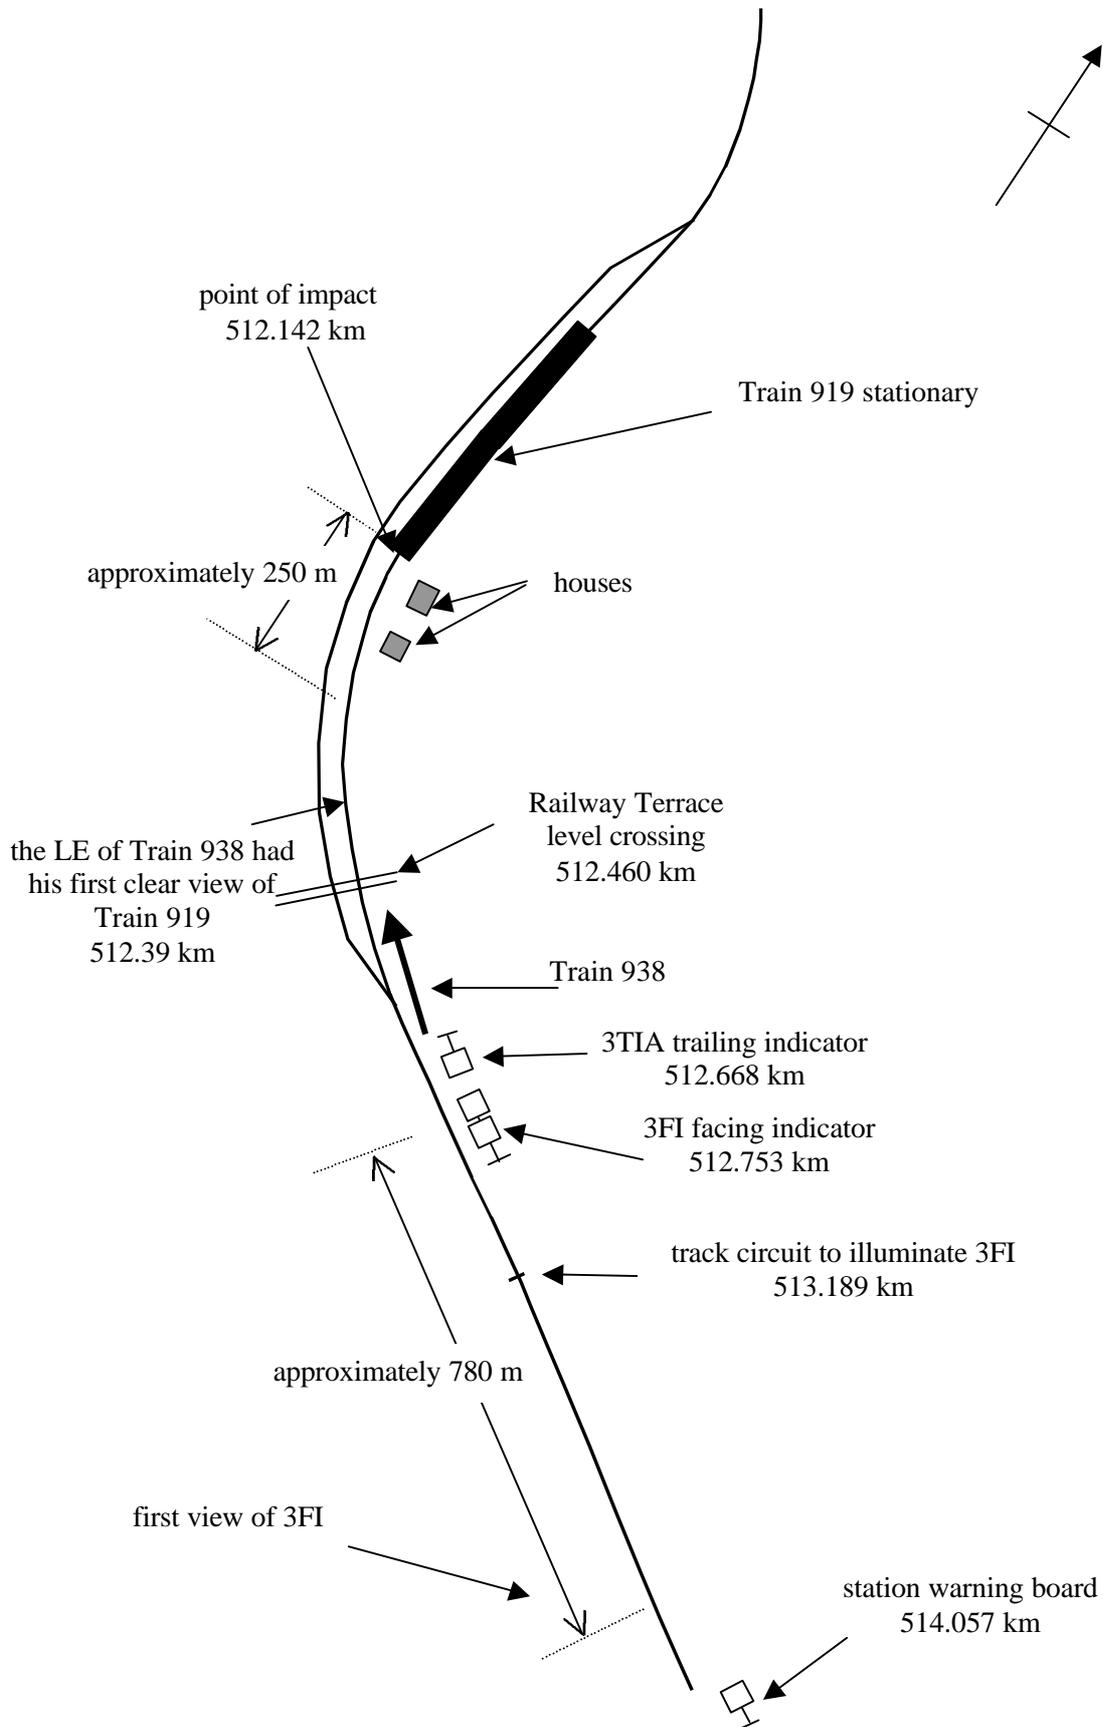
**Figure 4**  
**Site plan**  
 (not to scale)

- 1.3.1 Waipahi was a standard Track Warrant Station sited at 512 km MSL. The loop was about 1070 m long and generally on a curve. Figure 4 shows the station and the approaches.

- 1.3.4 Spilt diesel from a ruptured locomotive fuel tank, and the wreckage location, established the point of impact at 512.142 km on a short straight between curves. The front of Train 919 was pushed back about 30 m by the impact.

- 1.3.5 A deposit of sand was found near the left rail approximately 150 m before the impact point. The sand was similar to that used to assist locomotive braking and automatically deposited when emergency braking was applied.

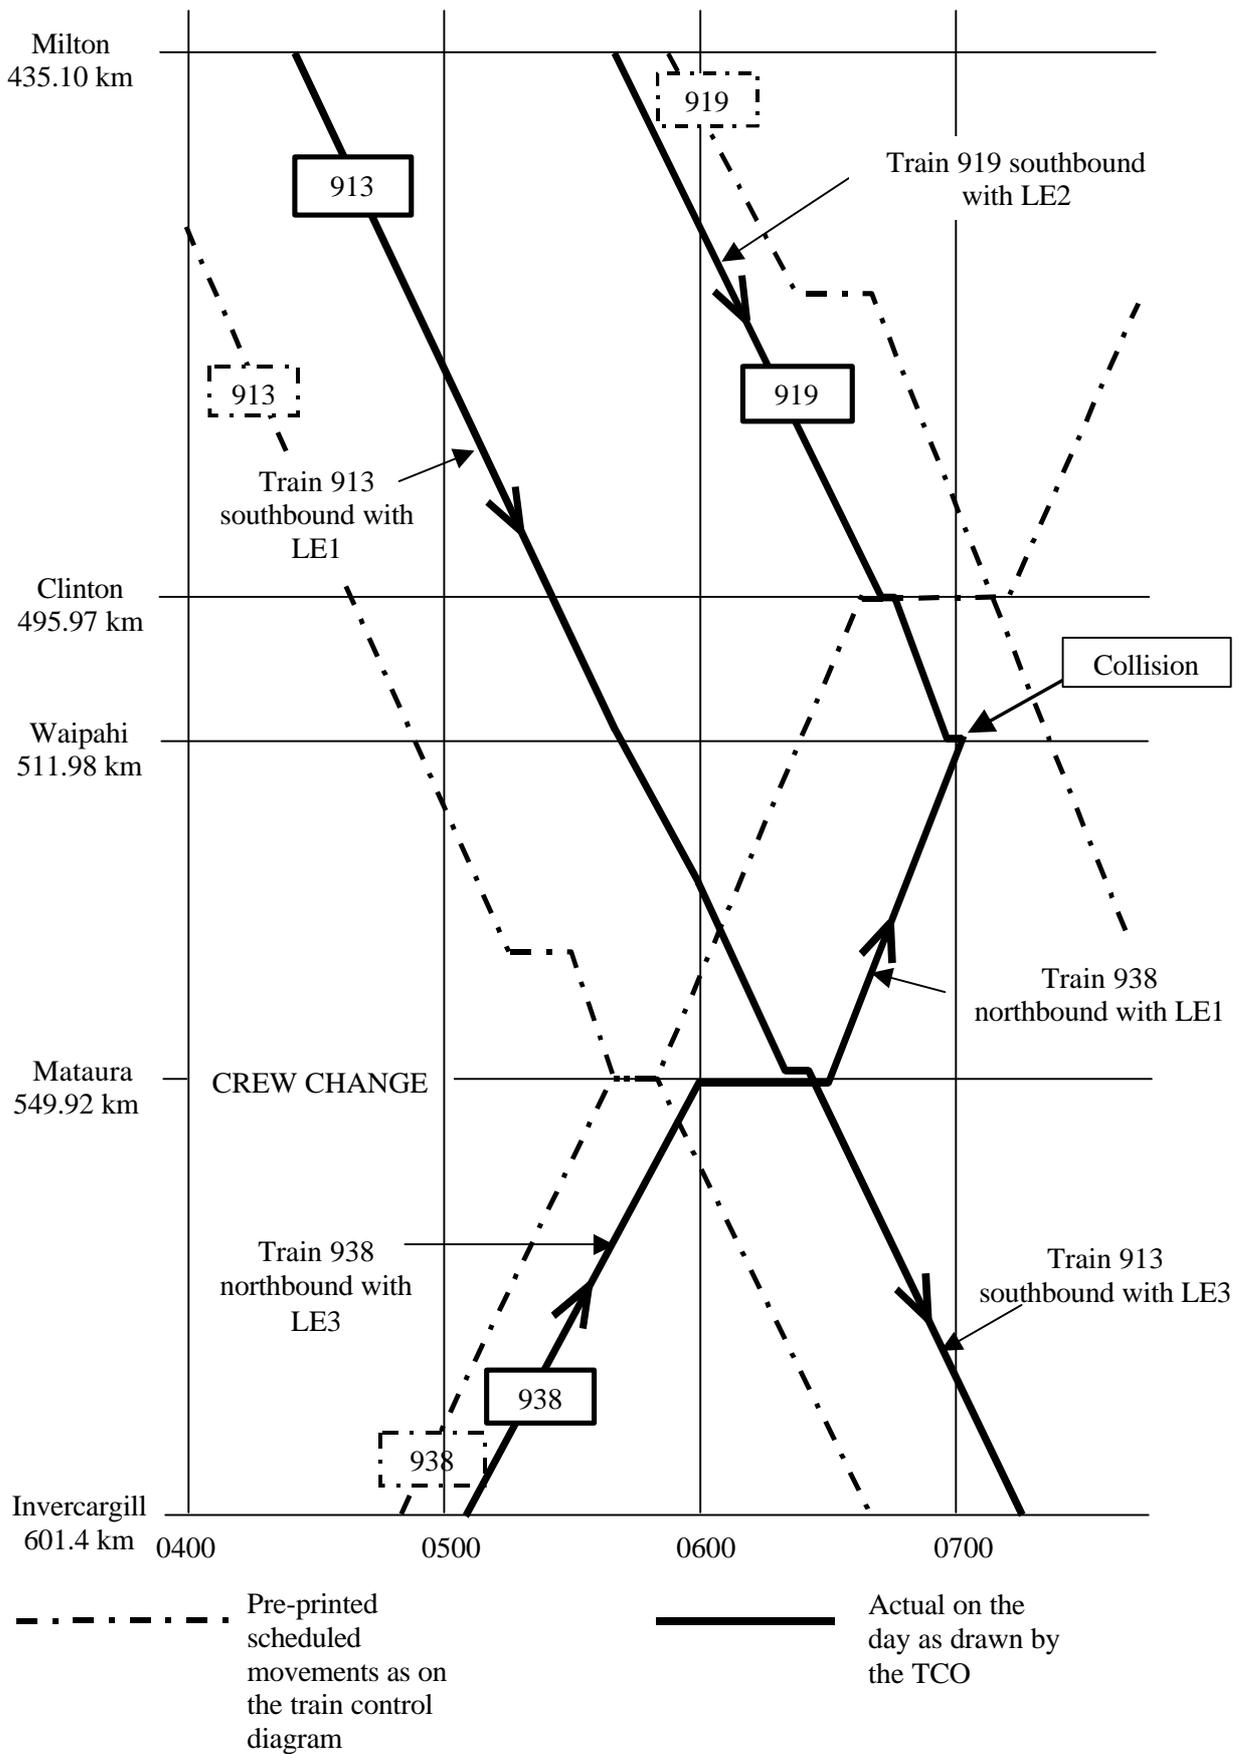
**Figure 5**  
**Simplified Train Control Diagram**  
**showing scheduled and actual train movements**

- 1.5.7 At about 0625 hours Train 913 arrived at Matura and the crew changeover took place.
- 1.5.8 Figure 5, derived from the train control diagram, shows the scheduled and actual paths of Trains 913, 919 and 938 on the day.
