Report 99-209

coastal passenger and freight ferry *Arahura*

premature release of rescue boat

21 May 1999

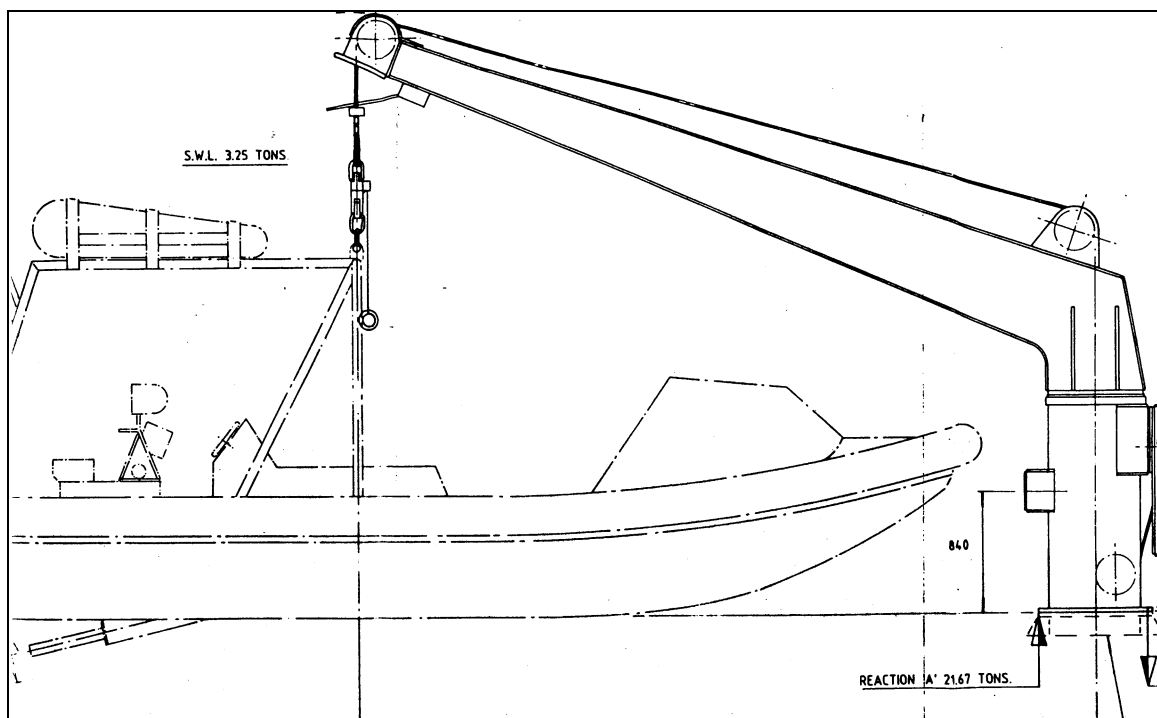
Figure 1
Profile of rescue boat and launching arrangement

- 1.1.6 The rescue boat was suspended on a single wire fall under a single-arm slewing davit, connected to it by an off-load quick-release hook which snapped on to the lifting frame of the boat (see Figure 1). As a defence against the quick-release hook letting go prematurely, an additional preventer chain and hook had been fitted between the lifting frame of the boat and the end of the wire fall.

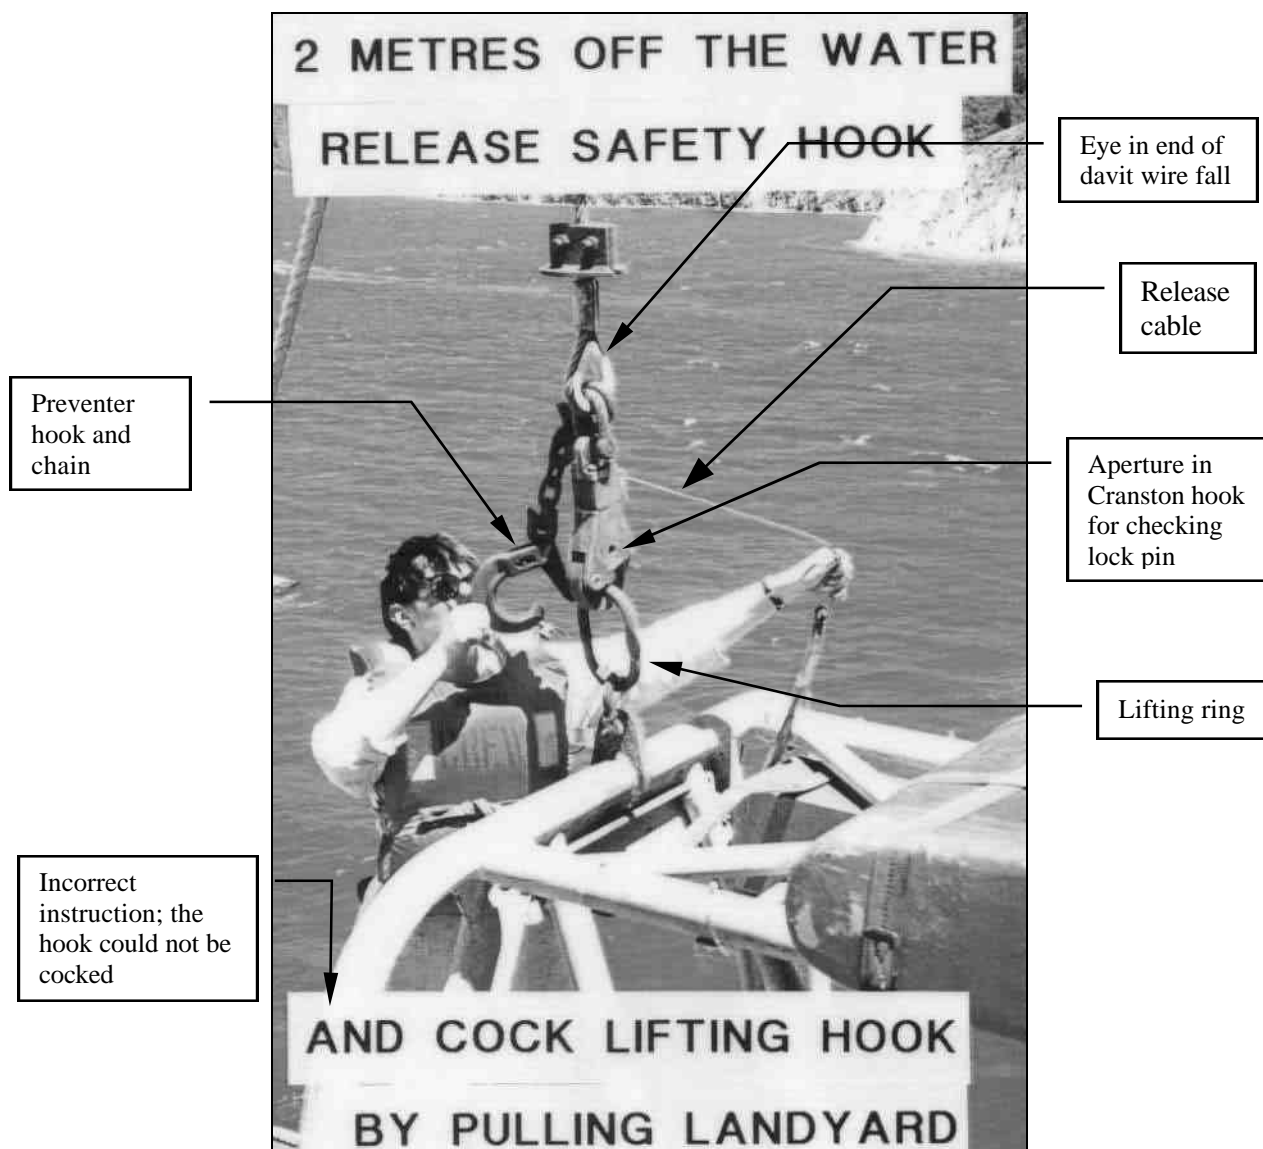
Figure 3
Lifting arrangement for rescue boat

- 1.4.7 The launching apparatus for the rescue boat was a single Schat slewing davit. The rescue boat was suspended under the davit on a single wire fall which culminated in a hard eye, to which the Cranston off-load, quick-release hook was shackled. The Cranston hook was connected to the lifting ring on the boat. In 1991, following an incident when the rescue boat released prematurely, the Interisland Line had added a preventer chain over the Cranston hook. One end of the preventer chain was shackled to the eye in the end of the wire fall and the other to a closable safety hook that was hooked on to the rescue boat lifting ring beside the Cranston hook (see Figure 3).

1.4.19 A set of instructions for launching the rescue boat was posted on the bulkhead in the vicinity of the launching station. The instructions consisted of a series of frames each containing a photograph and text overlaid on them. One frame clearly guided the reader to check that the Cranston hook was fully engaged before raising or lowering the rescue boat. The last frame however, erroneously led the reader to believe that the Cranston hook had to be cocked by pulling on the release cable before the boat reached the water, contrary to the operating instructions contained in the SOLAS training manual (see Figure 3).
