## **Report on investigations 99-212 and 99-213**

### **jet boats *Shotover 14* and *Shotover 15***

### **separate collisions with canyon wall**

### **Shotover River, near Queenstown**

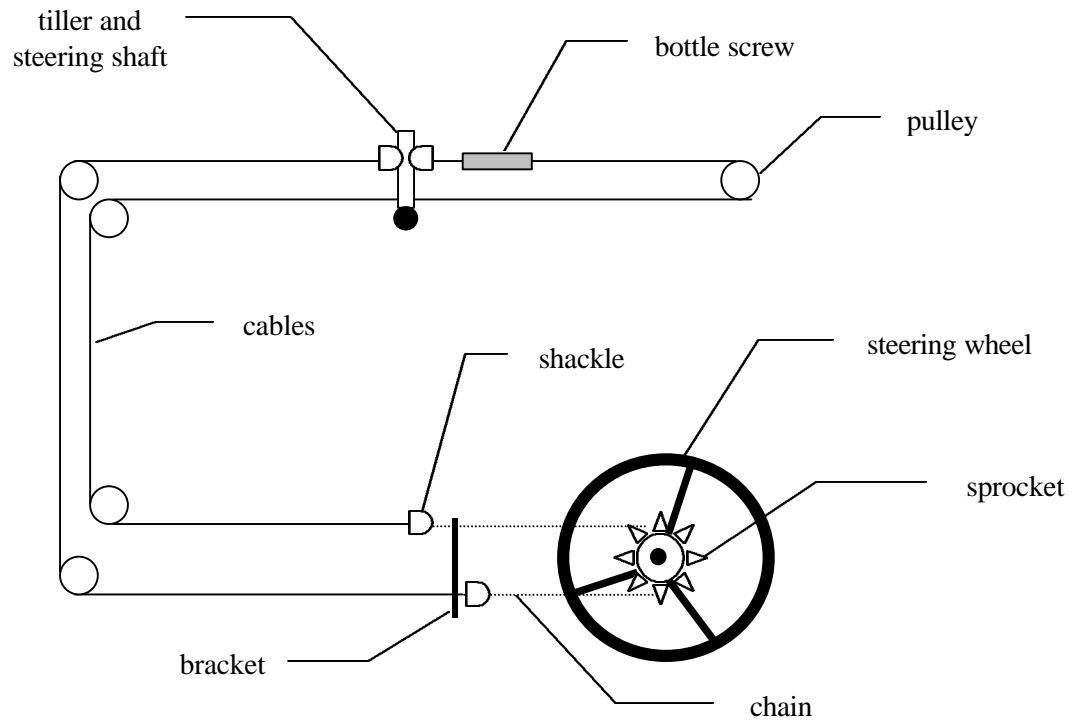
**Figure 3**  
**Schematic diagram of steering system**

- 1.4.5 The other end of the steering shaft was fitted with a tiller inside the transom of the boat. Left or right movement of this tiller was controlled by the steering wheel through a chain and sprocket arrangement behind the dashboard that pulled on a set of steering cables running through pulleys and connected to the tiller (see Figures 3 and 4).

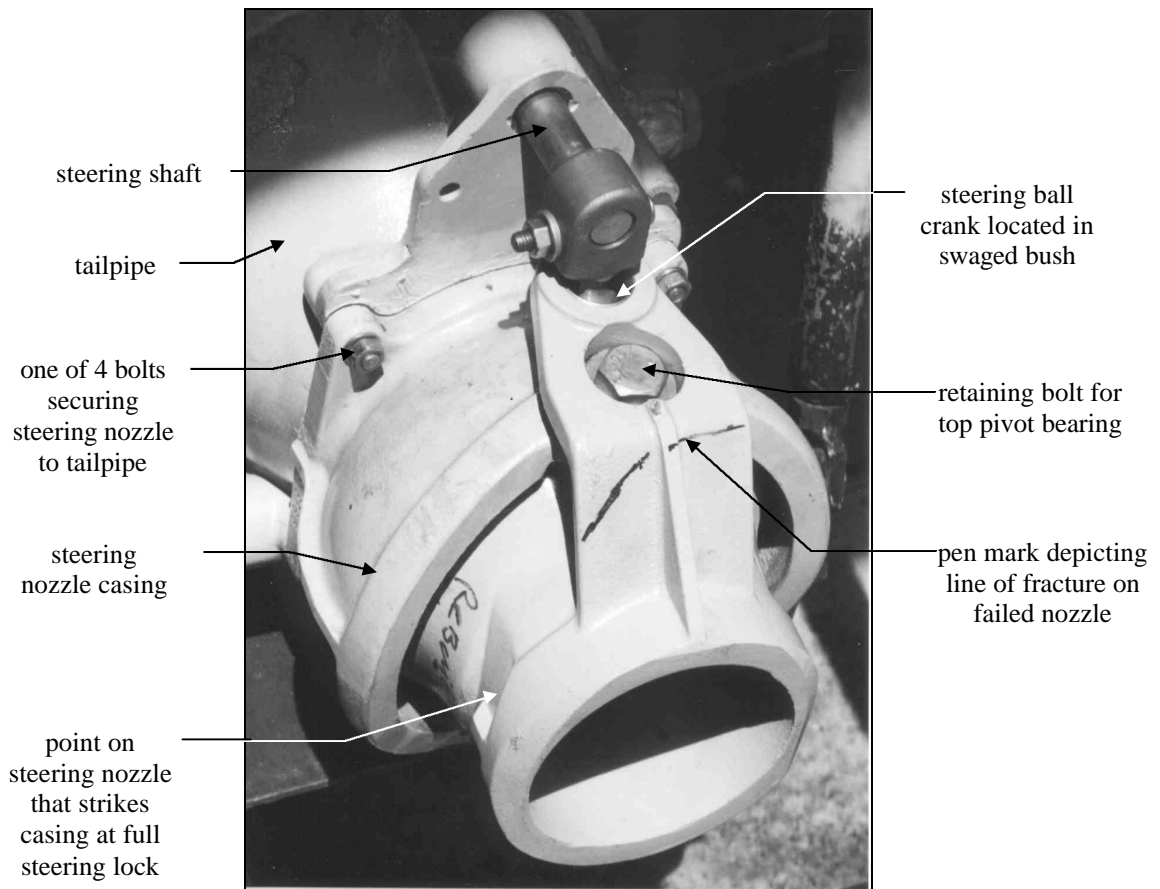
**Figure 4**  
**Hamilton HJ-212 steering nozzle with reverse bucket removed**

- 1.4.3 Steering was achieved by the water efflux from the jet unit being deflected left or right by a steering nozzle at the back of the jet unit tailpipe. The steering nozzle could rotate laterally about 2 bearings to achieve this. The nozzle had a steering arm on top. The nozzle and steering arm were made from a single aluminium casting.
