Transport Accident Investigation Commission

Final Report

Aviation inquiry AO-2017-003 ATR72, ZK-MCY Landing gear failure Nelson 9 April 2017

October 2019

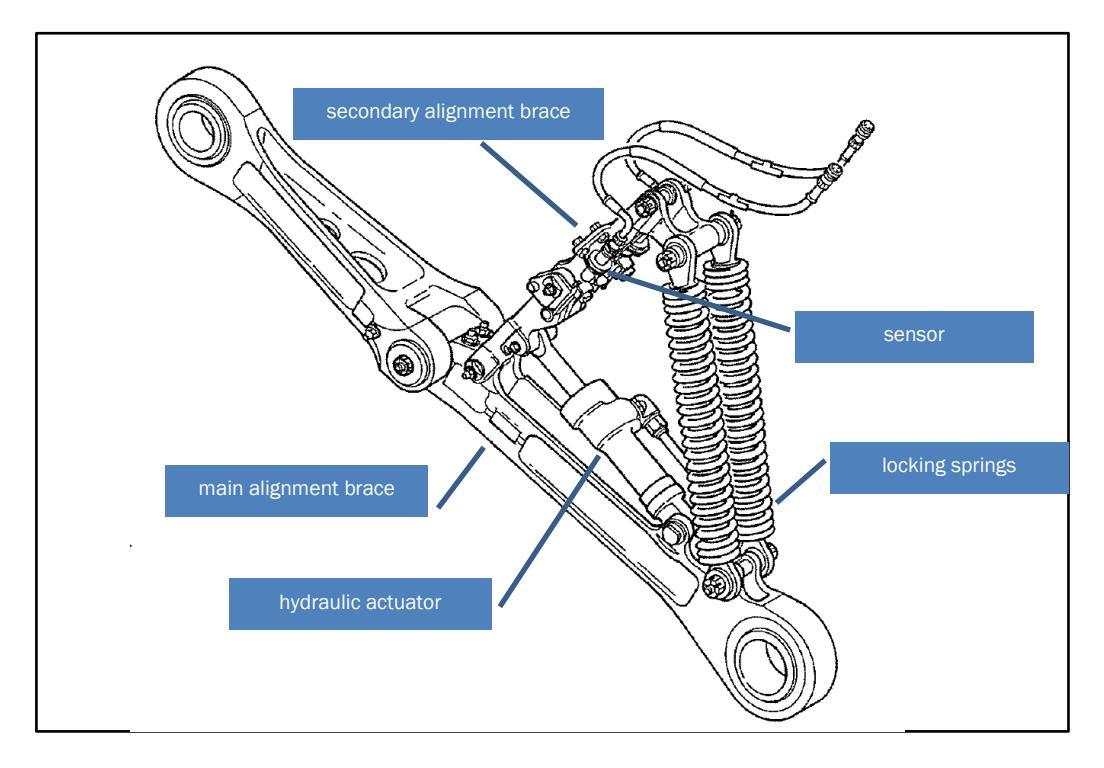
Figure 4: Side brace assembly in extended position

- 2.19. The left and right main landing gear were mirror images and included a side brace assembly to extend or retract the landing gear leg (see Figure 4). Two identical locking springs, part number D23209000¹⁸, pulled the secondary alignment brace into an overcentre down-lock position. For retraction, a hydraulic actuator released the down lock. Two proximity switches, for the primary and secondary indicating systems, detected when the secondary alignment brace was in the fully down and locked position. A pin could be manually inserted through two holes in the alignment arm to prevent accidental retraction during towing or maintenance work.
