Transport Accident
Investigation
Commission

Final report

***Aviation inquiry AO-2017-004
MBB BK117 A-3 helicopter, ZK-IED
Loss of control
Porirua Harbour
2 May 2017***

June 2020

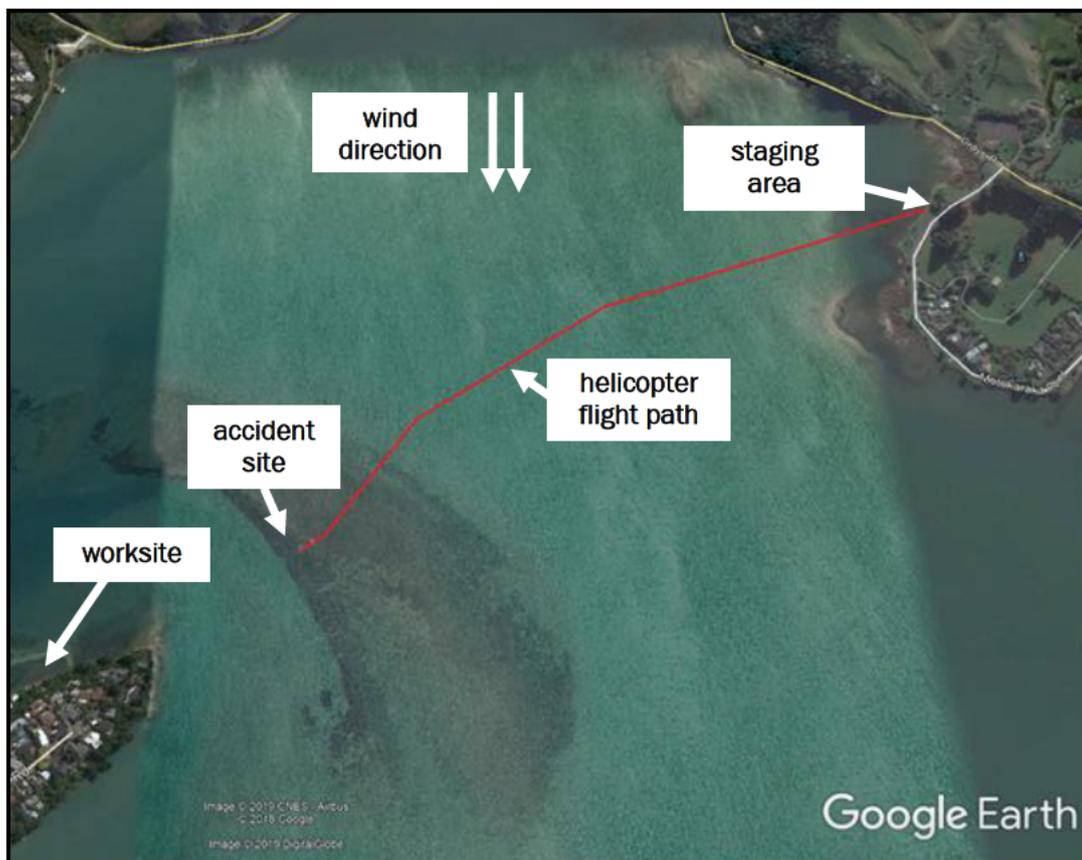
- 2.1. On 2 May 2017, a Messerschmitt-Bölkow-Blohm GmbH BK117 A-3 helicopter (the helicopter), was being used to transport three 11-metre long hardwood power poles from an area of open land (the staging area) near the shore on one side of the Pāuatahanui Arm of Porirua Harbour and place them in holes that had been prepared near the shoreline on the other side of the Arm (refer to Figure 3).

- 2.5. Meanwhile another pilot (the staff pilot) was ferrying the helicopter from the operator's Wellington base to the staging area.
- 2.6. Following a brief handover of the helicopter from the staff pilot and the removal of the right-hand door, the pilot took control of the helicopter and lifted into a hover while a member of the ground crew attached the lifting line to the helicopter's cargo hook. The helicopter then lifted the pole, and global positioning system (GPS) data showed that the helicopter climbed vertically to approximately 120 feet (37 metres). The helicopter repositioned, turned and transitioned forward to a speed of about 40 knots (74 km/h), climbing to 230 feet (71 metres) above the water. It flew in a southwesterly direction towards the worksite (see Figure 3).

Figure 3: Google Earth image depicting helicopter flight path and wind direction (credit: Google Earth, modified by the Commission)

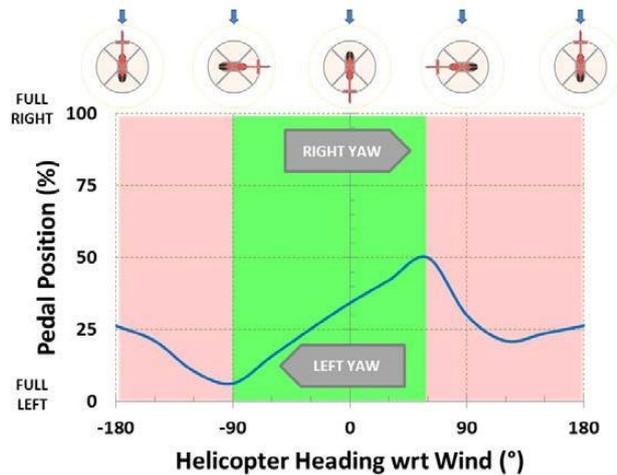
An example is provided in **Figure 1**. The well-known critical azimuth, which gives the smallest pedal margin, corresponds in this Figure to about -90° heading (wind coming from the right hand side with respect to the helicopter).

The blue curve corresponds to hover trim conditions. From there, when right pedal is added (i.e. the pedal position moves above the blue curve) the helicopter yaws to the right, and when left pedal is added it yaws to the left (the pedal position moves below the curve).

Figure 1: Example of hover pedal curve

Where a headwind is present (green area in **Figure 1**) the helicopter is stable in yaw. If a gust alters the heading of the helicopter, from 0° to -10° for example, the pedal position is now above the curve (the heading was brought to -10° with the pedal position that existed at 0°). The helicopter yaws right until it crosses the trim curve, which happens at the initial 0° heading. Shifted away from the trim position, it comes back to it.

On the opposite side of **Figure 1** the red area represents an area of a yaw instability. When the helicopter is shifted from its trim position, it moves further away until a stable headwind condition is found. This tailwind instability is well known by helicopter pilots who are aware that yaw must be very carefully controlled when the wind approaches from behind (tailwind).

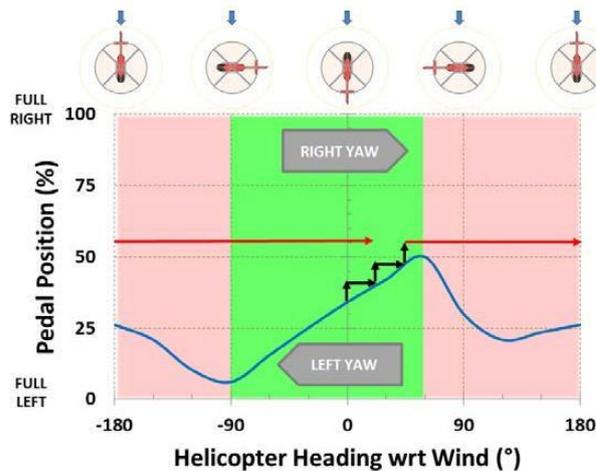
Figure 2: Starting an Unanticipated Right Yaw

position beyond the highest point of the pedal curve. This means a nose-right rotation will occur, as indicated by a red arrow. As the trim curve is never reached, however, rotation of the helicopter (i.e. spinning) will not stop unless left pedal is added. On the basis of the previous behavior of the helicopter, a 20° heading step with a limited yaw rate was expected. On the third pedal step, however, spinning is reached, with strong yaw acceleration. This is the "uncommanded rapid yaw rate which does not subside of its own accord" which defines unanticipated yaw.

The gap between the current pedal position (red arrow) and the blue trim curve gives an indication of the encountered yaw rate. In the **Figure 2** example, after passing the maximum of the blue curve (about 60° heading), that gap increases drastically. It is not due to a pedal input, but to a trim position that is moving away. The pilot has no indication of this changing trim position and the resulting yaw acceleration is therefore wrongly perceived as being uncommanded, attributable to some external factor.

This is illustrated in the graph in **Figure 2**. Starting from 0° wind heading, a right pedal step is made (indicated by a vertical black arrow). This brings the control position above the trim curve and the helicopter therefore rotates to the right until it crosses the trim curve, where it stops. In headwind conditions, pedal provides an attitude command: a control step mainly produces a heading step.

A second right pedal step is included in **Figure 2**. It has a similar effect to the first pedal step, leading to a second heading step.

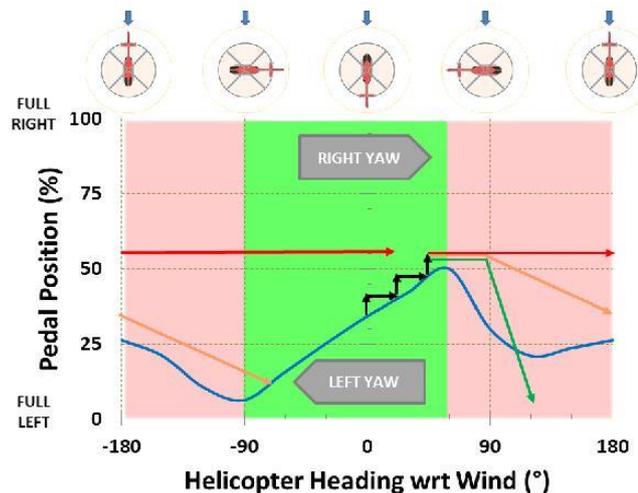
Following unanticipated right yaw occurrence depicted in Figure 2, three recovery strategies have been plotted in Figure 3. Here, the pilot is assumed to have been caught unaware by the helicopter's behavior and reacted late in the vicinity of a 90° heading.

The most probable reason for accidents following unanticipated yaw events is a late and too limited pedal input. The pedal curve shows that this cannot stop the yaw in the short term. During an unanticipated yaw event, the tail rotor remains fully effective and provides the best chance to recover. Yaw rate and wind conditions reduce its thrust if it is at a constant pitch. There must be counterbalance by a huge pitch increase. The only warning the pilot may get of potential loss of control is the onset of unanticipated yaw.

The apparent lack of efficiency of a limited pedal input can lead to misinterpretation of an unanticipated yaw as a full loss of tail rotor thrust (for example, as would be the case after rupture of the tail rotor drive). The symptom (unexpected intense right yaw) is similar and the short term response to a small and late pedal input is almost zero for both. Only full left pedal input will make the required difference and enable the pilot to identify whether he is experiencing unanticipated yaw or full loss of tail rotor thrust (due to malfunction) and, as a result, enable him to take the most appropriate action. If full left pedal has no effect on the yaw, it is clear that there has been a definite full loss of thrust, necessitating an immediate landing. If, however, full left pedal decelerates the yaw, it becomes clear that the issue is unanticipated yaw in character, which necessitates staying well clear of the ground and obstacles until a full recovery has been achieved.

Figure 3: Recovering from an Unanticipated Right Yaw
