Final Report AO-2017-007: Airbus A320 VH-VGY,  
Descent below clearance limit, Christchurch, 6 August 2017

Aviation inquiry AO-2017-007  
Airbus A320 VH-VGY  
Descent below clearance limit  
Christchurch  
6 August 2017

Approved for publication: March 2019

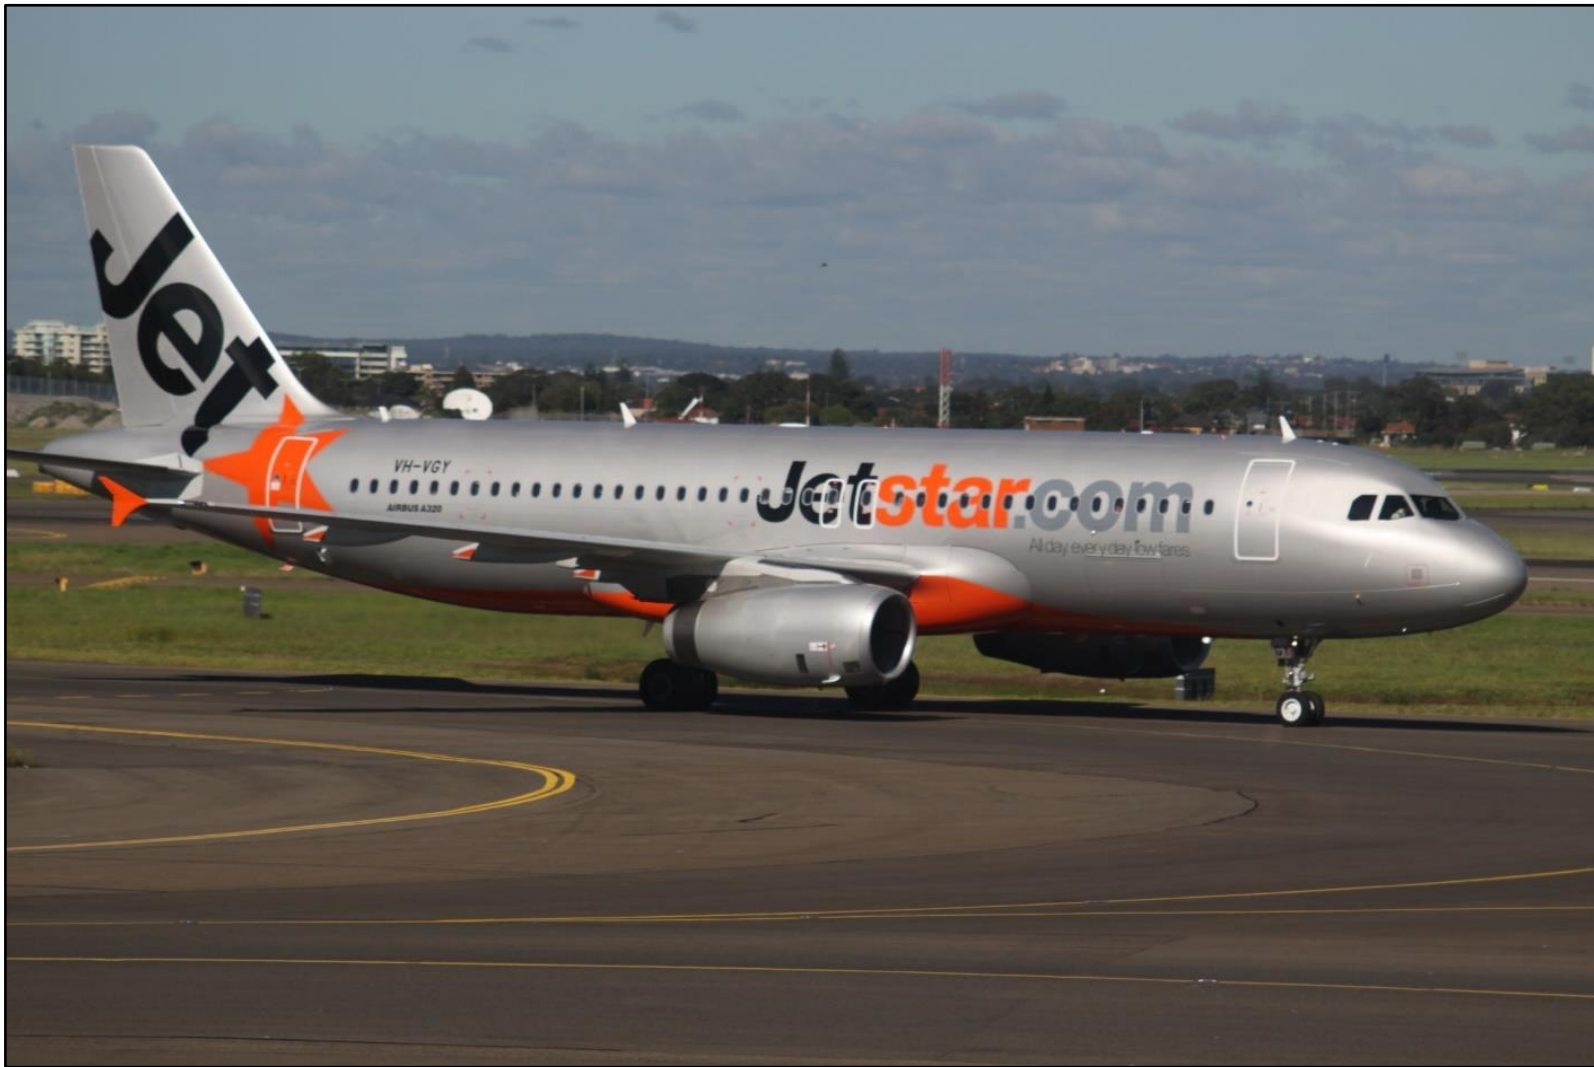
Airbus A320 VH-VGY  
(Courtesy of aeroprints.com)

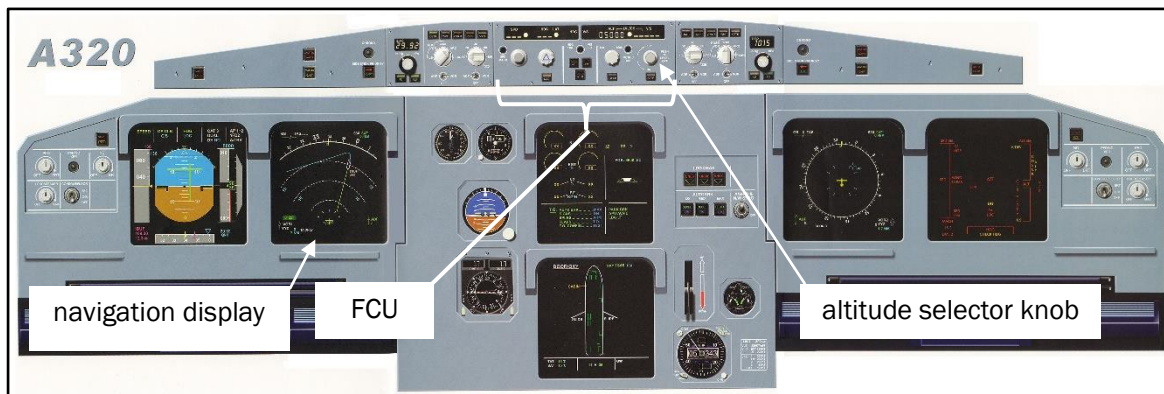
**Figure 3**  
A320 instrument panel  
(Courtesy of Airbus)

- 4.3.8. The FMGS and the auto-flight system are intended to ease a pilot's workload, allowing the crew to focus on ensuring the continued safe operation of the aeroplane. In managed-descent mode the FMGS follows a programmed procedure. However, in some conditions the aeroplane may deviate from the planned flight path. To protect against this, pilots need to monitor the performance of their aeroplane continually, and intervene to avoid any potential limit exceedance. For the A320, this monitoring information is presented to the pilots by a number of means, primarily the navigation display.
