Final report

Aviation report AO-2018-001 Tandem parachute UPT Micro Sigma, registration 31Z Double malfunction Queenstown 10 January 2018

June 2021

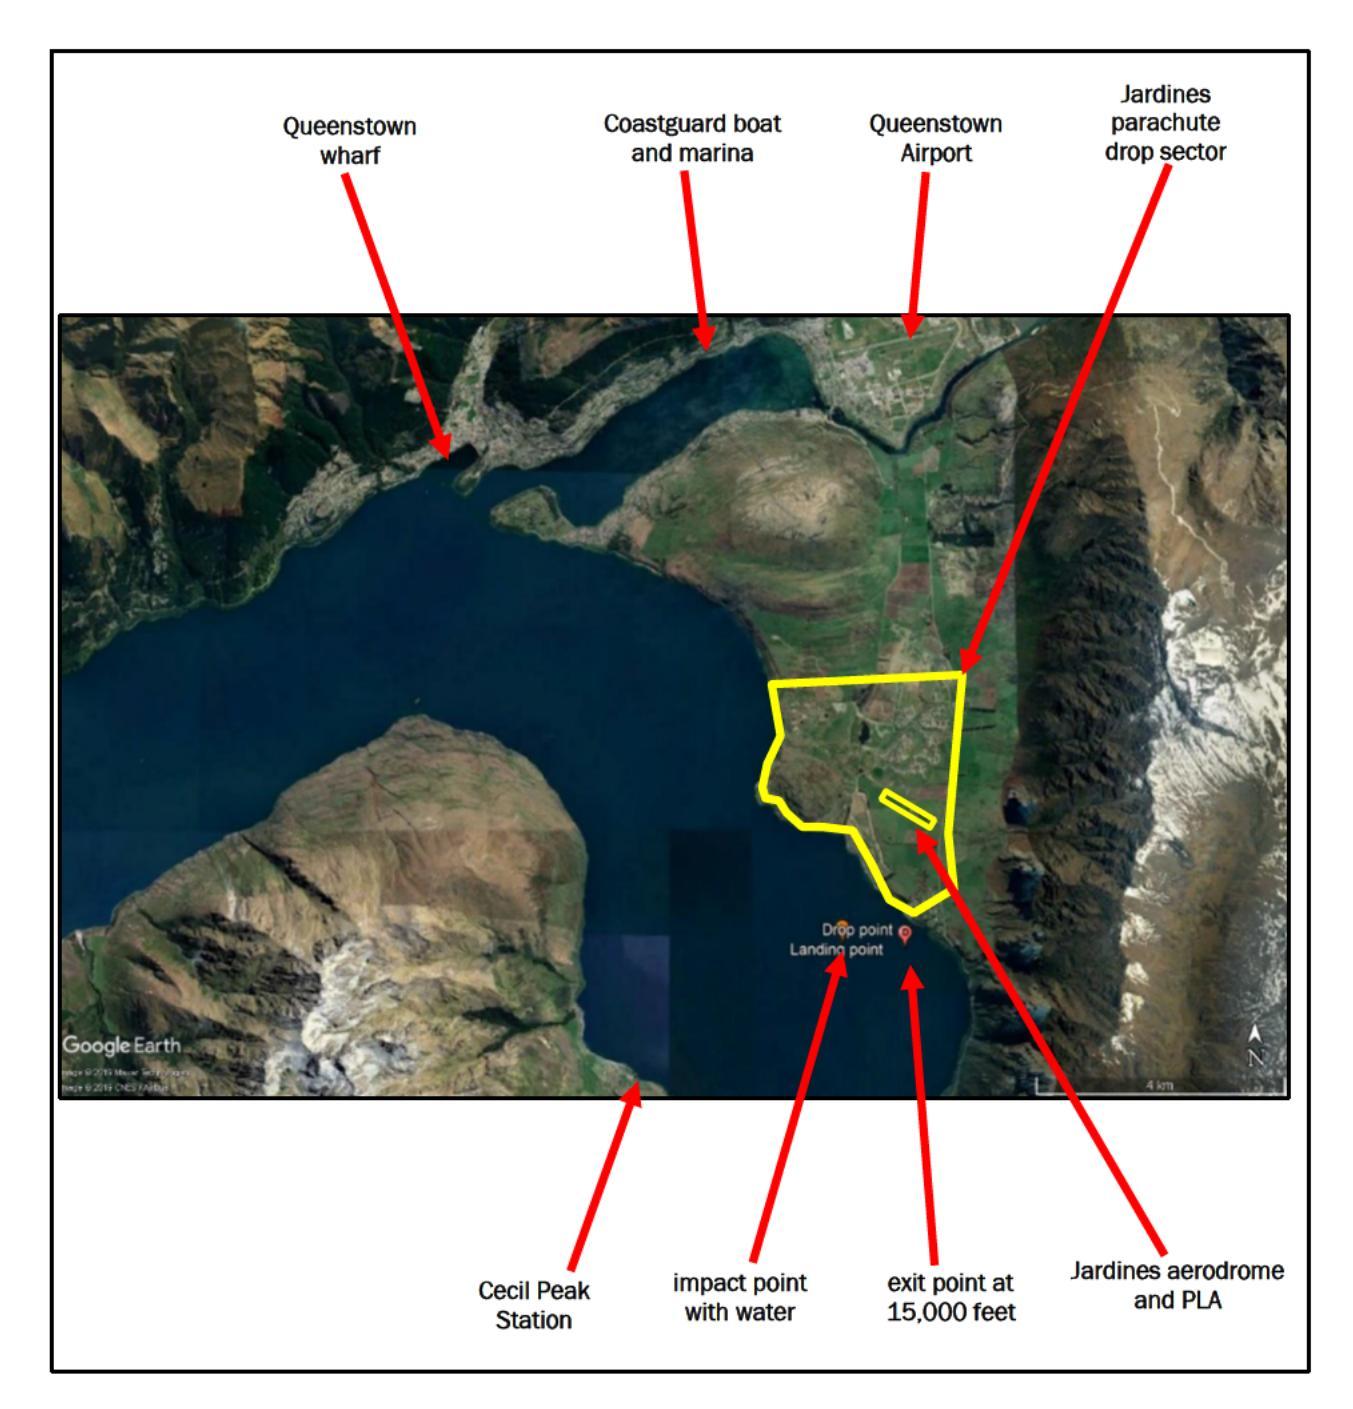
Figure 4: Location of accident

- 2.7. The tandem pair was forced outwards by the centrifugal force of the spinning parachute, to lie right-side down at an angle of about 30 degrees to the lake surface. They struck the surface of the lake at 1336, approximately 800 m from the shoreline (see Figure 4) then sunk to a depth of about 1 m before resurfacing. The canopy and suspension lines collapsed above them.

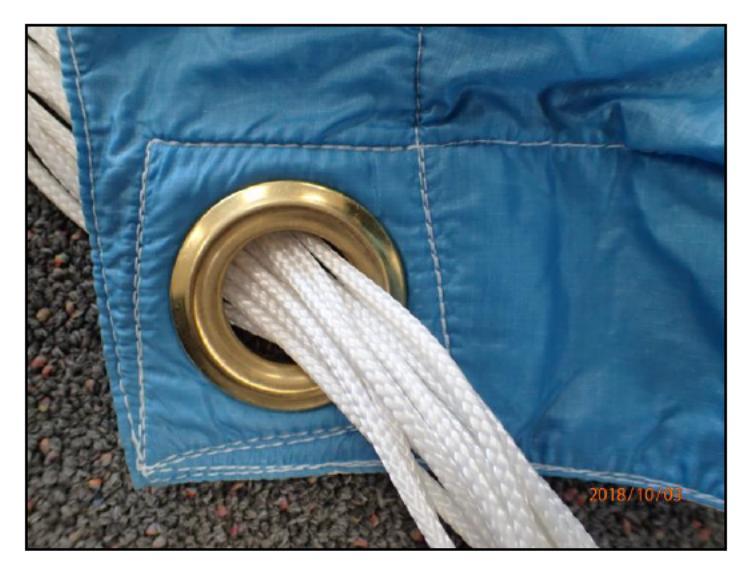
Figure 7: Typical 25-millimetre grommet in slider

- two reserve parachute suspension lines to the two outer right-hand cells had permanent compression marks in three localised spots (line D4 to Cell 6 and line C5 to Cell 8, shown in Figure 6). The suspension lines were new and the fibre weave was loose from not having been under tension before, so the localised compression marks were visually different from the rest of the suspension lines. No other lines had similar marks. These compression marks were consistent with the pressure that could be exerted by a tension knot. These lines connected to the rear right-hand side of the canopy and passed through the same eyelet in the slider²¹ (see Figure 7)
