Final Report

Aviation inquiry AO-2018-005 MD Helicopters 600N, ZK-ILD Engine control malfunction and forced landing Ngamatea Station 14 June 2018

June 2021

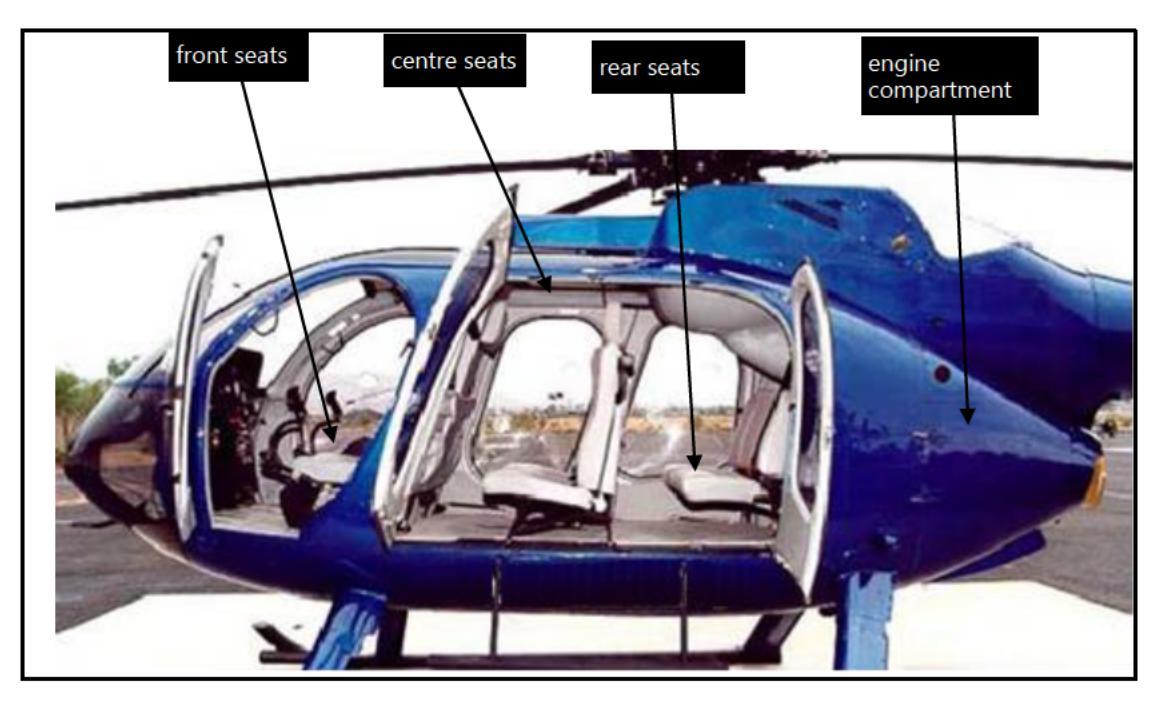
Figure 3: Example of cabin arrangement

- 2.8 The two occupants seated in the centre seats reported remaining conscious throughout the accident sequence and received minor injuries. After the accident sequence they vacated the helicopter, observed a fire in the engine compartment and subsequently removed the other occupants from the helicopter. They then extinguished the fire with a hand-held fire extinguisher.
