Transport Accident
Investigation
Commission

Aviation inquiry AO-2018-006

Robinson R44, ZK-HTB

Loss of control

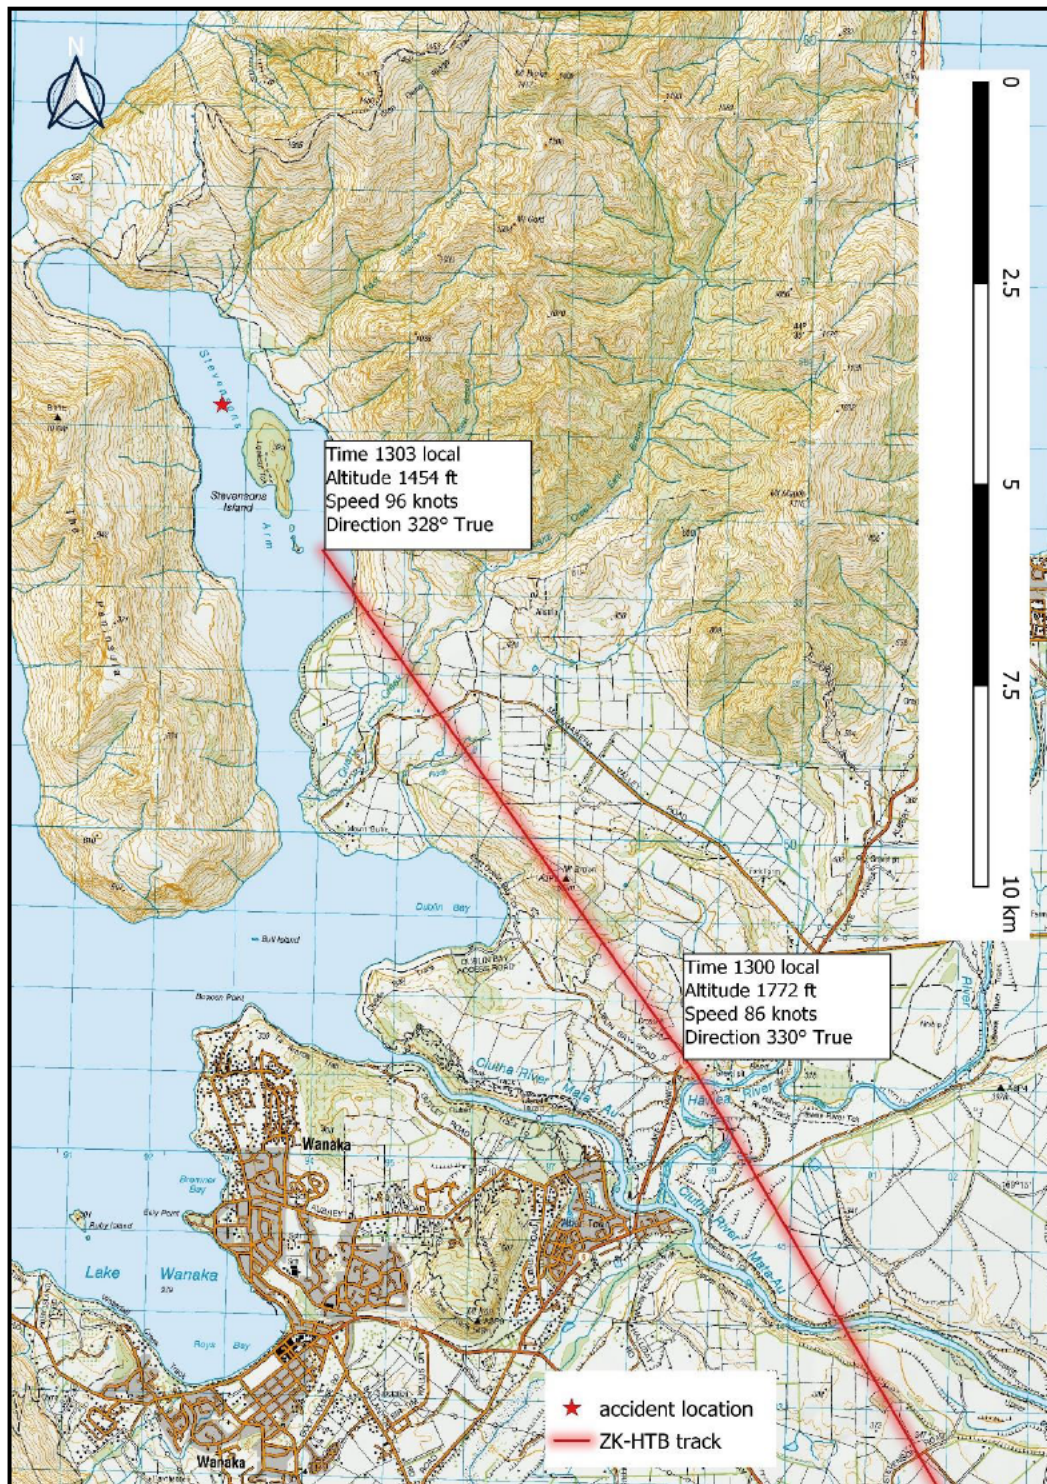
Figure 3: Track record
(credit: Land Information New Zealand, modified by the Transport Accident Investigation Commission)

- 2.5. The flight tracking system fitted to the helicopter made position reports every three minutes. The system transmitted its first in-flight report from the helicopter at 1300:25. It recorded the helicopter passing to the east of Albert Town, about halfway to Dublin Bay (see Figure 3). The helicopter was flying at an altitude³ of 1,772 feet (540 metres (m)), approximately 600 feet (180 m) above the ground, and at a groundspeed of 86 knots⁴ (160 km per hour (km/h)).

- 2.7. At about 1308, a person responsible for maintaining 'flight following'⁵ for the aircraft noted that nearly five minutes had elapsed since the last position report from the helicopter. The duty person refreshed the display and, with no update seen, initiated the 'aircraft overdue' actions. The duty person tried calling the pilot several times but received no response. It was soon confirmed that the helicopter had not arrived at the lodge and it was then declared to be missing.

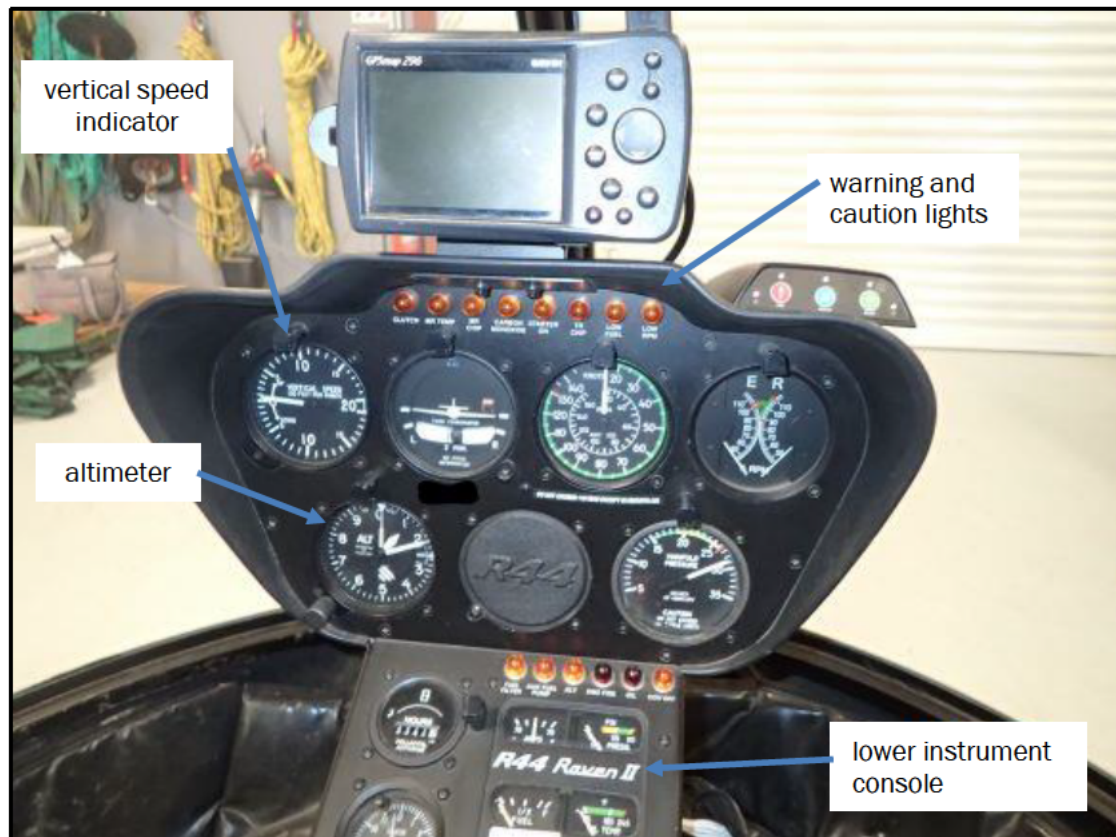
Figure 6: R44 instrument consoles shown pre-accident

- 2.30. The R44 upper instrument console contained the flight instruments and an array of warning and caution lights (see Figure 6). It was dislodged but remained attached by electrical wiring. The vertical speed indicator, located at the top left of the instruments, was missing.

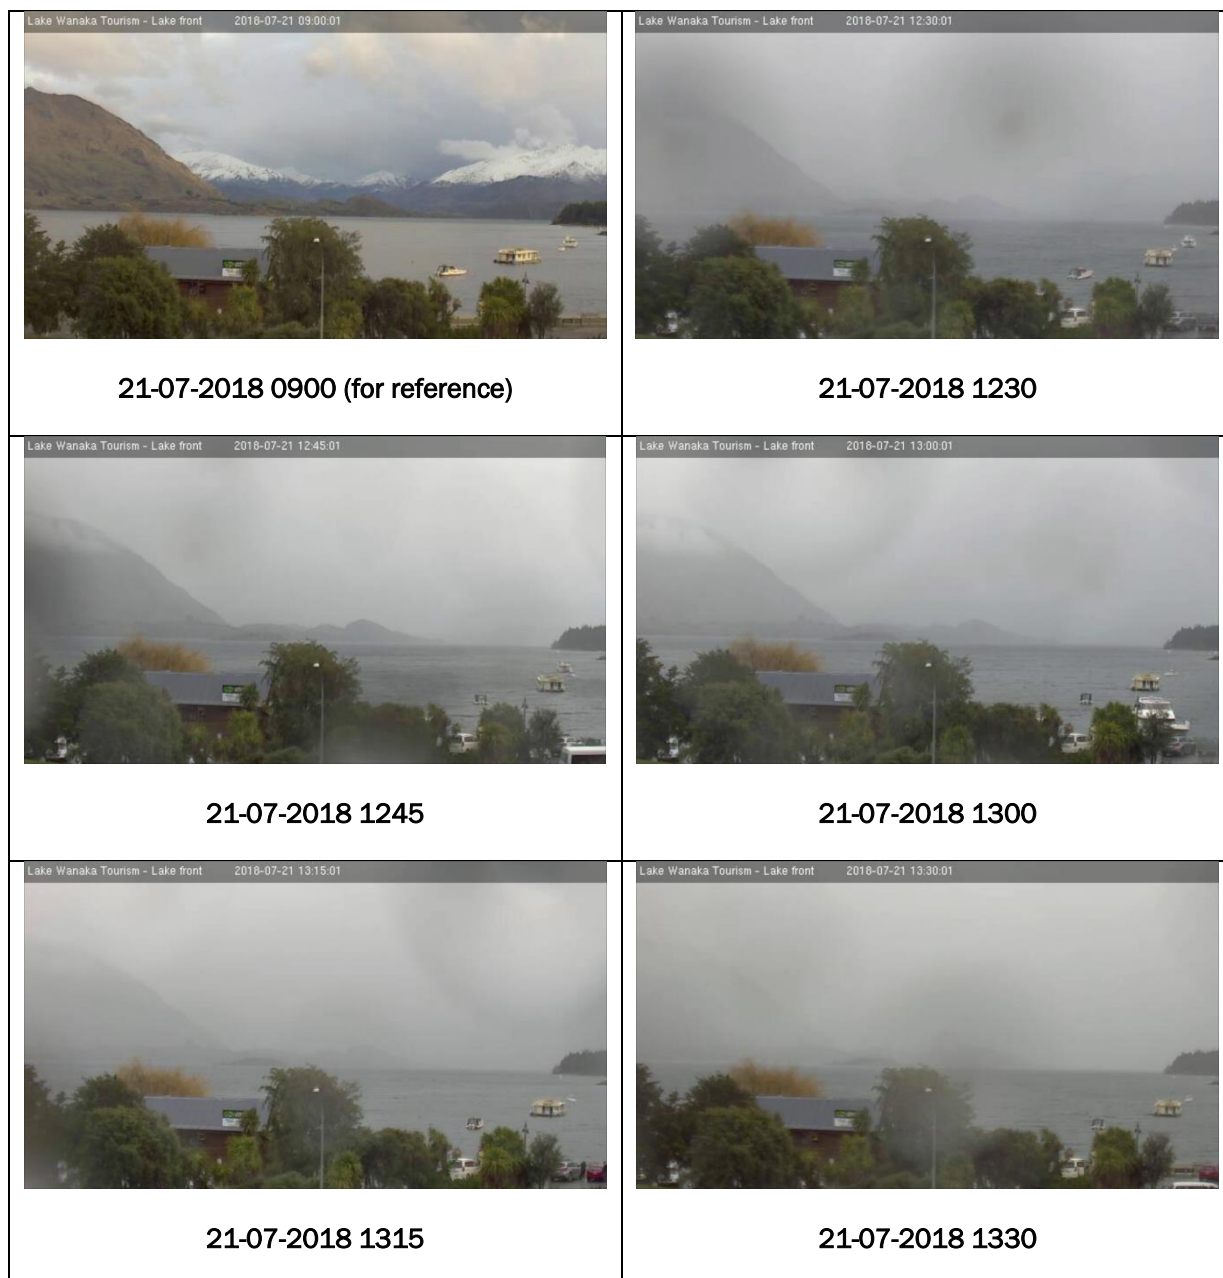
**Figure 7: Still images from CCTV at Wanaka township overlooking Lake Wanaka
(credit: Wanaka Tourism, modified by the Commission)**

- 2.46. CCTV footage taken from cameras located in the Wanaka township and at the aerodrome recorded showers passing through the area (see Figure 7). The wind was generally from the north-west, sufficient to cause swells and occasionally produce significant whitecaps.
