Transport Accident
Investigation
Commission

Final report

Aviation inquiry A0-2019-002
Bombardiers DHC-8-311, ZK-NEH and ZK-NEF
'Loss of separation' near Wellington,
New Zealand
12 March 2019

April 2022

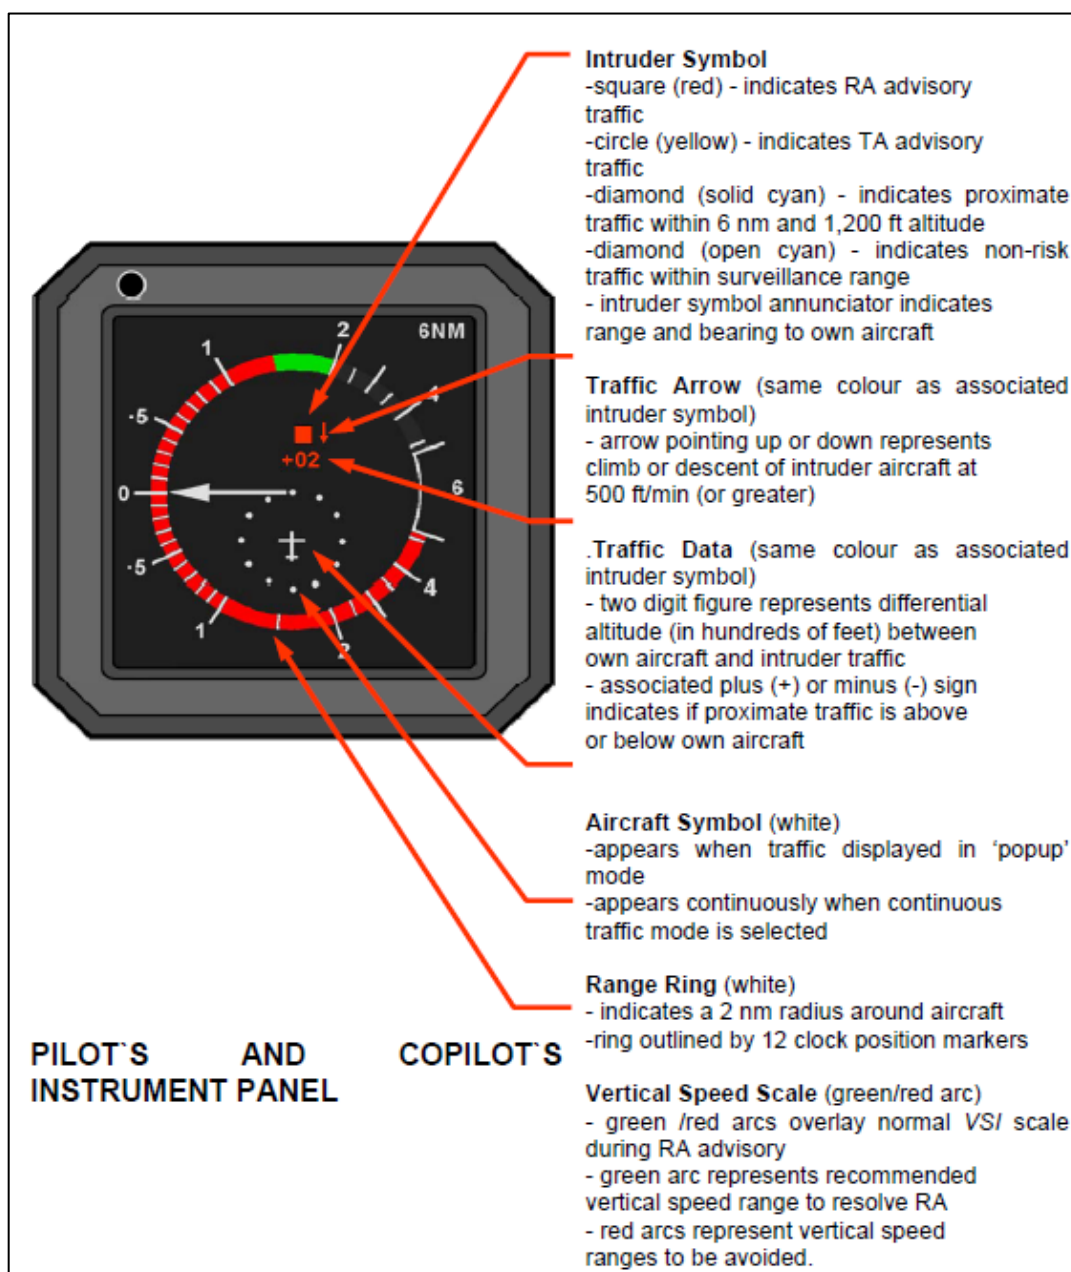
Figure 6: Collins TCAS-94 Resolution Advisory Indication

- 2.45. The Collins TCAS-94, TCAS II identifies and displays potential and predicted collision threats. The system protects a volume of airspace around an aircraft by interrogating transponders²⁰ in nearby aircraft and provide appropriate aural and visual advisories to a flight crew when another aircraft is predicted to infringe on the protected airspace.
- 2.46. TCASs provide two advisory levels to flight crew. The first advisory level, Traffic Advisory, displays and annunciates the relative positions of intruding aircraft that are

Advisory provides the flight crew with adequate time to visually locate the intruding aircraft and initiate evasive manoeuvres. The second advisory level, Resolution Advisory, displays and annunciates a vertical manoeuvre that increases separation when the intruding aircraft is approximately 25 seconds from the closest point of approach. When in receipt of a TCAS-RA the flight crew must initiate evasive manoeuvres based on the TCAS-RA unless compliance is unsafe.²¹ If both aircraft have TCASs, the equipment coordinates avoidance advisories to maximise separation, for example by instructing one aircraft to climb and the other to descend.
