Transport Accident  
Investigation  
Commission

# Final report

***Aviation inquiry AO-2019-003  
Diamond DA42 aeroplane, ZK-EAP  
Controlled flight into terrain  
Kaimanawa Range, near Taupō  
23 March 2019***

November 2021

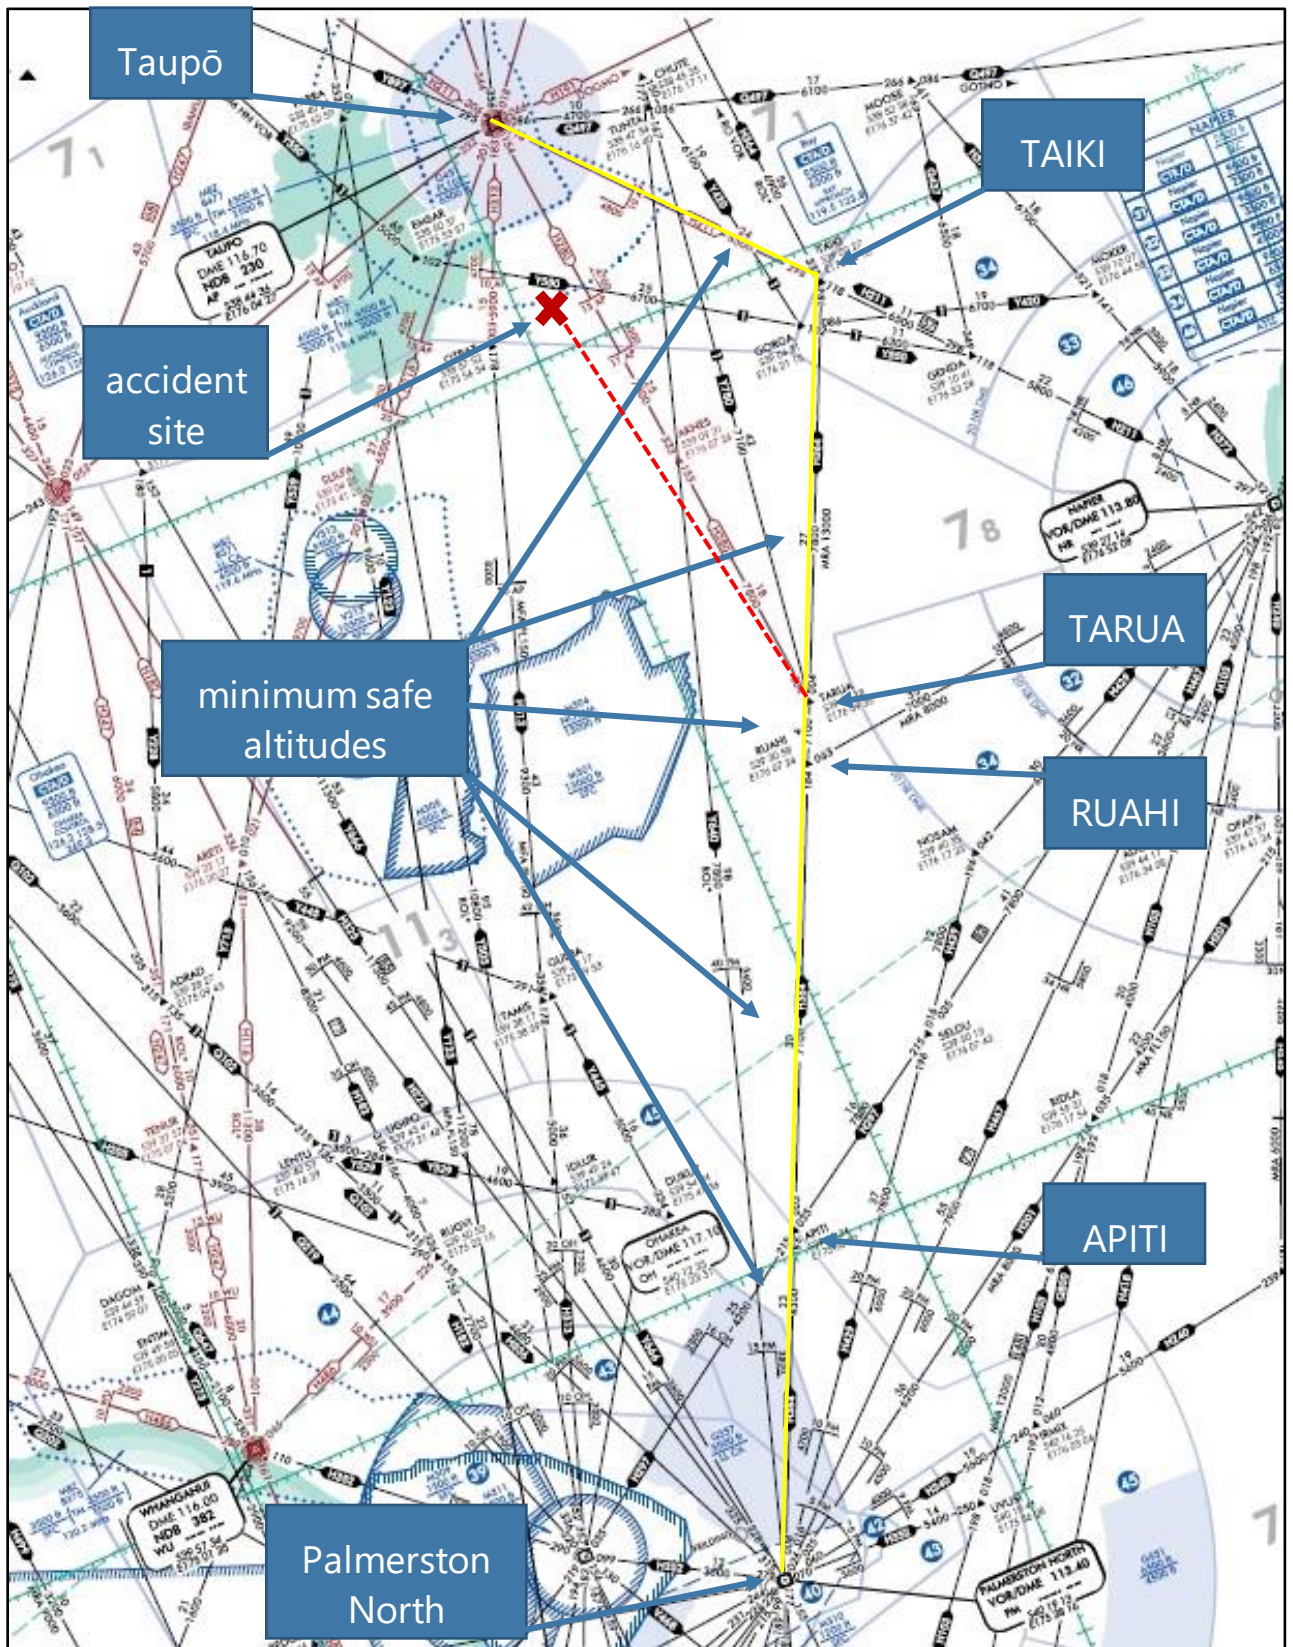
**Figure 3: Flight planned route**  
 (Not to be used for navigation)  
 (Credit: Aeropath [Civil Aviation Authority])

- 2.5. At 2205 the aeroplane was recorded on radar turning left as it passed TARUA. At the same time the pilot reported 'top of descent'<sup>11</sup> and the aeroplane was recorded as starting to descend from 9,000 feet. The FIO replied, advising that there was no reported traffic for the descent to Taupō, and asked, "Which runway lights would you like?".<sup>12</sup> At 2207, after two further calls by the FIO, the pilot responded and was given the local area altimeter pressure setting.

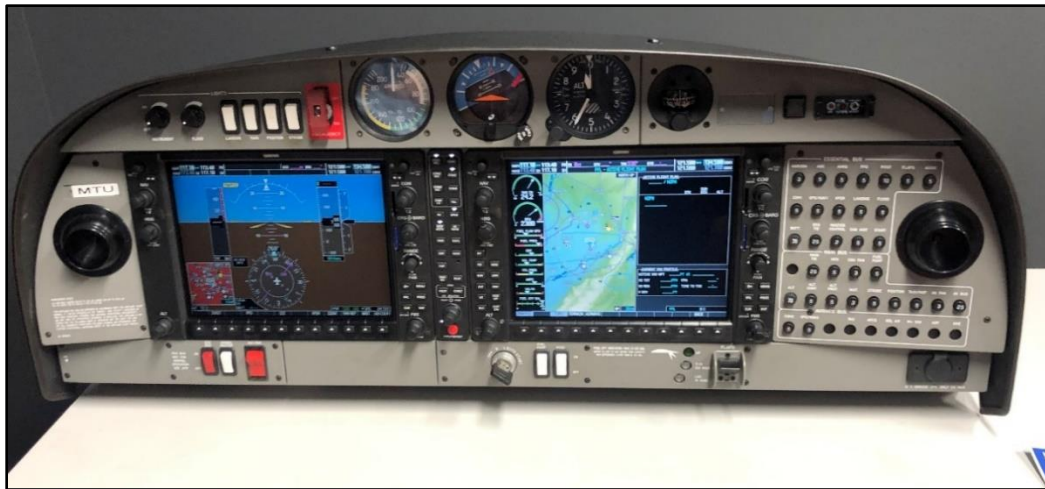
**Figure 4: The Diamond DA42 aeroplane G1000 instrument panel**

- 2.28. The aeroplane was equipped with a Garmin G1000 integrated flight instrument system and a three-axis GFC 700 digital autopilot. The G1000 system in the accident aircraft comprised two electronic display units. The display unit on the left was typically used as the primary flight display. The display unit on the right was typically used as a multifunctional display (MFD) (see Figure 4). The MFD could be used to programme flight plan data and display engine parameters and navigation information, including a moving map and terrain-conflict-proximity information. The functions could be moved between the two display units.

- 2.29. Terrain-conflict-proximity information was displayed graphically on the moving map. Colour-coded areas of the map corresponded to the altitude of the aeroplane determined by the global positioning system (GPS) with respect to the terrain elevation stored in the digital database loaded into the G1000 system.

- 2.30. Yellow on the map signified that the terrain elevation was within 1,000 feet (304 m) of the aeroplane's GPS altitude. Red signified that the terrain elevation was within 100 feet (30 m) of the aeroplane's GPS altitude (see Figure 5). The terrain conflict proximity functionality could be selected on and off by the pilot. In night or low-light flight the displays could be dimmed to reduce the glare generated by the display units.
