Transport Accident
Investigation
Commission

Final report

***Aviation inquiry A0-2019-003
Diamond DA42 aeroplane, ZK-EAP
Controlled flight into terrain
Kaimanawa Range, near Taupō
23 March 2019***

November 2021

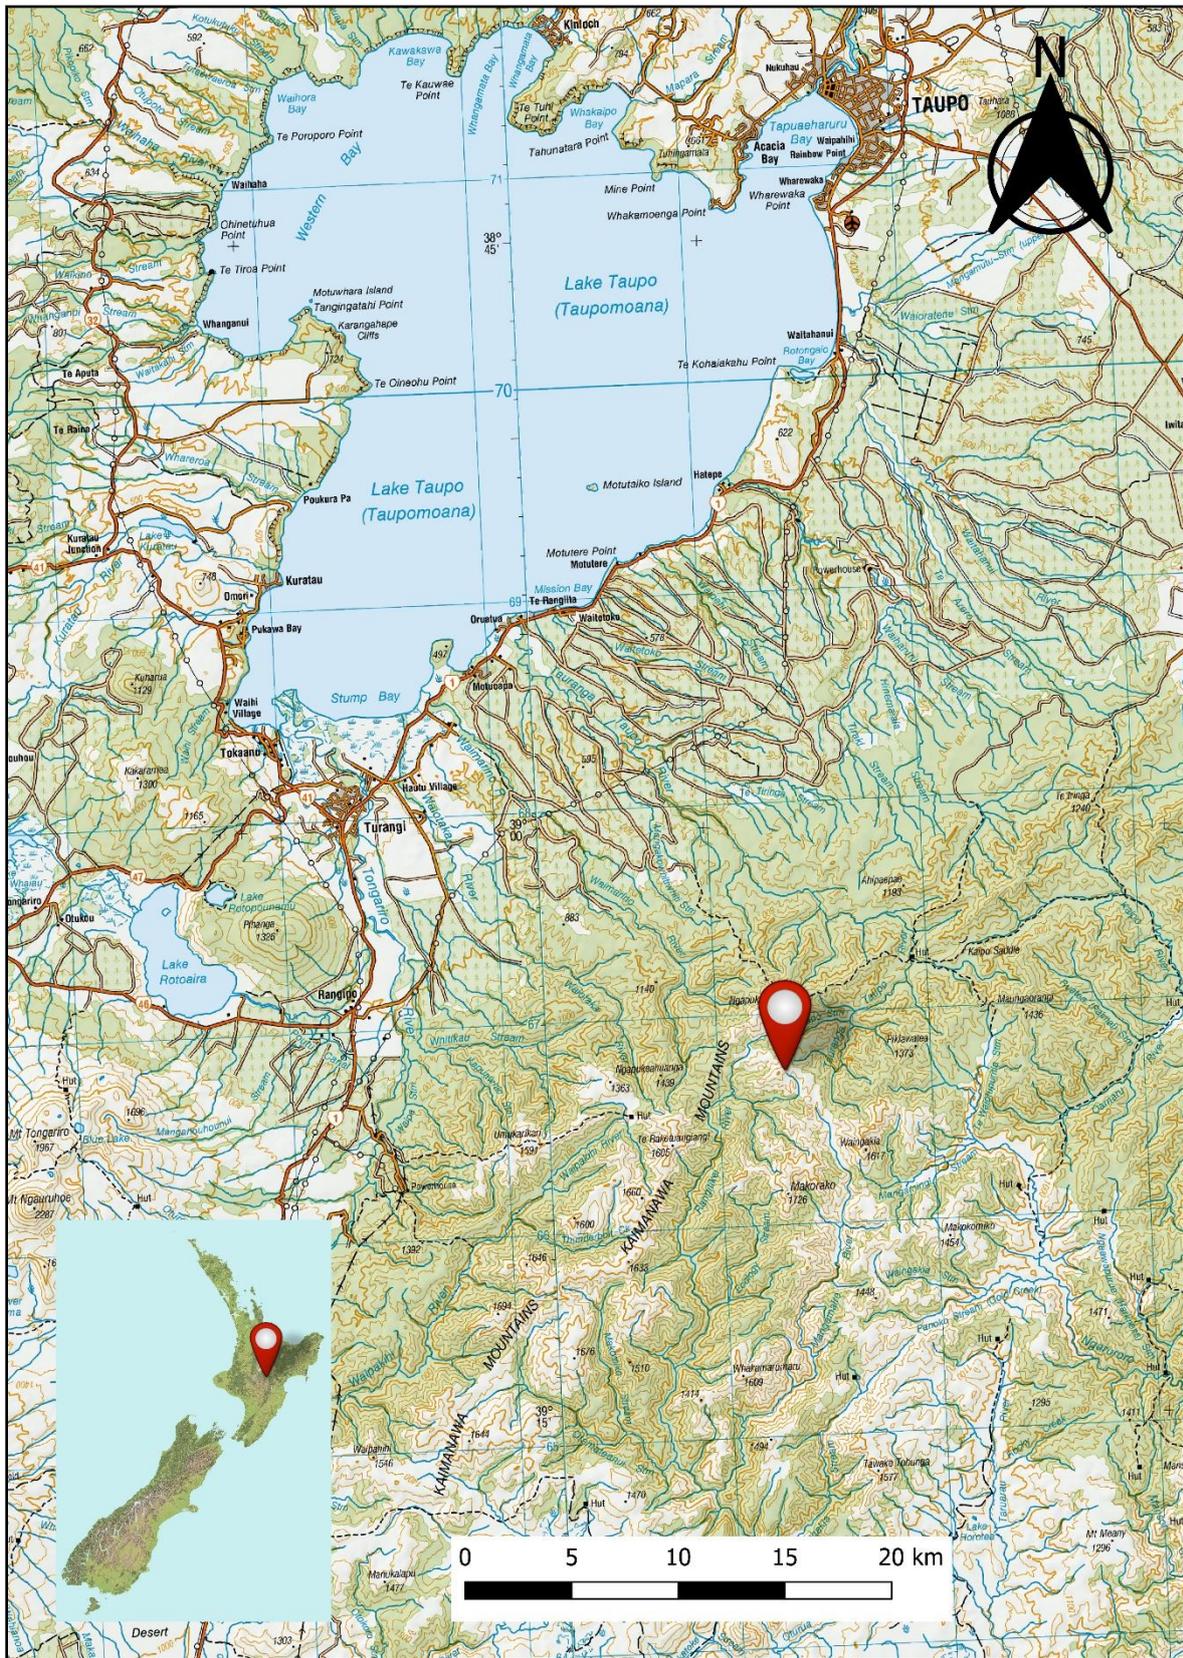
Figure 2: Location of accident reproduced on LINZ Topo250 map

- 2.36. The accident scene was situated at 4,500 feet (1,371 m) on sloping ground in the Kaimanawa Range, approximately 38 km south of Taupō Aerodrome (see Figure 2).
- 2.37. The aeroplane had first hit the ground with the left wing tip. The left wing had separated as a result. With the terrain sloping away, the remainder of the aeroplane had continued in the general direction of the original flightpath for a further approximately 250 m before striking the northern face of a gully. The initial ground scar made by the left wing tip and the location of the wreckage showed that the aeroplane had been in about a straight and level attitude when the ground strike occurred (see Figure 8).

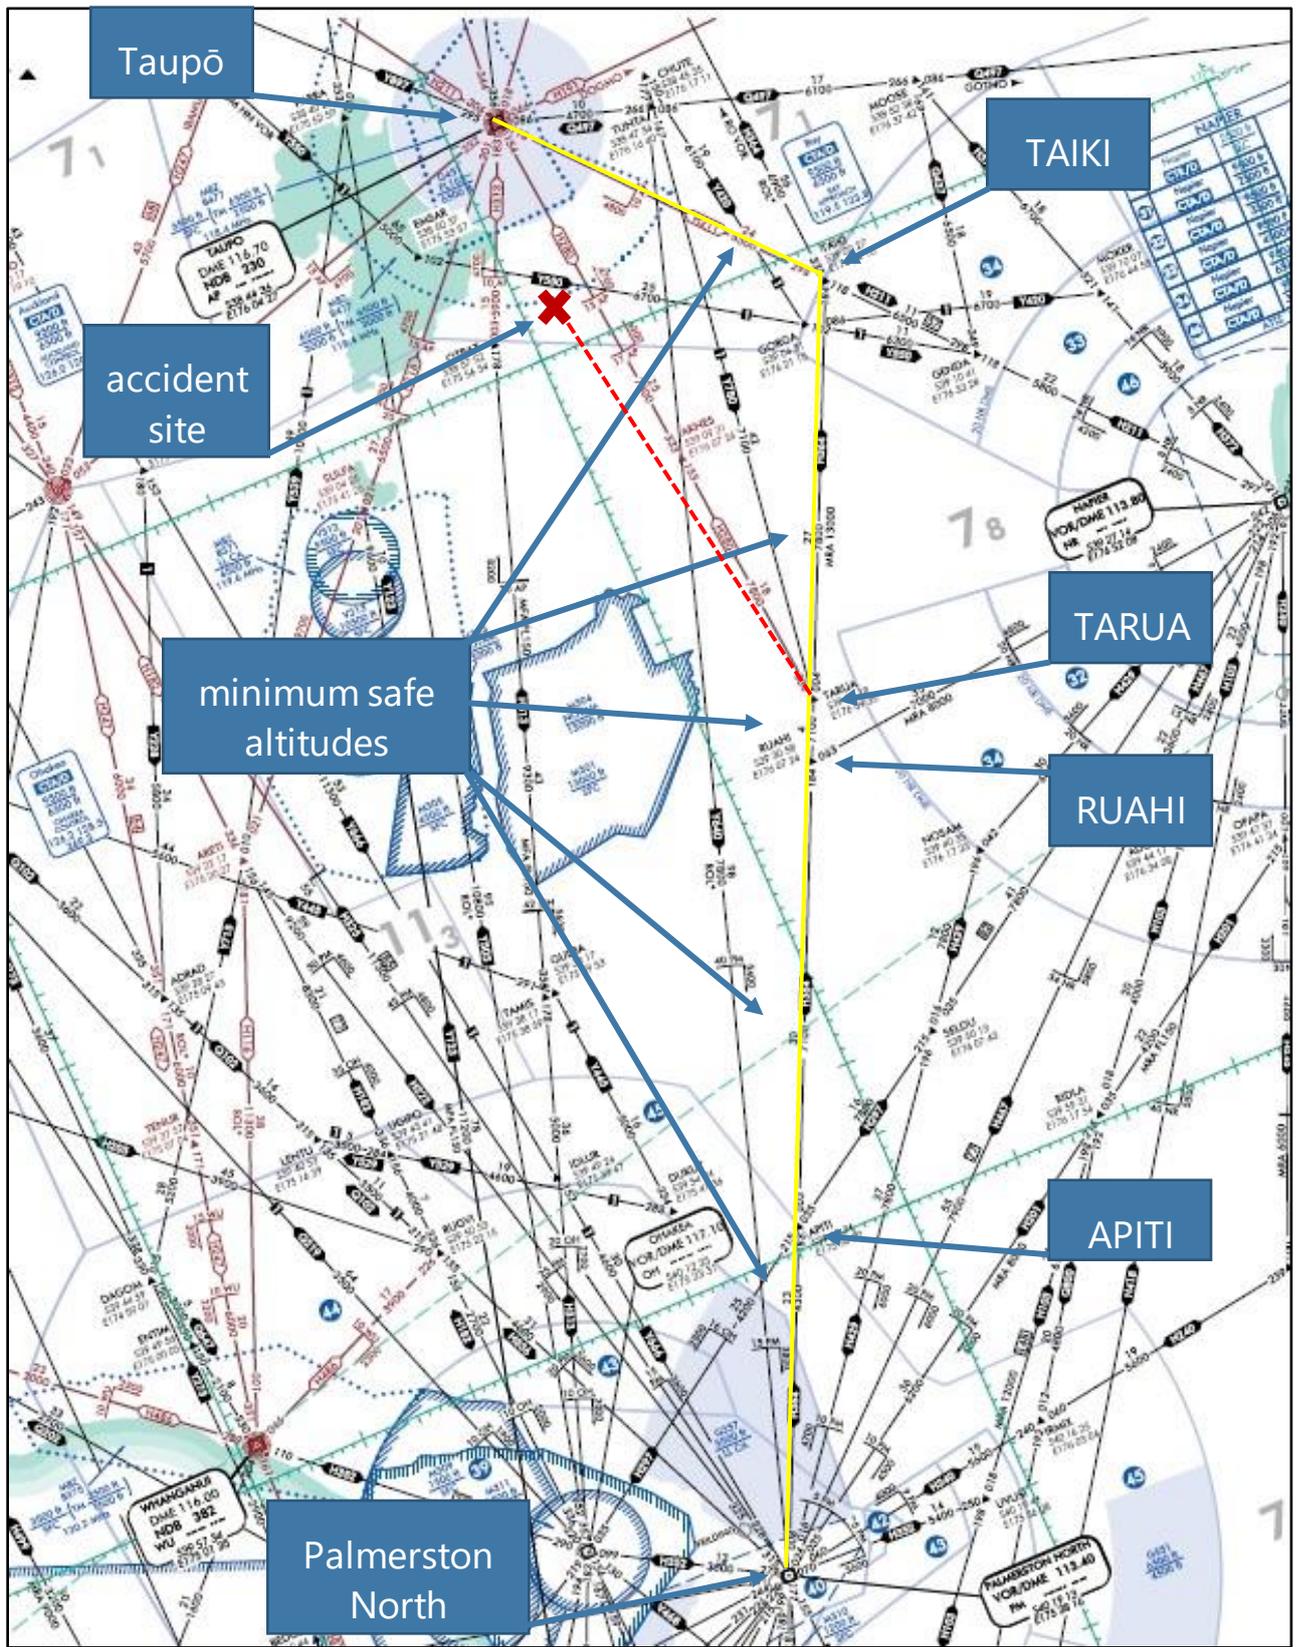
**Figure 3: Flight planned route
(Not to be used for navigation)
(Credit: Aeropath [Civil Aviation Authority])**

- 2.2. While on the ground at Palmerston North Aerodrome, the pilot talked to Ōhakea Control and obtained an air traffic control clearance for the next leg to Taupō.³ The aeroplane was “cleared Taupō via [reporting points⁴] APITI, RUAHI, TURUA, TAIKI at 9,000 feet [2,745 metres (m)]” above sea level⁵ (see Figure 3).⁶ At 2135 the aeroplane departed Palmerston North. Once clear of Palmerston North Aerodrome the pilot called Ōhakea Control and advised climbing past 2,300 feet (700 m) for 9,000 feet. The Ōhakea controller acknowledged the call and advised that the aeroplane had been identified.

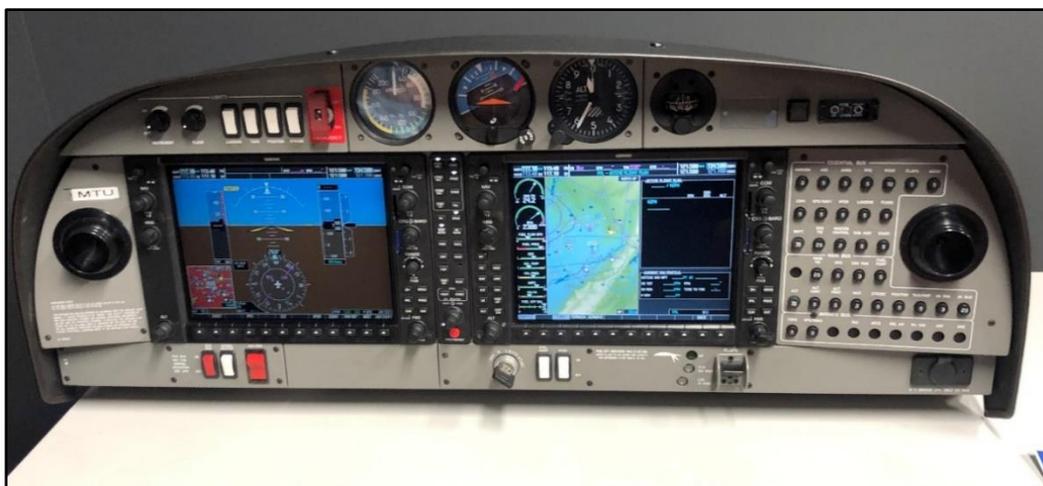
Figure 4: The Diamond DA42 aeroplane G1000 instrument panel

- 2.28. The aeroplane was equipped with a Garmin G1000 integrated flight instrument system and a three-axis GFC 700 digital autopilot. The G1000 system in the accident aircraft comprised two electronic display units. The display unit on the left was typically used as the primary flight display. The display unit on the right was typically used as a multifunctional display (MFD) (see Figure 4). The MFD could be used to programme flight plan data and display engine parameters and navigation information, including a moving map and terrain-conflict-proximity information. The functions could be moved between the two display units.

- 2.29. Terrain-conflict-proximity information was displayed graphically on the moving map. Colour-coded areas of the map corresponded to the altitude of the aeroplane determined by the global positioning system (GPS) with respect to the terrain elevation stored in the digital database loaded into the G1000 system.

- 2.30. Yellow on the map signified that the terrain elevation was within 1,000 feet (304 m) of the aeroplane's GPS altitude. Red signified that the terrain elevation was within 100 feet (30 m) of the aeroplane's GPS altitude (see Figure 5). The terrain conflict proximity functionality could be selected on and off by the pilot. In night or low-light flight the displays could be dimmed to reduce the glare generated by the display units.

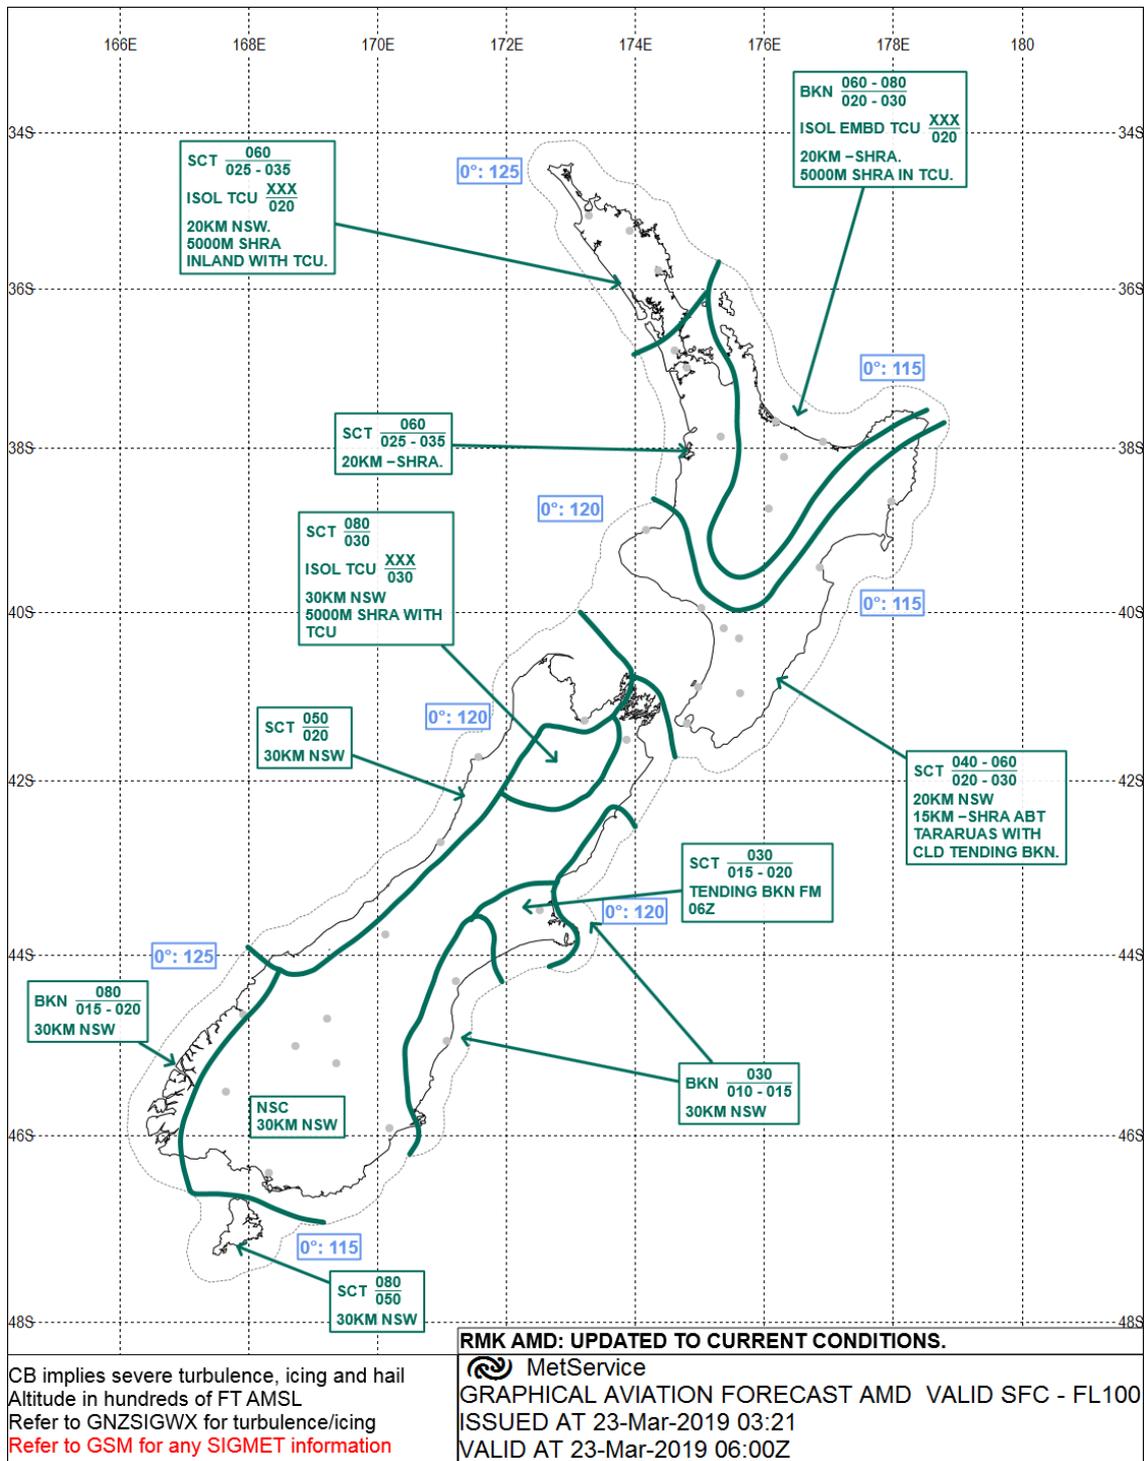
Figure 6: GAFOR before the accident

2.32. The graphical aviation forecast (GAFOR) valid for approximately three hours prior to the time of the accident (see Figure 6) specified for the Bay of Plenty and Taupō area broken cloud²¹ between 2,000–3,000 feet (609–914 m) and 6,000–8,000 feet (1,828–2,438 m), isolated embedded towering cumulonimbus above 2,000 feet, 20 km visibility with showers and rain and 5 km visibility with showers and rain in towering cumulonimbus cloud.

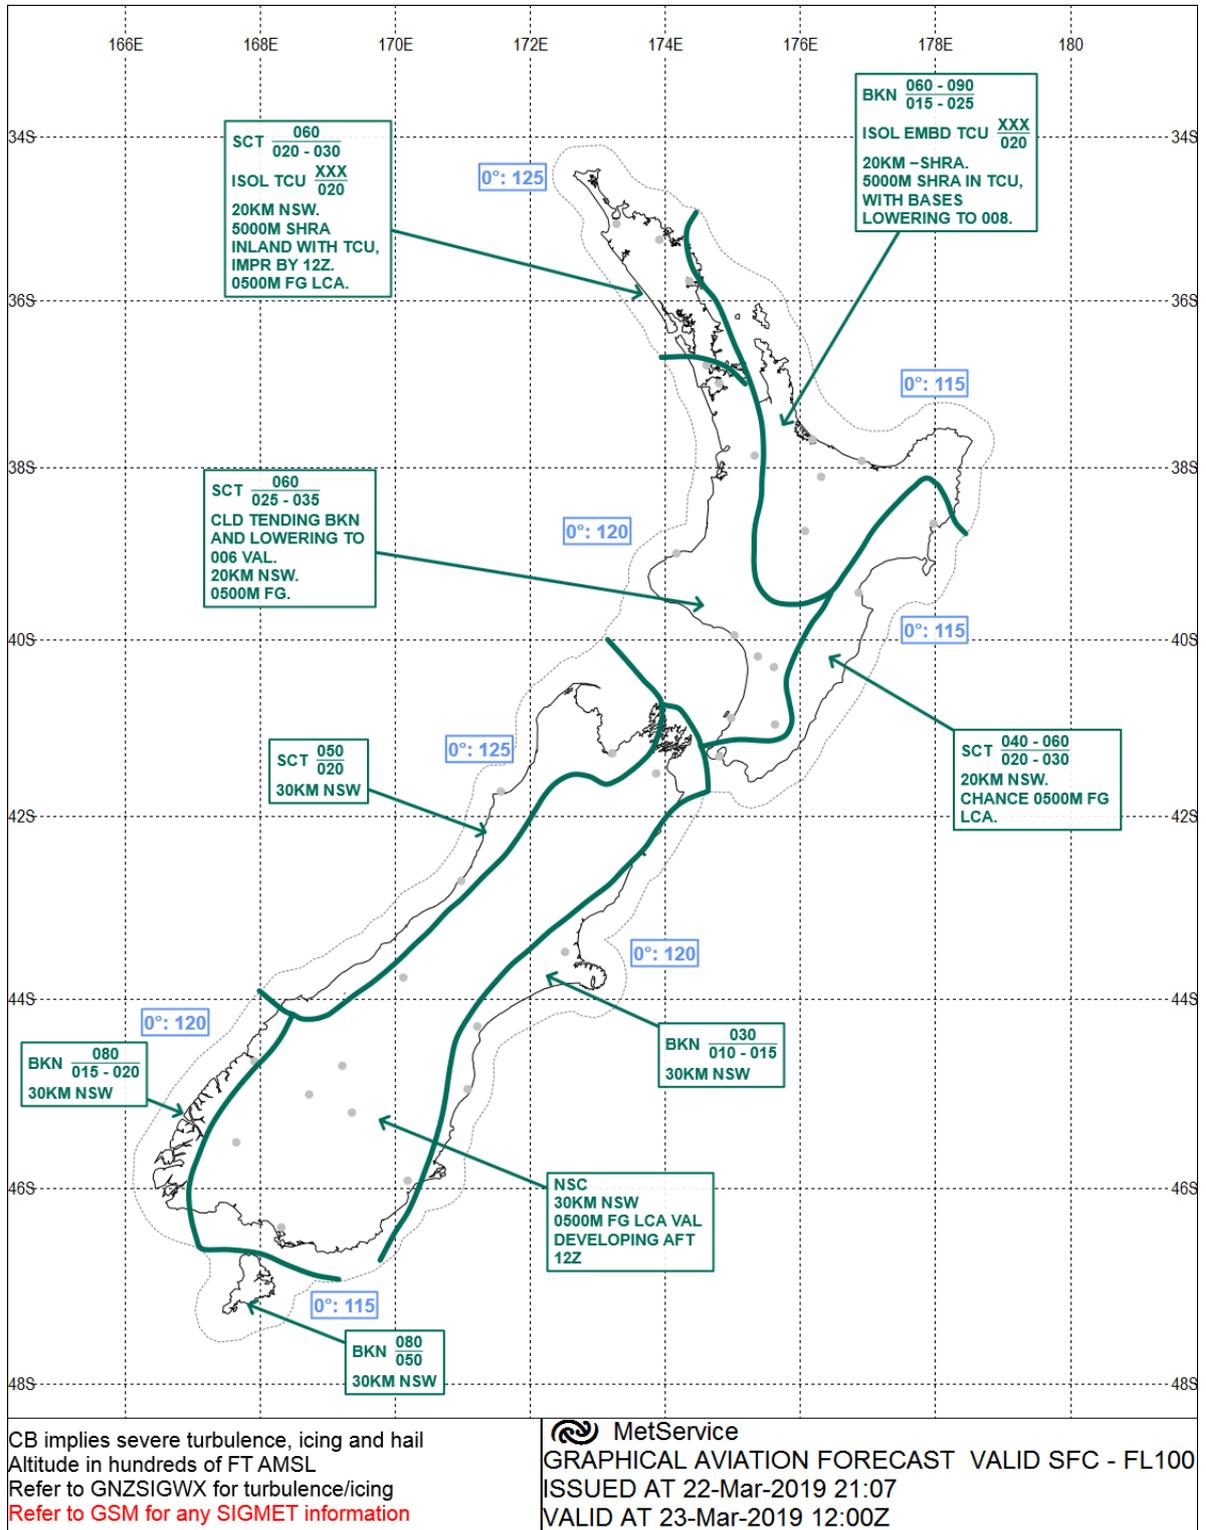
Figure 7: GRAFOR after the accident

The GRAFOR valid for approximately three hours after the time of the accident (see Figure 7) detailed broken cloud between 1,500-2,500 feet (457-762 m) and 6,000-9,000 feet (1,828-2,745 m), isolated embedded towering cumulonimbus above 2,000 feet (609 m), visibility 20 km with showers and rain and 5 km visibility with showers and rain in towering cumulonimbus cloud, with cloud bases lowering to 800 feet (243 m).
