Final report Tuhinga whakamutanga

Aviation inquiry AO-2019-006 Cessna 185A, ZK-CBY and Tecnam P2002, ZK-WAK Mid-air collision, near Masterton 16 June 2019

September 2022

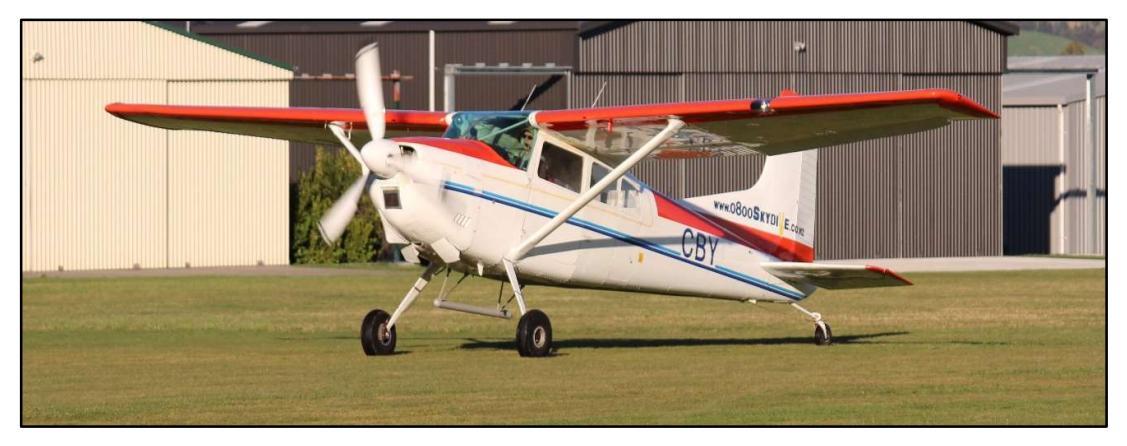
Figure 1: Cessna 185A ZK-CBY (Credit: Skydive Wellington)

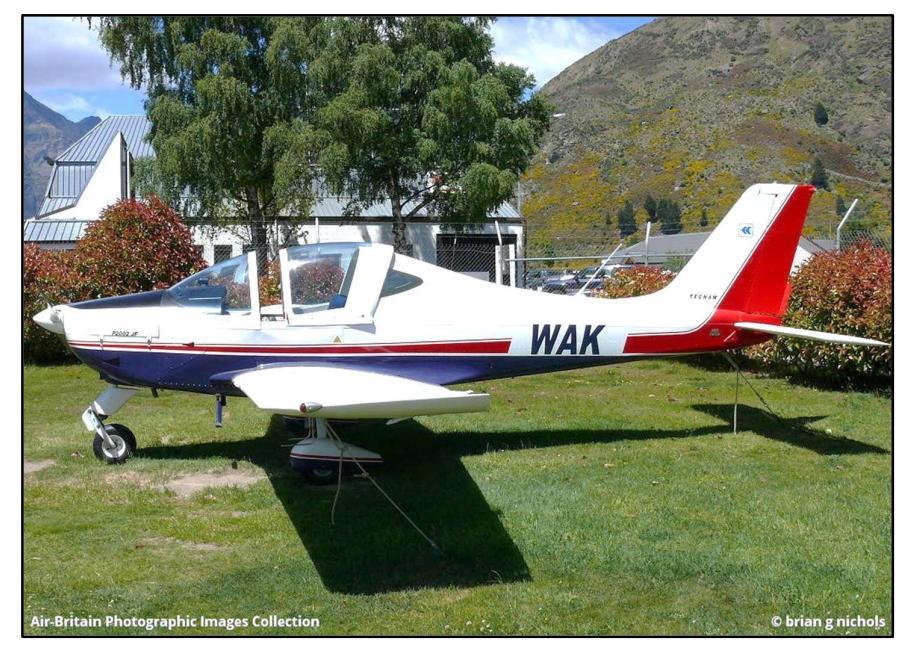
Figure 2: Tecnam P2002 ZK-WAK (Credit: Brian G Nichols)

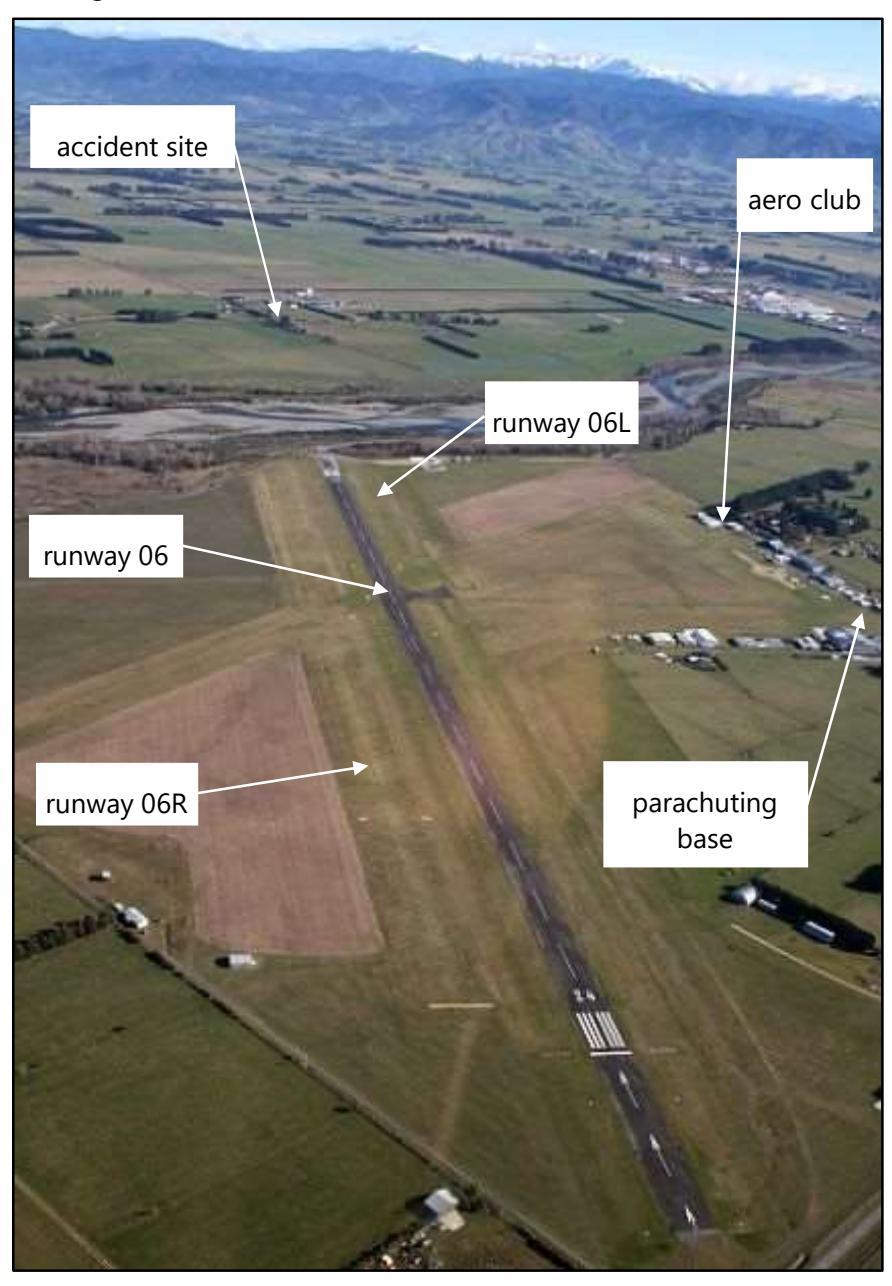
- 2.3. At 1052:49, the pilot of ZK-WAK called taking off from runway 06 to vacate to the north of the aerodrome, returning to Masterton about 10 minutes later (see figure 4). The second Tecnam, ZK-WRA, was operating in the runway 06 circuit at this time. Between about 1100 and 1104, the pilot of ZK-CBY used the aeroplane's second radio to call Ohakea Control and obtain air traffic control clearance to enter the controlled airspace and climb to 13,000 feet (4000 metres) over the aerodrome for the drop. At 1104:12, the pilot of ZK-CBY made a call on the local radio frequency advising "two minutes to drop, there will be two canopies over the field".

Figure 4: Masterton Aerodrome (Credit: Masterton District Council)

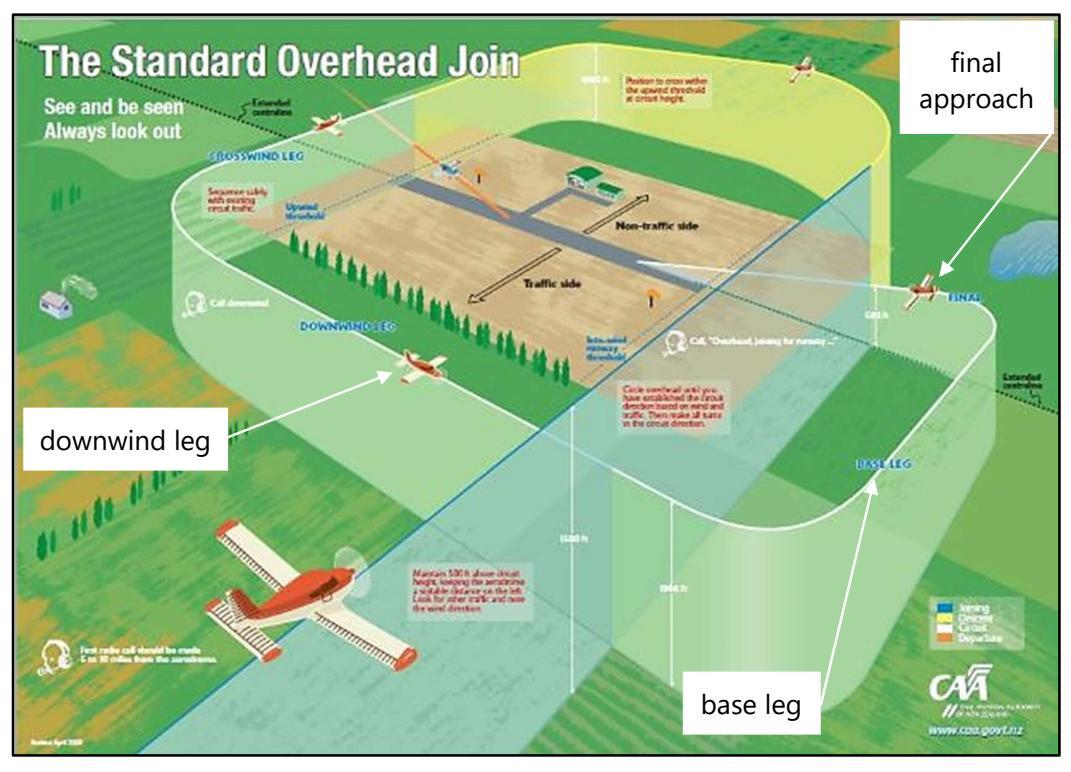
- 2.66. The joining procedures to be followed at aerodromes in New Zealand were contained in the Aeronautical Information Publication New Zealand (AIP). Some aerodromes around New Zealand, mainly those with an air traffic service, had specific joining procedures for pilots to follow, but most uncontrolled aerodromes did not.¹⁸ Unless stated otherwise, a pilot could therefore join an aerodrome via any part of the circuit, including the downwind, base or final approach, provided it complied with CAR 91.223 (see figure 10).
- 2.67. Where a pilot was unfamiliar with an aerodrome or unsure about the conditions, they could join via a standard overhead join. The CAA Flight Instructor Guide stated that "The standard overhead join procedure is a recommended means of complying with this rule...", referring to CAR 91.223 (CAA, 2021). The AIP included similar directions.

Figure 10: Circuit and standard overhead joining procedure (left-hand circuit) (Credit: CAA)

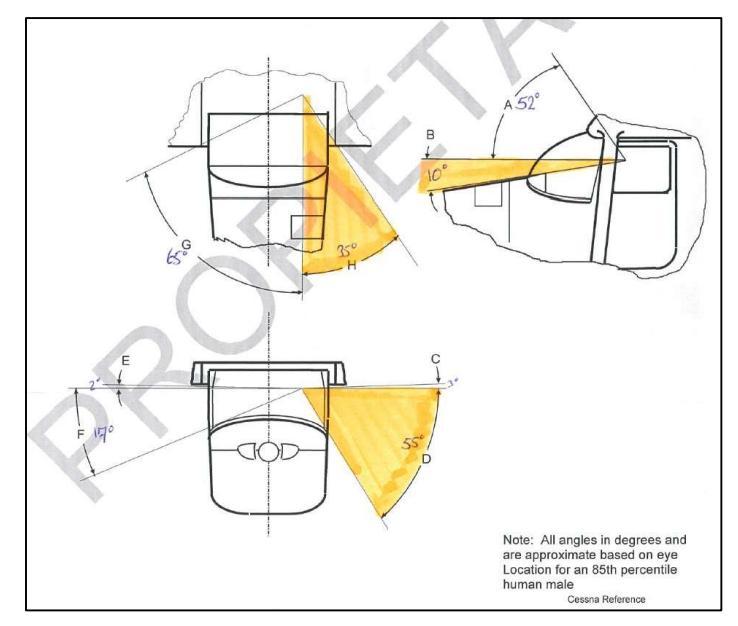
3.19. The engine cowling and propeller of a Cessna 185 type of aeroplane extends some 1.6 metres in front of the pilot's instrument panel. This limits a pilot's field of view when looking forward. Figure 13 shows the 'field of view' chart for the Cessna 185 aeroplane. The chart is based on the '85th percentile human male'.²⁹

- 3.20. Working back from the known collision point and impact angle, the recorded approach path and speed of ZK-CBY and the likely approach speed of ZK-WAK,³⁰ it was possible to determine the approximate relative bearings of the two aeroplanes leading up to the collision. From this, it was determined to be **very likely** that the pilot of ZK-CBY's view of ZK-WAK would have been obscured by the aeroplane's engine cowling in the approximately 15–20 seconds leading up to the collision.
- 3.21. During training, pilots are taught about blind spots and the need to check these areas to ensure they are free of potential hazards. This may be by moving the head and upper body, or by manoeuvring the aircraft. To assist in locating and identifying other aircraft, pilots can also use their radios if fitted.

Figure 13: Cessna 185 visibility diagram (Credit: Cessna Aircraft Company)
