Transport Accident
Investigation
Commission

Final report

Aviation inquiry AO-2019-006
Cessna 185A, ZK-CBY and
Tecnam P2002, ZK-WAK
Mid-air collision, near Masterton
16 June 2019

November 2022

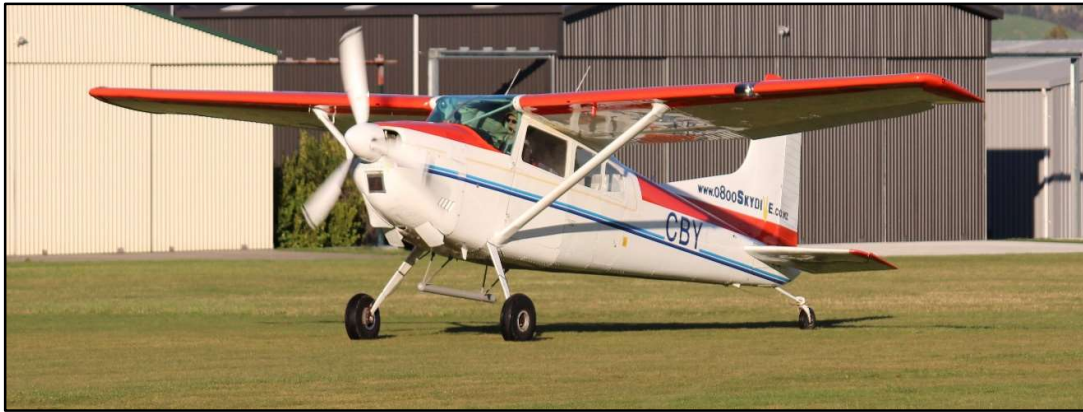
Figure 1: Cessna 185A ZK-CBY
(Credit: Skydive Wellington)

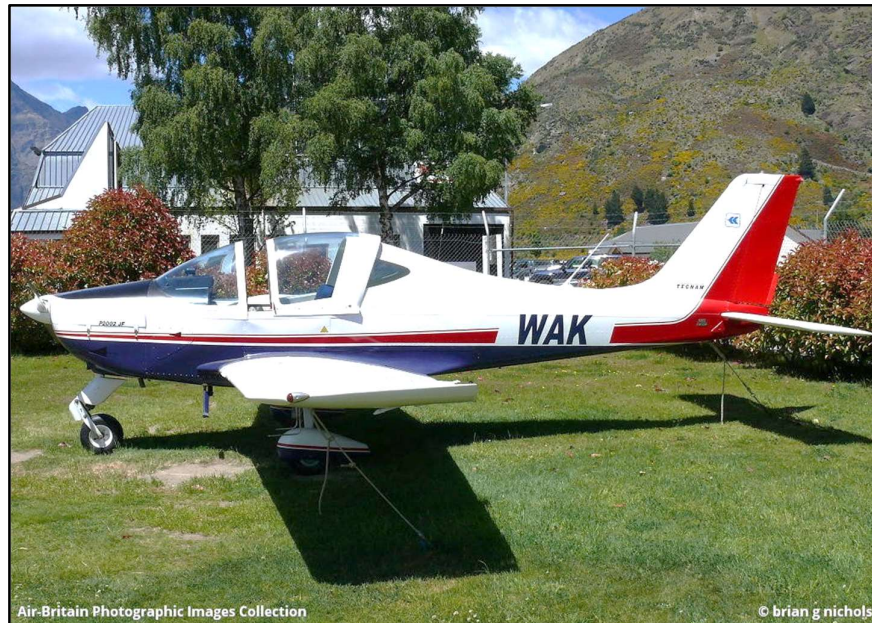
Figure 2: Tecnam P2002 ZK-WAK
(Credit: Brian G Nichols)

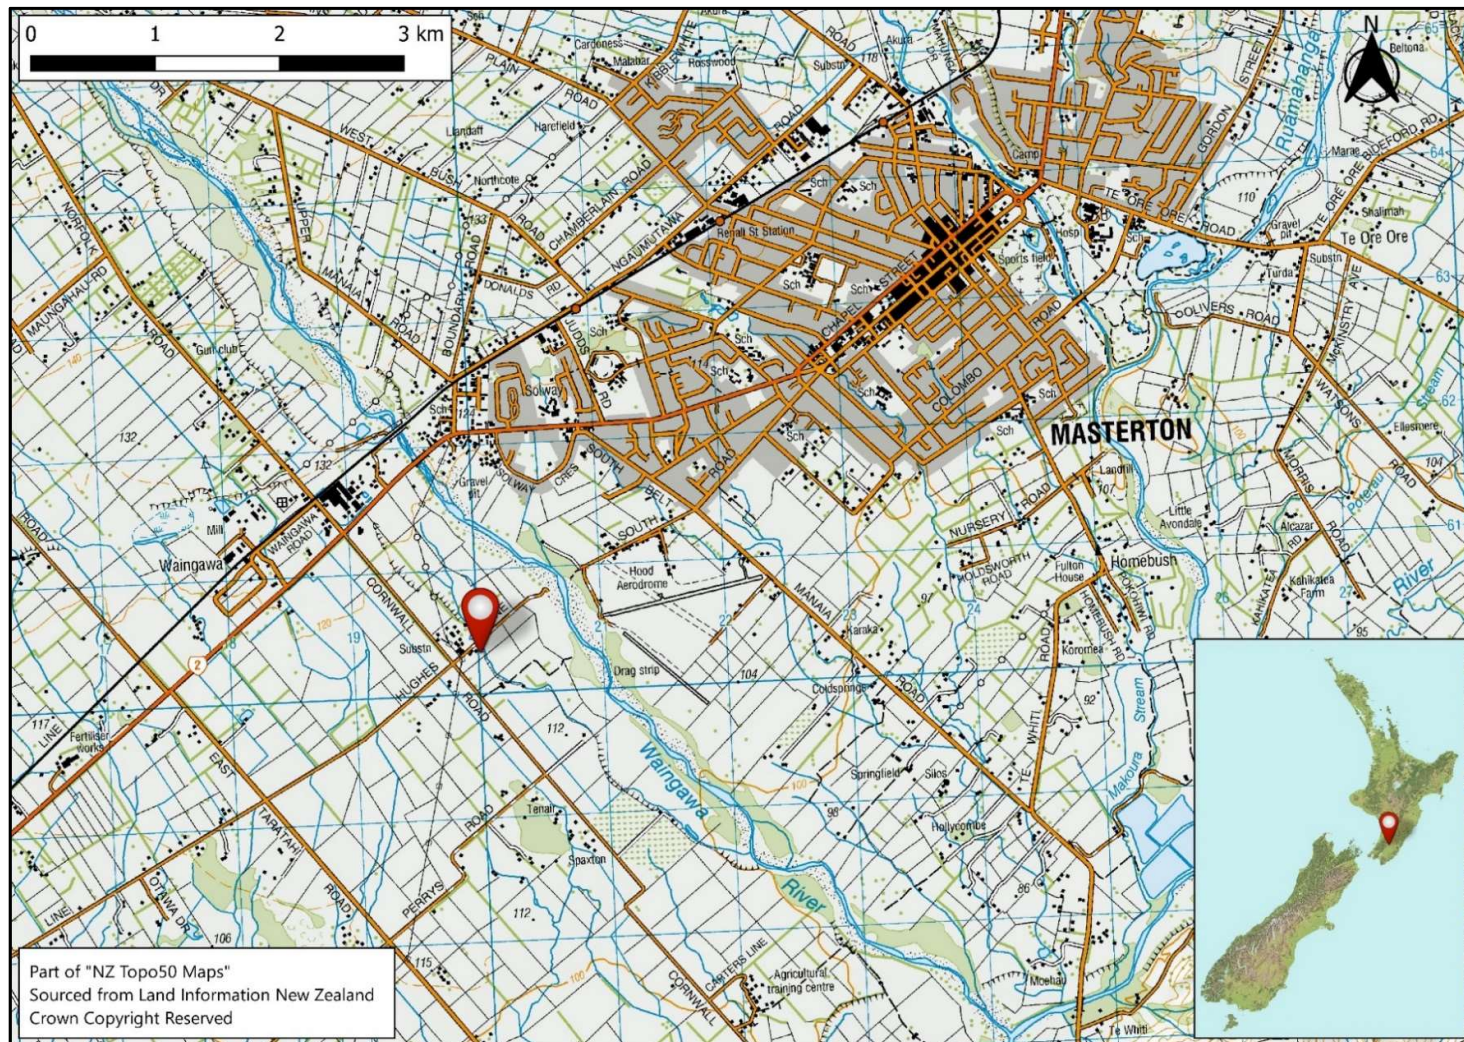
Figure 3: Location of accident

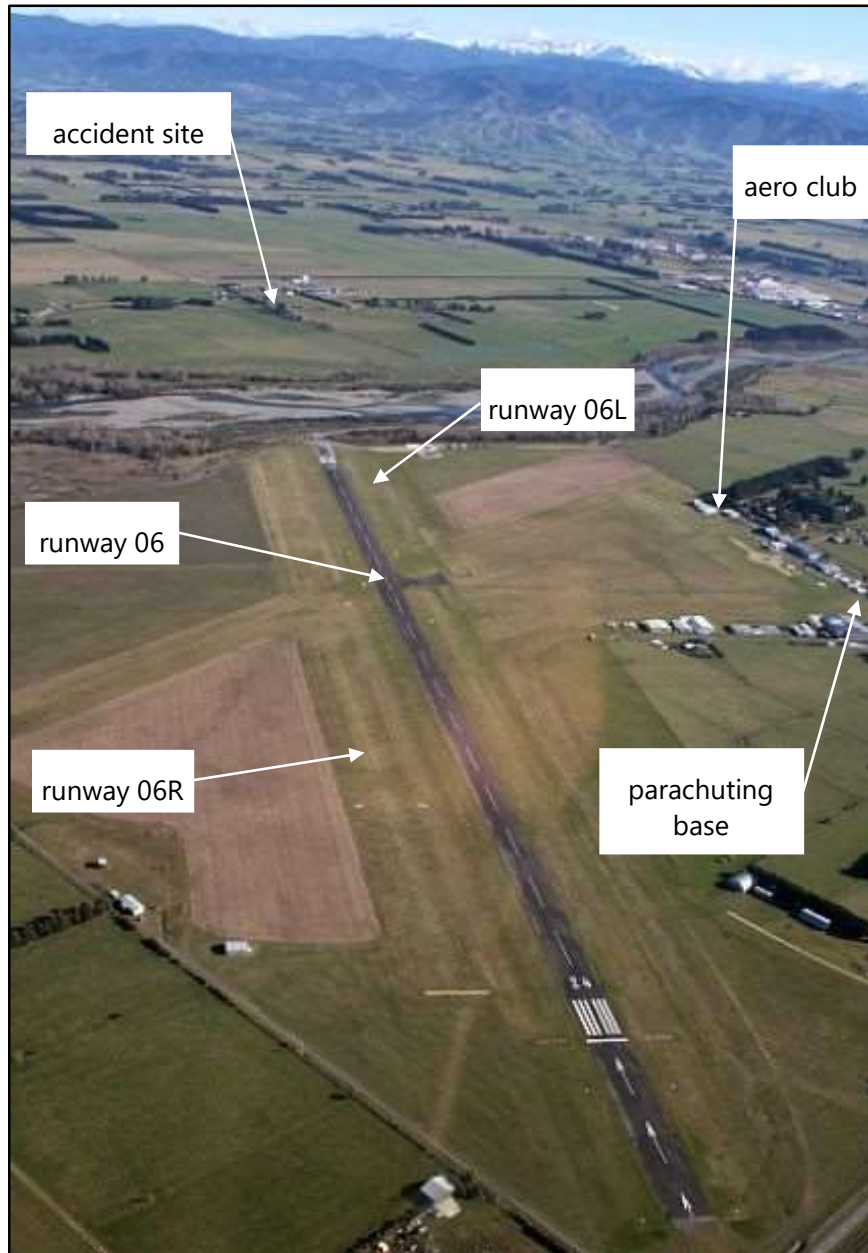
- 2.3. At 1052:49, the pilot of ZK-WAK called taking off from runway 06 to vacate to the north of the aerodrome, returning to Masterton about 10 minutes later (see figure 4). The second Tecnam, ZK-WRA, was operating in the runway 06 circuit at this time. Between about 1100 and 1104, the pilot of ZK-CBY used the aeroplane's second radio to call Ohakea Control and obtain air traffic control clearance to enter the controlled airspace and climb to 13,000 feet (4000 metres) over the aerodrome for the drop. At 1104:12, the pilot of ZK-CBY made a call on the local radio frequency advising "two minutes to drop, there will be two canopies over the field".

Figure 4: Masterton Aerodrome
(Credit: Masterton District Council)

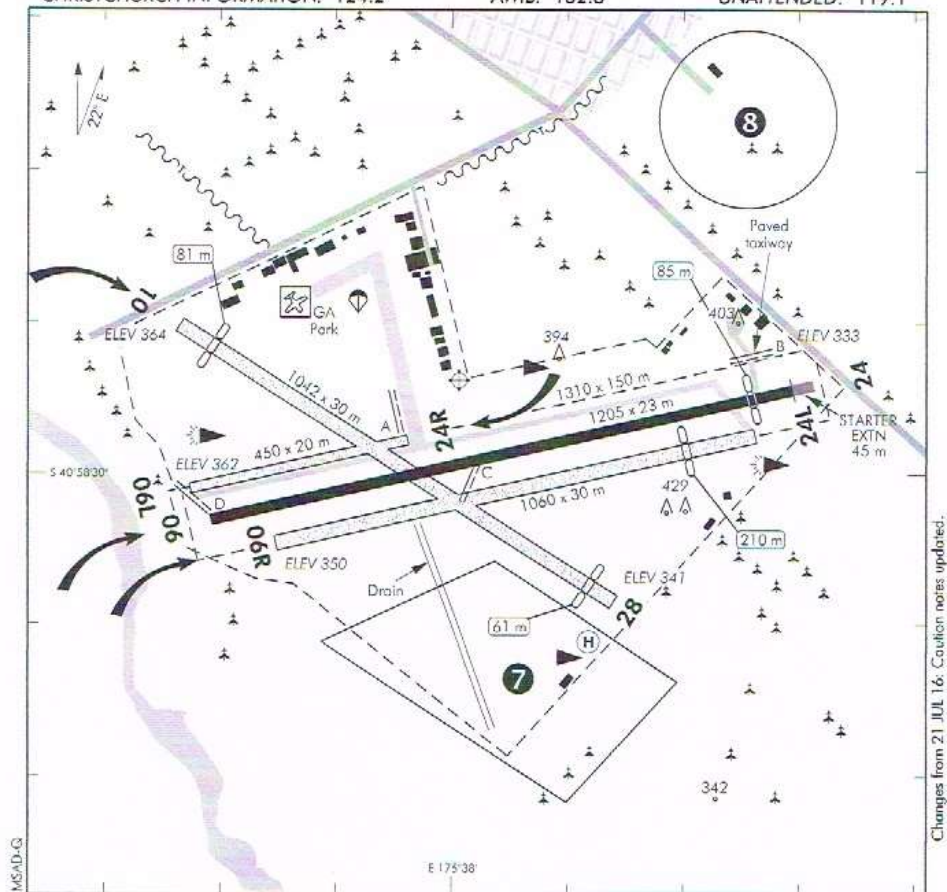
MASTERTON
AERODROME (1)

- 1.5. Both aeroplanes were approaching the runways at the same time. The aerodrome chart informed pilots that 'simultaneous operations' were prohibited. However, there was no definition of what 'simultaneous operations' were, and as a result there were a range of interpretations. A recommendation was made to address this deficiency and review aerodrome charts generally to ensure they are relevant and consistent.

1. Circuit:
Sealed RWY06 — Right hand
24 — Left hand
Grass RWY 10 and Southern grass RWY 06R — Right hand
Grass RWY 28 and Southern grass RWY 24L — Left hand
Northern grass vector 06L — Left hand
24R — Right hand
2. Simultaneous operations on parallel paved and grass runways prohibited.
3. Grass areas very soft when wet in winter.
4. Northern parallel grass vector 06L/24R restricted to locally based operators only.
5. **CAUTION:** (a) All aircraft over 5700 kg MCTOW are advised to remain on main runway or main taxiways.
(b) **NORDO movements can take place on any day.**
(c) **Parachute activity takes place — surface to 12,000 ft AMSL. Pilots should avoid overhead join procedure when parachute operations are in progress. Listen out on 119.1.**
(d) Gliders operate and operations can be quite extensive.
(e) Open drain hazard to the south of intersection of Gr RWY 06R/28.

8. Model aircraft flying takes place in this area up to 400 ft AGL.
9. If radio equipped listen to AWIB to determine likely RWY in use.
10. A standard overhead join is recommended, except when parachute operations are in progress.

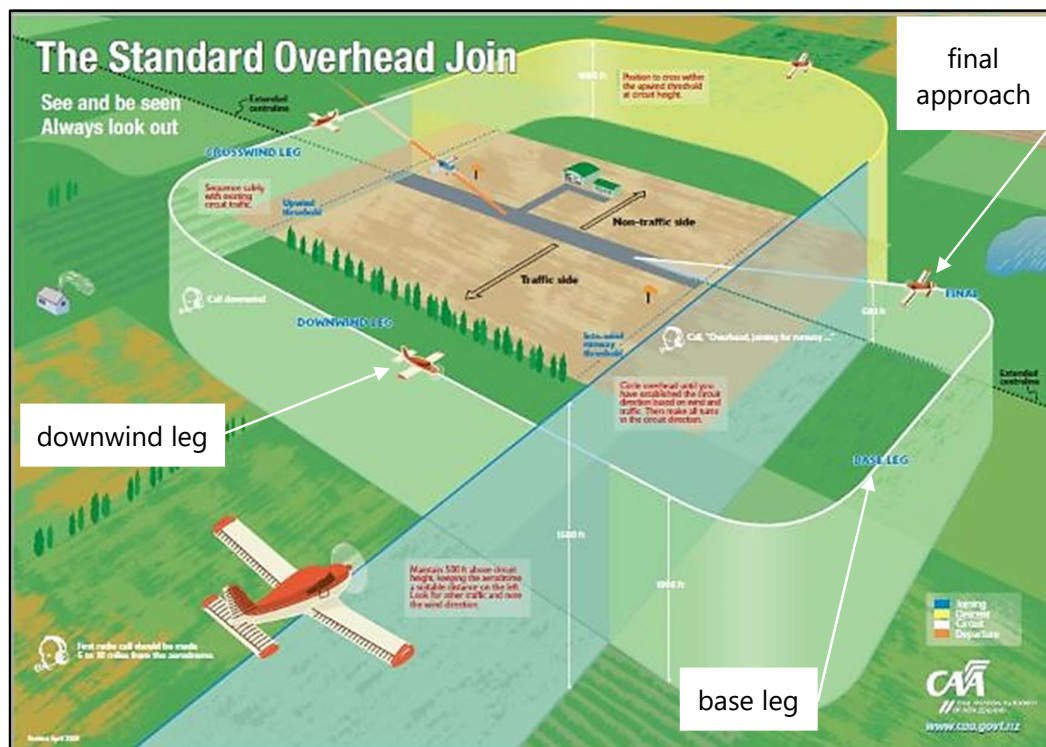
- 2.66. The joining procedures to be followed at aerodromes in New Zealand were contained in the Aeronautical Information Publication New Zealand (AIP). Some aerodromes around New Zealand, mainly those with an air traffic service, had specific joining procedures for pilots to follow, but most uncontrolled aerodromes did not.¹⁸ Unless stated otherwise, a pilot could therefore join an aerodrome via any part of the circuit, including the downwind, base or final approach, provided it complied with CAR 91.223 (see figure 10).
- 2.67. Where a pilot was unfamiliar with an aerodrome or unsure about the conditions, they could join via a standard overhead join. The CAA Flight Instructor Guide stated that “The standard overhead join procedure is a recommended means of complying with this rule...”, referring to CAR 91.223 (CAA, 2021). The AIP included similar directions.

Figure 10: Circuit and standard overhead joining procedure (left-hand circuit)
